# Tesla Model 3 Susceptibility to Sudden Unintended Acceleration

Ronald A. Belt  
Plymouth, MN [REDACTED]

1 May 2023

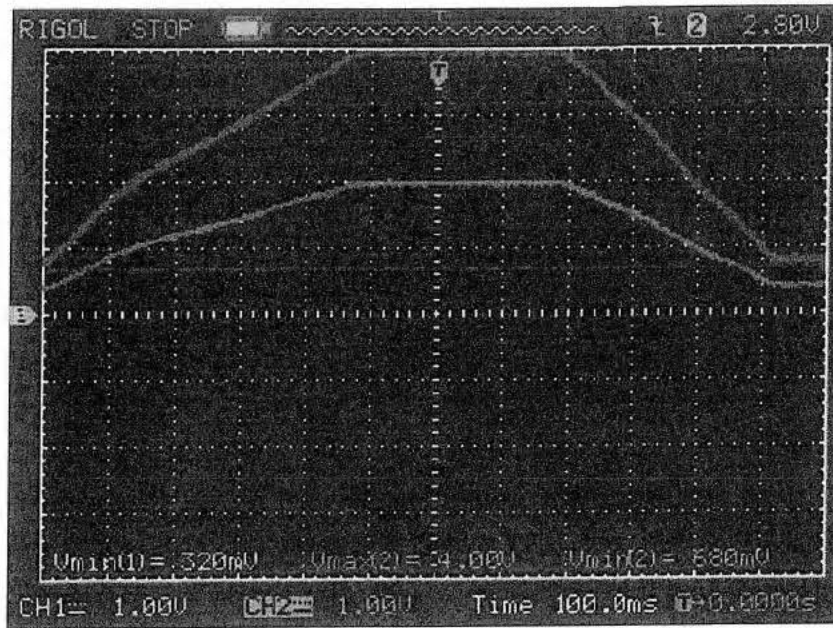
Figure 11 shows that the two APP sensor signals, which are created using separate 5V voltage regulators on the TLF35584QVVS2 PMIC chip, can vary between 0.68 and 4.0V for the top APP sensor and between 0.34V and 2.0V for the bottom APP sensor. Before applying these two APP sensor signals to the inputs of two different ADC's as shown in Figure 10, these voltages must be converted from a 5V basis  $V_{5V}$  to a 3.3V basis  $V_{3V3}$  by dividing them down using voltage dividers which multiplies them by the ratio  $3.3V/5V$ . The  $V_{3V3}$  signals are then digitized by the ADC's, which give the results as a number of counts  $N_{3V3}$  based on the maximum ADC signal  $V_{REF}$  being 3.3V. The voltage corresponding to this number of counts is the voltage  $V_{3V3}$  equal to  $N_{3V3}$  times the gain  $G$  of the ADC where the gain  $G = 3.3V/N_{MAX}$ , with  $N_{MAX}$  being the maximum number of counts the ADC can produce. For a 10-bit ADC,  $N_{MAX} = 1023$  and for a 12-bit ADC,  $N_{MAX} = 4095$ . The voltages  $V_{3V3}$  are then transferred into CPU RAM as 32-bit floating point values. Before any checks can be performed on the two APP sensor signals, these  $V_{3V3}$  values must first be converted back into a  $V_{5V}$  values by multiplying by  $5V/3.3V$ . Then, the two signals are checked to see if they lie within the limits of the maximum and minimum signals based on 5V. If either

Figure 11. Oscilloscope traces of the APP sensor signals from a Tesla accelerator pedal.<sup>[12]</sup> The top sensor is always twice the voltage of the bottom sensor, with the top sensor increasing from 0.68V to 4.0V as the pedal is pressed from 0% to 100% while the bottom sensor increases from 0.32V to 2.0V as the pedal is pressed from 0% to 100%.

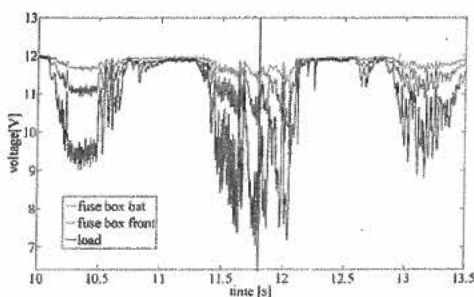
So, how can a negative-going voltage spike occur on the attenuated 5V calibration voltage while it is being digitized by the ADC? First, the negative-going voltage spike can occur on the “12V” supply line because it is used by the electric power steering booster motor, which draws a whopping 100A or greater DC current in Tesla vehicles. This current load is so high because the weight of Tesla’s high voltage battery makes Tesla vehicles some of the heaviest passenger vehicles on the road, requiring a power steering system with the greatest torque and the highest current available. Then, when the power assist motor in this system is suddenly turned on by turning the vehicle’s steering wheel while making a sharp low-speed turn in a parking lot, the assist motor suddenly draws an inrush current three to five times higher than the DC current for several hundred microseconds. This higher inrush current can’t be supported by the “12V” battery, which can supply a maximum current of only 100A or less, and the DC/DC converter, which can only supply about 200A or less. Therefore, the “12V” supply line is pulled down to near zero volts for several hundred microseconds. See Figures 12 and 13 which provide evidence on the existence these voltage dips.

Fig. 12. Voltage spikes on the “12V” supply line of an ICE vehicle as caused by an electronic power steering (EPS) system during a slalom maneuver.<sup>[20]</sup>

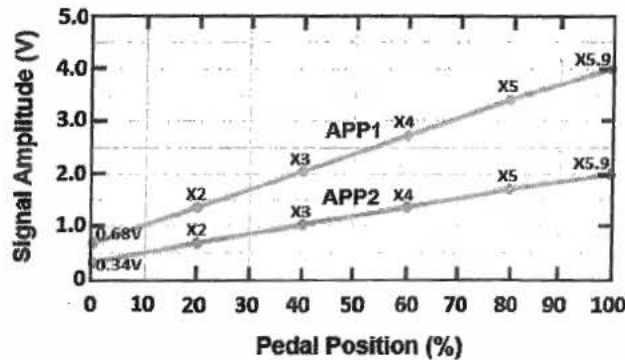
Figure 13 shows the values X in Table 3 that multiply the released APP sensor signals after they have been calibrated superimposed on the transfer function (APP sensor voltage vs pedal depression) of the normal APP sensor signals. One can see that the released APP sensor signals, when corrected for a decrease in the “1.65V” calibration voltage, lie on the same transfer function as the original APP sensor signals, making it clear that they will pass all tests performed on the original APP sensor signals.

Figure 13. APP signal transfer functions showing that multiplying the released pedal values by the factors xN produces values that lie on the same curves as the original transfer functions, allowing the corrected signals to pass all tests performed on the original APP signals.

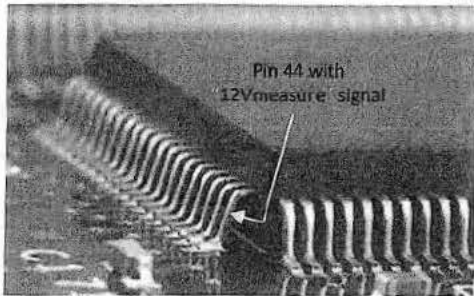
One can verify that the proposed cause of sudden acceleration is correct by opening the Model 3 inverter housing to access the inverter PWB as shown in Figure 1. Then, one can lift DSP pin 44 from its PWB pad and attach a wire to the lifted pin as shown in Figure 13 below. This wire can then be passed through the 30-pin connector on one of its three unused pins (pin 9, 19, or 29). If this wire is then accessed on the other side of the 30-pin connector when the inverter housing is closed back up, one can then impose a variable voltage on the wire. If one keeps this voltage

Figure 14A. DSP pin 44 with the “12V measure” signal is the last pin on the left.

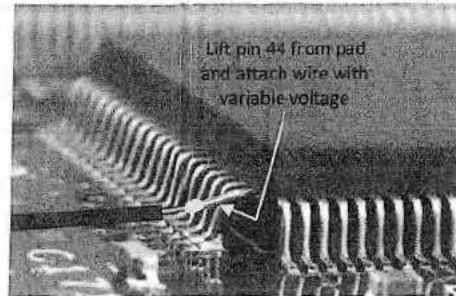
Figure 14b. Lift DSP pin 44 and attach a wire with a variable voltage.

constant at 5V scaled down to 1.65V, then the inverter will run normally with torque being varied by pressing the accelerator pedal. But if one changes this voltage to 0.281V or less, which can happen when the 12V supply dips temporarily to 2.14V, then the APP sensor outputs will read 4V and 2V, which is equivalent to flooring the accelerator pedal. This causes sudden unintended acceleration without the driver pressing on the accelerator pedal.

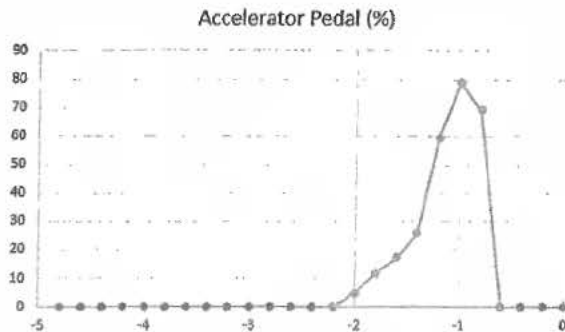
Fig A1. EDR data for a female driver approaching a garage on a level driveway<sup>[24]</sup>

At first it would seem that both these signals were made by drivers pressing on the accelerator pedal instead of the brake pedal. This is a common conclusion when it is believed that the signals can be non-zero only when the driver is pressing on the accelerator pedal. Whoever believes these EDR APP sensor signals were made by drivers pressing on the accelerator pedal instead of the brake pedal must also explain the similarity between the two signals even though they were produced by two different drivers in vastly different situations. This similarity lies not only in the large amplitudes of the two signals, but also in the similarity of the two rise times; namely, a slow one lasting for about 0.8 seconds followed by a faster one that rises to a maximum in less than a half a second. Are we to believe that two drivers of different sexes and in two entirely different driving situations could press the accelerator pedal inadvertently at almost exactly the same rates of movement with a slow depression first followed by a faster occurring at almost the same time later? This author believes not.

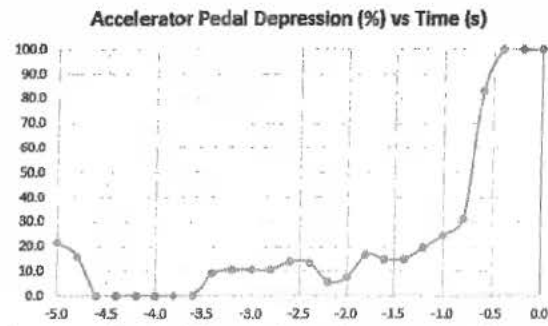
Fig A2. EDR data for a male driver going down-hill in a parking ramp<sup>[25]</sup>

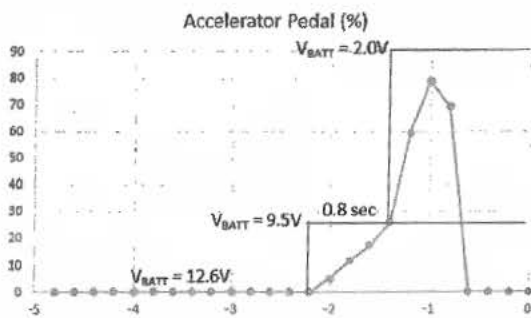
Fig A3. EDR data shows two step functions with  $V_{BATT}$ 's equal to 9.5V and 2.0V separated by 0.8 sec

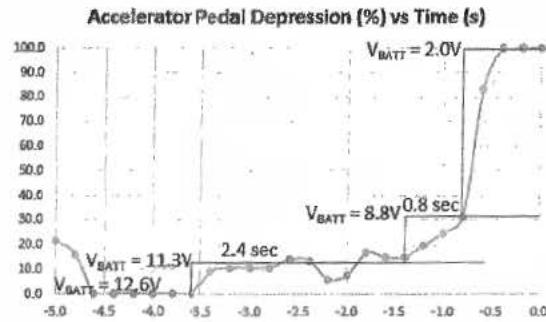
Fig A4. EDR data shows three step functions with  $V_{BATT}$ 's equal to 11.3V, 8.8V, and 2.0V separated by 2.4 sec and 0.8 sec
