Revised **May** 2016

Dealer Service Instructions for:

Safety Recall R06 / NHTSA 15V-046 Occupant Restraint Control Module

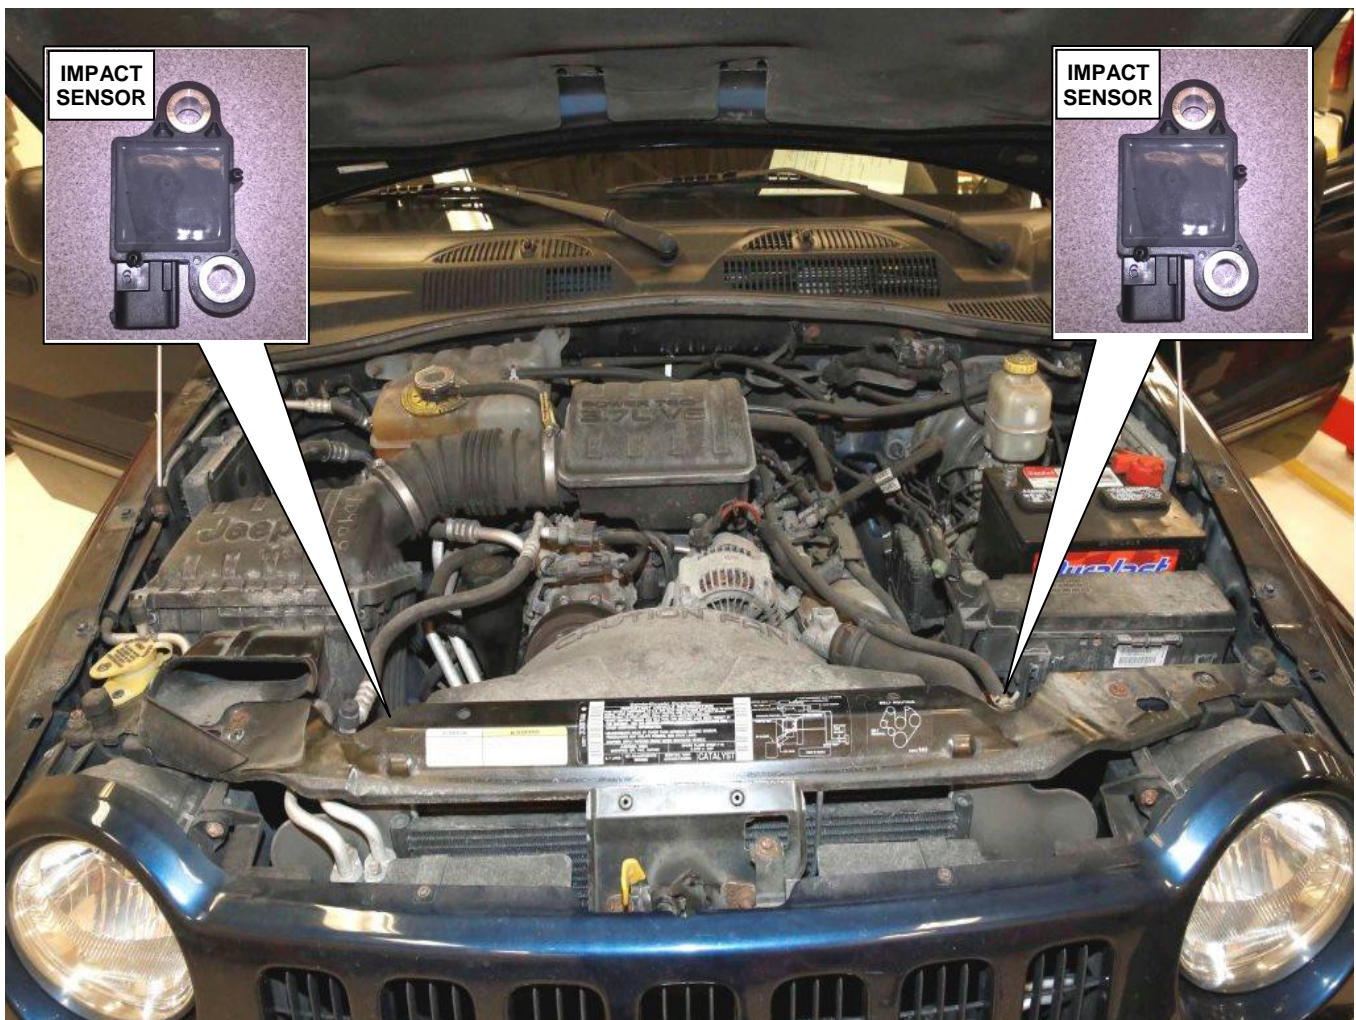
Figure 10 – Front Impact Sensor Location

NOTE: The front impact sensors are located to the right and left of the radiator on the radiator support vertical member (Figure 10).

2. Remove and save the two mounting bolts on the front impact sensor.
3. Disconnect the electrical connector from the front impact sensor.
4. Remove and discard the original front impact sensor.
