DOT Auto Safety Hotline  
**Vehicle Owner's Questionnaire**  
To Report Vehicle Safety Defects  
1-888-DASH-2-DOT  
(1-888-327-4236)  
INTERNET: www.nhtsa.dot.gov/hotline

17 digit Vehicle Identification Number (located in front of windshield on driver's side) **1J4GW58S0AC723830** Make **JEEP** Model **GRAND CHEROKEE** Model Year **1999**  
Date Purchased **10/2000** Dealer's Name and Telephone Number **Ed Schmidt 419-874-4331** Engine: **4.0** Fuel Type: **Unleaded**  
Original Owner  Dealer's City **Perrysburg** State **OH** Zip Code **43051** No. Cylinders  
Transmission Type **Automatic**  Anti-lock Brakes Powertrain  Cruise Control Vehicle Component Code **063200 ENGINE AND ENGINE COOLING:EXHAUST SYSTEM:MANIFOLD**  
Multiple Failure: 1

RE: Complaint letter sent to Daimler Chrysler  
(Revised letter-original dated February 24, 2003)

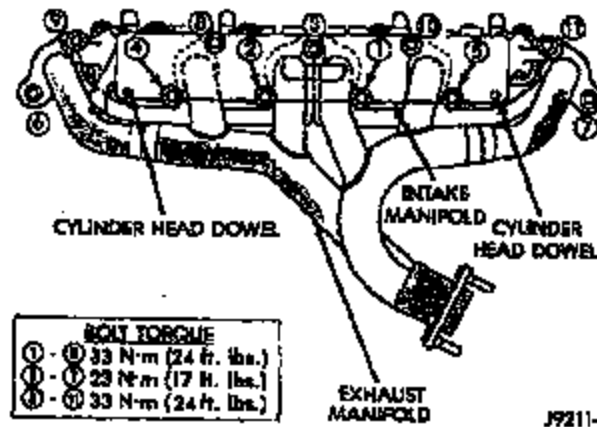
## Exhaust Manifold: Specifications

This is what WE  
Did to eliminate  
The Squeal.
