**DOT Auto Safety Hotline**  
**Vehicle Owner's Questionnaire**  
To Report Vehicle Safety Defects  
1-888-DASH-2-DOT  
(1-888-327-4236)  
INTERNET: [www.nhtsa.dot.gov/hotline](http://www.nhtsa.dot.gov/hotline)

Make  
WINNEBAGO

Model  
ADVENTURER

Vehicle Component Code  
103000 POWER TRAIN/AUTOMATIC TRANSMISSION

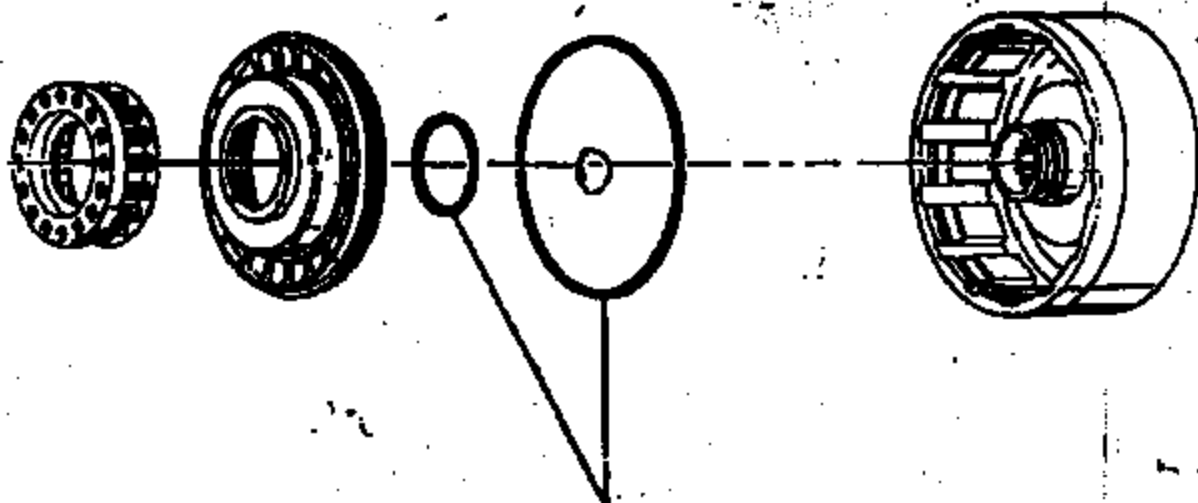
#### DIRECT CLUTCH HOUSING ASSEMBLY

### LOSS OF REVERSE WHEN HOT

TRANSMISSION HAS GOOD REVERSE UNTIL THE UNIT REACHES FULL OPERATING TEMPERATURE, PRIMARILY AFTER SUSTAINED HIGHWAY SPEEDS.

THE CAUSE HAS BEEN TRACED TO THE USE OF SHORT LIP SEALS ON THE DIRECT DRUM PISTON CAUSING THE DIRECT CLUTCH NOT TO APPLY WHEN REVERSE IS SELECTED.

USE LONG LIP SEALS WHEN RECONDITIONING THE DIRECT DRUM, TO CORRECT THIS PROBLEM. ALL KITS DATE CODED 880186 HAVE THE UPDATED LIP SEALS. ALSO MAKE CERTAIN A NEW CENTER SUPPORT BOLT IS USED AND THAT THE CENTER SUPPORT IS FULLY DRAWN UP TO THE CASE. (BOLT TORQUE IS 37 Ft Lbs.)

**INSTALL LONG LIP SEALS  
IN THESE LOCATIONS**

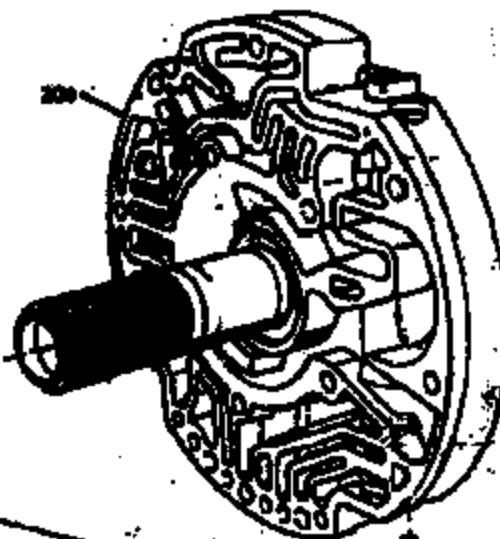
## THM 4L80-E / 4L80-EHD HIGH LINE PRESSURE IN REVERSE

BEFORE AND/OR AFTER REBUILD, THE UNIT HAS A VERY HIGH LINE PRESSURE READING WHEN THE SELECTOR LEVER IS PLACED IN THE REVERSE POSITION, AND IT MAY REPEATEDLY BREAK THE DIRECT CLUTCH PISTON AND/OR THE LOW-REVERSE BAND ASSEMBLY. THE CAUSE MAY BE A WORN BOOST VALVE SLEEVE AND/OR VALVE IN THE PUMP ASSEMBLY. LISTED BELOW ARE THE OEM PART NUMBERS THAT SHOULD BE REPLACED TO CORRECT AND TO GUARD AGAINST THIS PROBLEM.

REVERSE BOOST VALVE  
PART NO. 8480545

BOOST VALVE SLEEVE  
PART NO. 8482856
