RE: REF # 10044323 2002 Isuzu Axiom

Mr Jordan  
NHTSA Correspondence Research Division  
Office of Defects Investigation  
400 Seventh Street, S.W.  
Washington, DC 20590

# Orig & Complaint NHTSA I

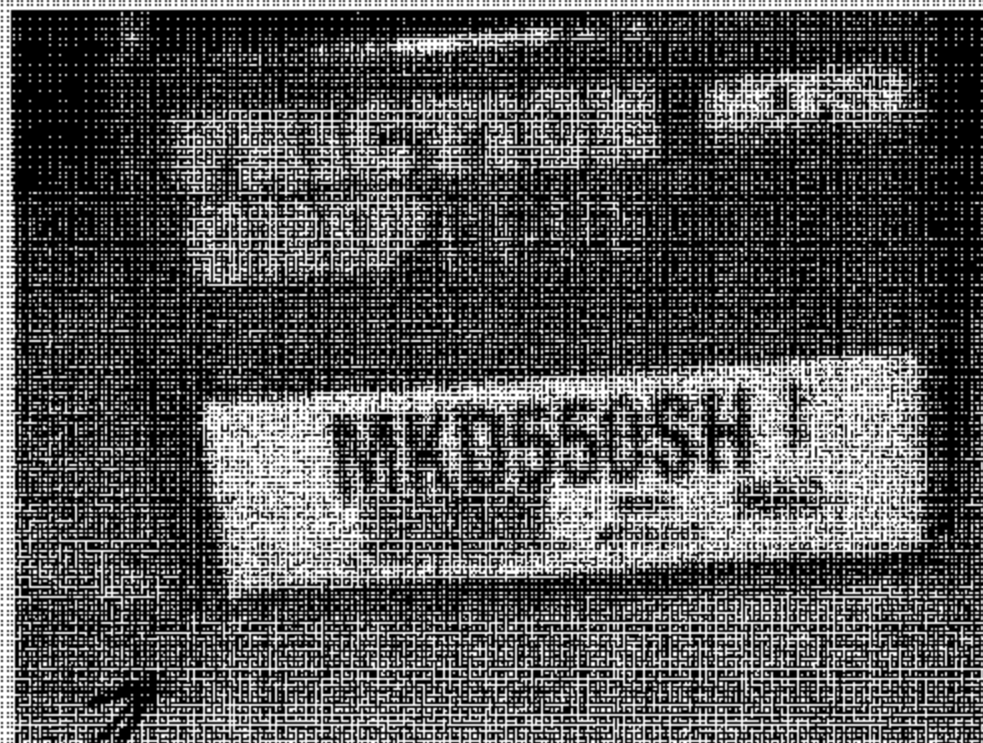
Sumitomo  
M9286 FF  
G1724  
A-FS13WB

This Brake is ON  
My Vehicle Now

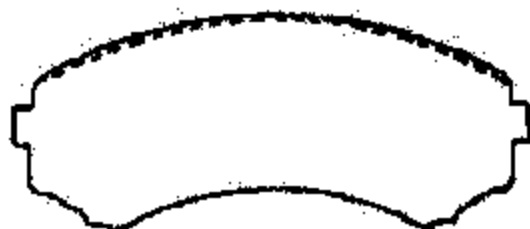
2003 Isuzu Axiom Front Brake Pads

ON MY  
Vehicle  
Now

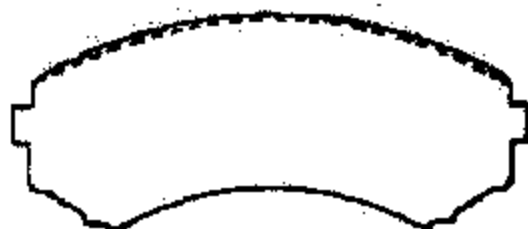
2004 Isuzu Axiom Front Brake pads

On My Vehicle  
NOW

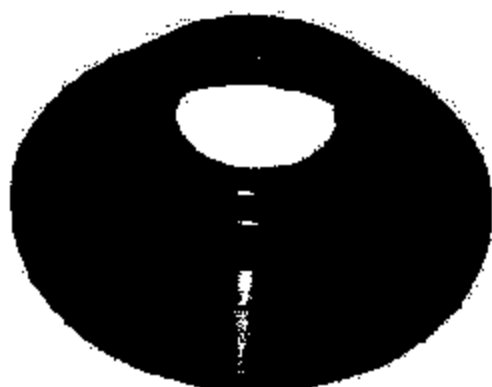
2003 isuzu Front rotor

different  
parts  
Then what  
supposed to  
be on my  
vehicle

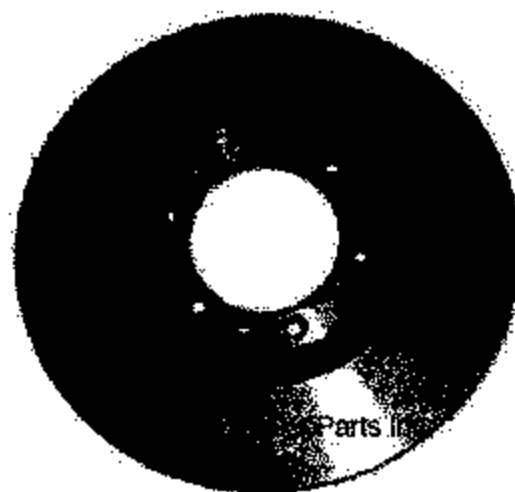
2002 Isuzu Axiom Front Rotor

different  
parts  
than what's  
supposed to  
be on my  
vehicle
