DOT Auto Safety Hotline  
**Vehicle Owner's Questionnaire**  
To Report Vehicle Safety Defects  
1-888-DASH-2-DOT  
(1-888-327-4236)  
INTERNET: www.nhtsa.dot.gov/hotline

CONSUMER STATED BRAKING SYSTEM OPERATED POORLY. HAD VEHICLE INSPECTED, AND DISCOVERED THAT ALL FOUR REAR WHEELS BRAKE ASSEMBLY WAS CRACKED. ELEVEN FAILURES WERE REPORTED WITH DEALER WITHIN 22 MONTHS. \*AK

November 14, 2003

This letter and the attached enclosures augment the Vehicle Owner's Questionnaire from your office to bring attention to the serious problem of defective brake assemblies. Specifically these are the S cam Brake assemblies installed on the tri axle truck of my client; and common to other trucks with the same rear axle assemblies.

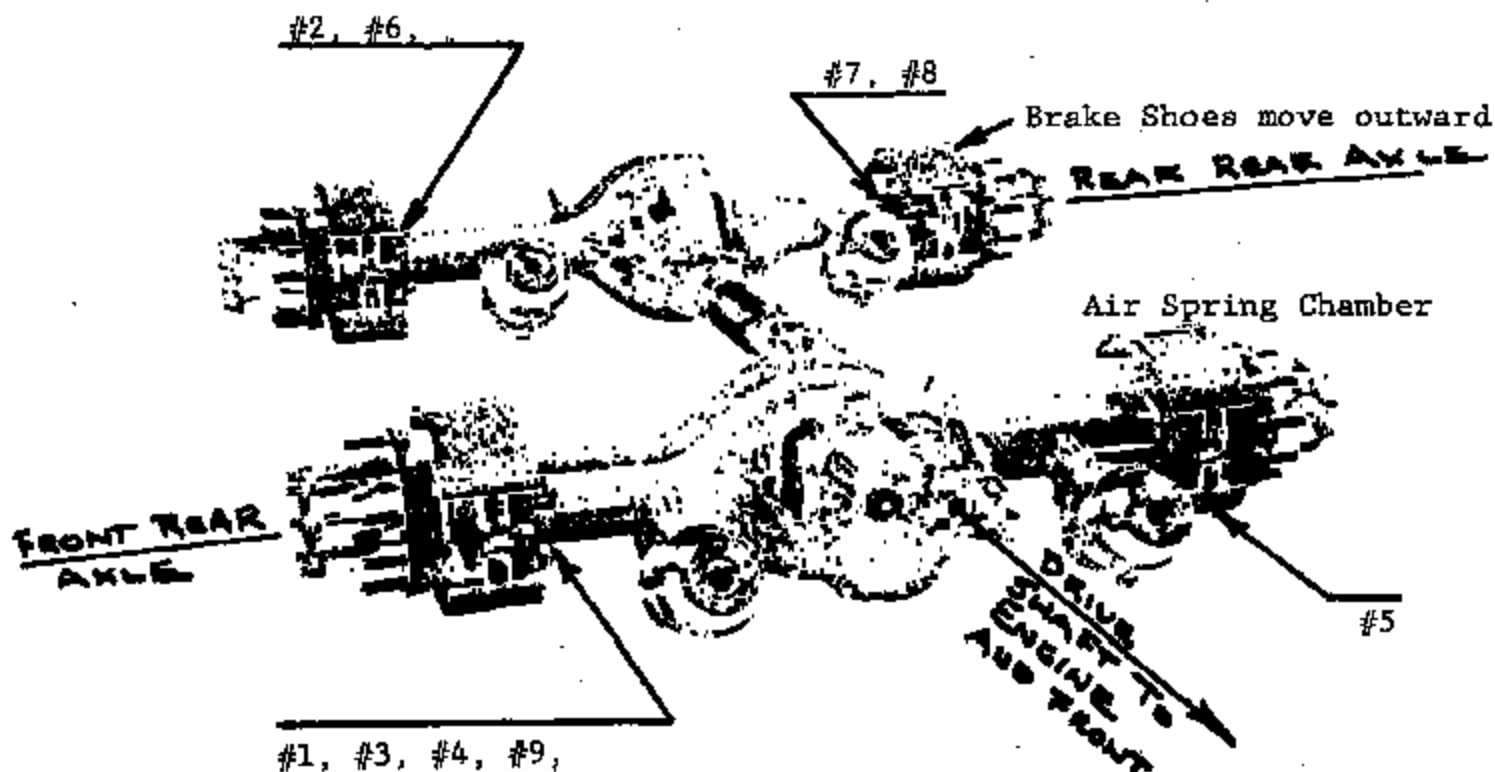
## ENCLOSURE # 5

The drawing below is an excerpt from Peterbilt sales literature. Shown there are the locations of the S cam Brake failures on the Wardell truck.

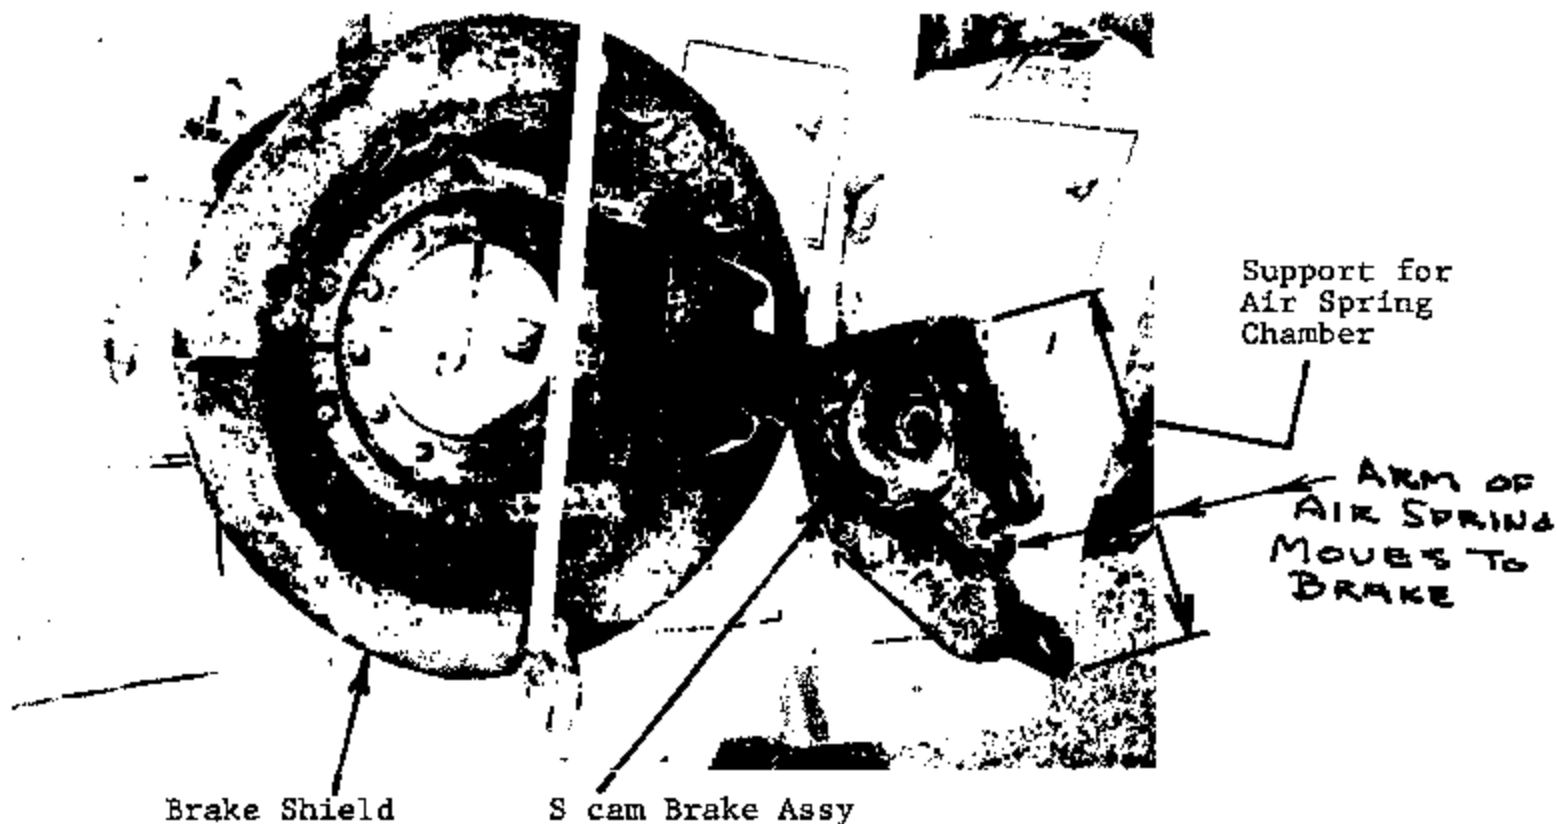
These pictures make up a view of the attachment of the S cam Brake Assembly to the Brake Shield/Rear Axle which is stationary. Below the failure area occurs in the welding at the Chamber support.

Weld of tube to bracket fails (not shown)

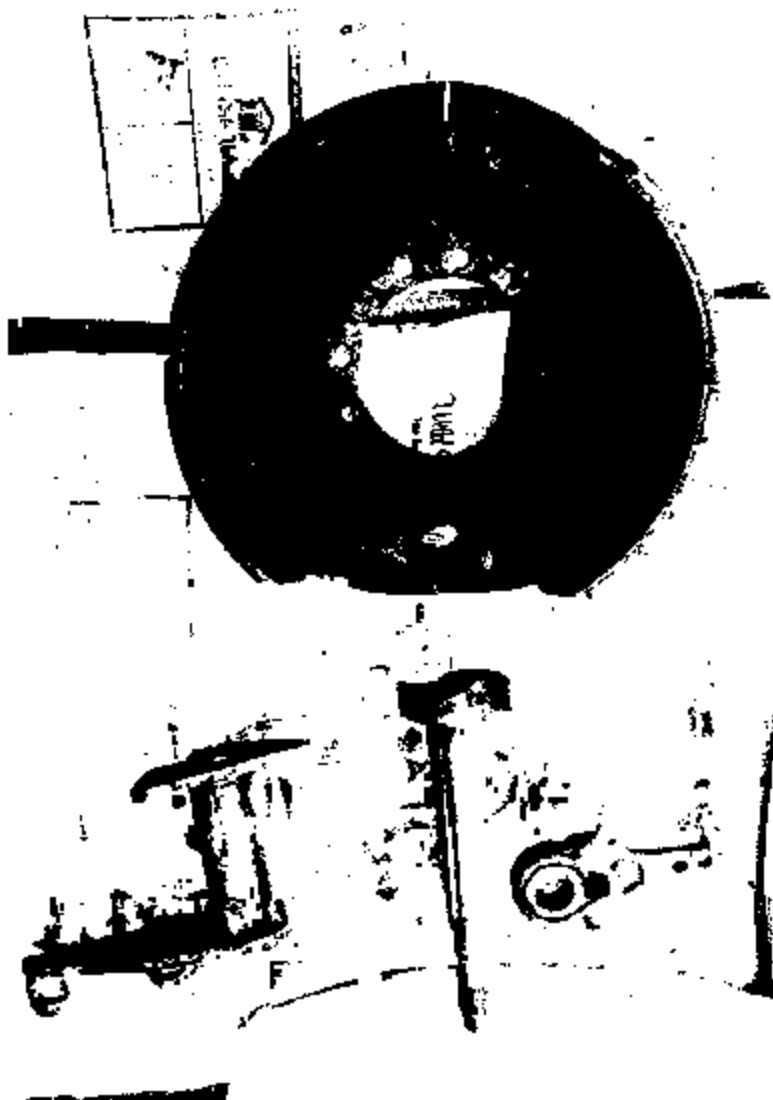
The left side pictures show that side of the bracket where a weld fillet ties it to the tube. The yellow clay bead locates the area just off the weld metal where cracking occurs.

The right side pictures show the area of a cut away specimen that will be examined to show area of the weld and its tie into the tube metal and the bracket metal.

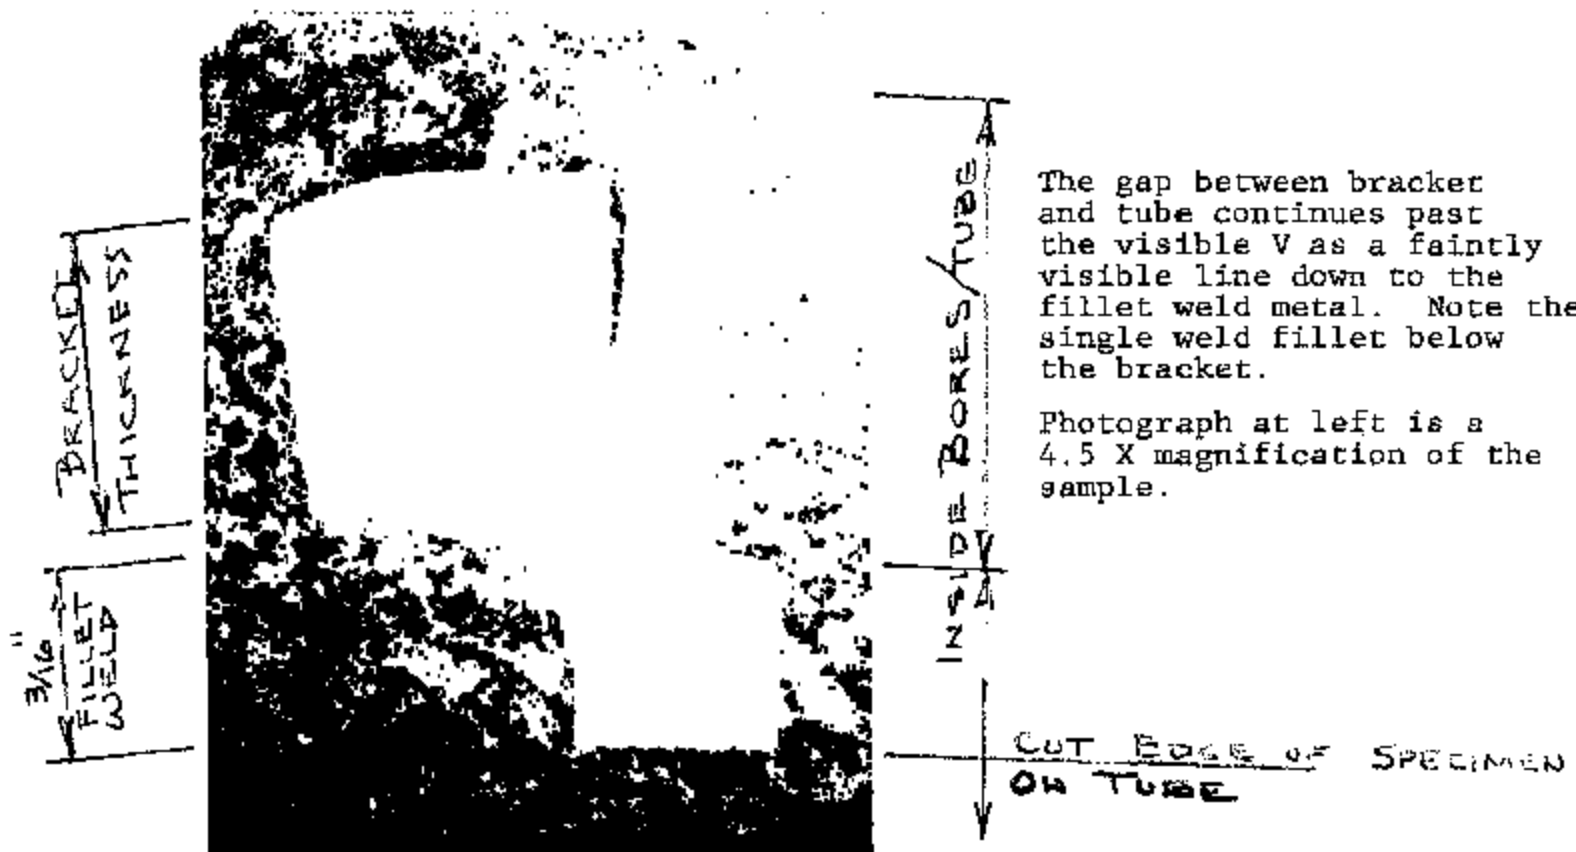
The cause of the repeated failures over a 11 month period for a new truck was due to bending across that bracket supporting the air spring chamber. The polished cross section of the weld fillet between the tube and one side only of the bracket is adjacent to a gap caused by their loose fit. The bending in the bracket can be seen when braking was initiated while the truck was standing still. The repeated bending is causing cracking in the bracket adjacent to the weld in what is referred to as its heat effected zone, depicted by a ring of clay in the photographs in Enclosure 7. Adding a second fillet weld around the tube at the opposite side of the bracket plus closer fitting with the tube it is believed will eliminate the bending failure.

Above picture is the metallographic sample at 4.5 X magnification across the saw cut, after mounting, polishing and etching.

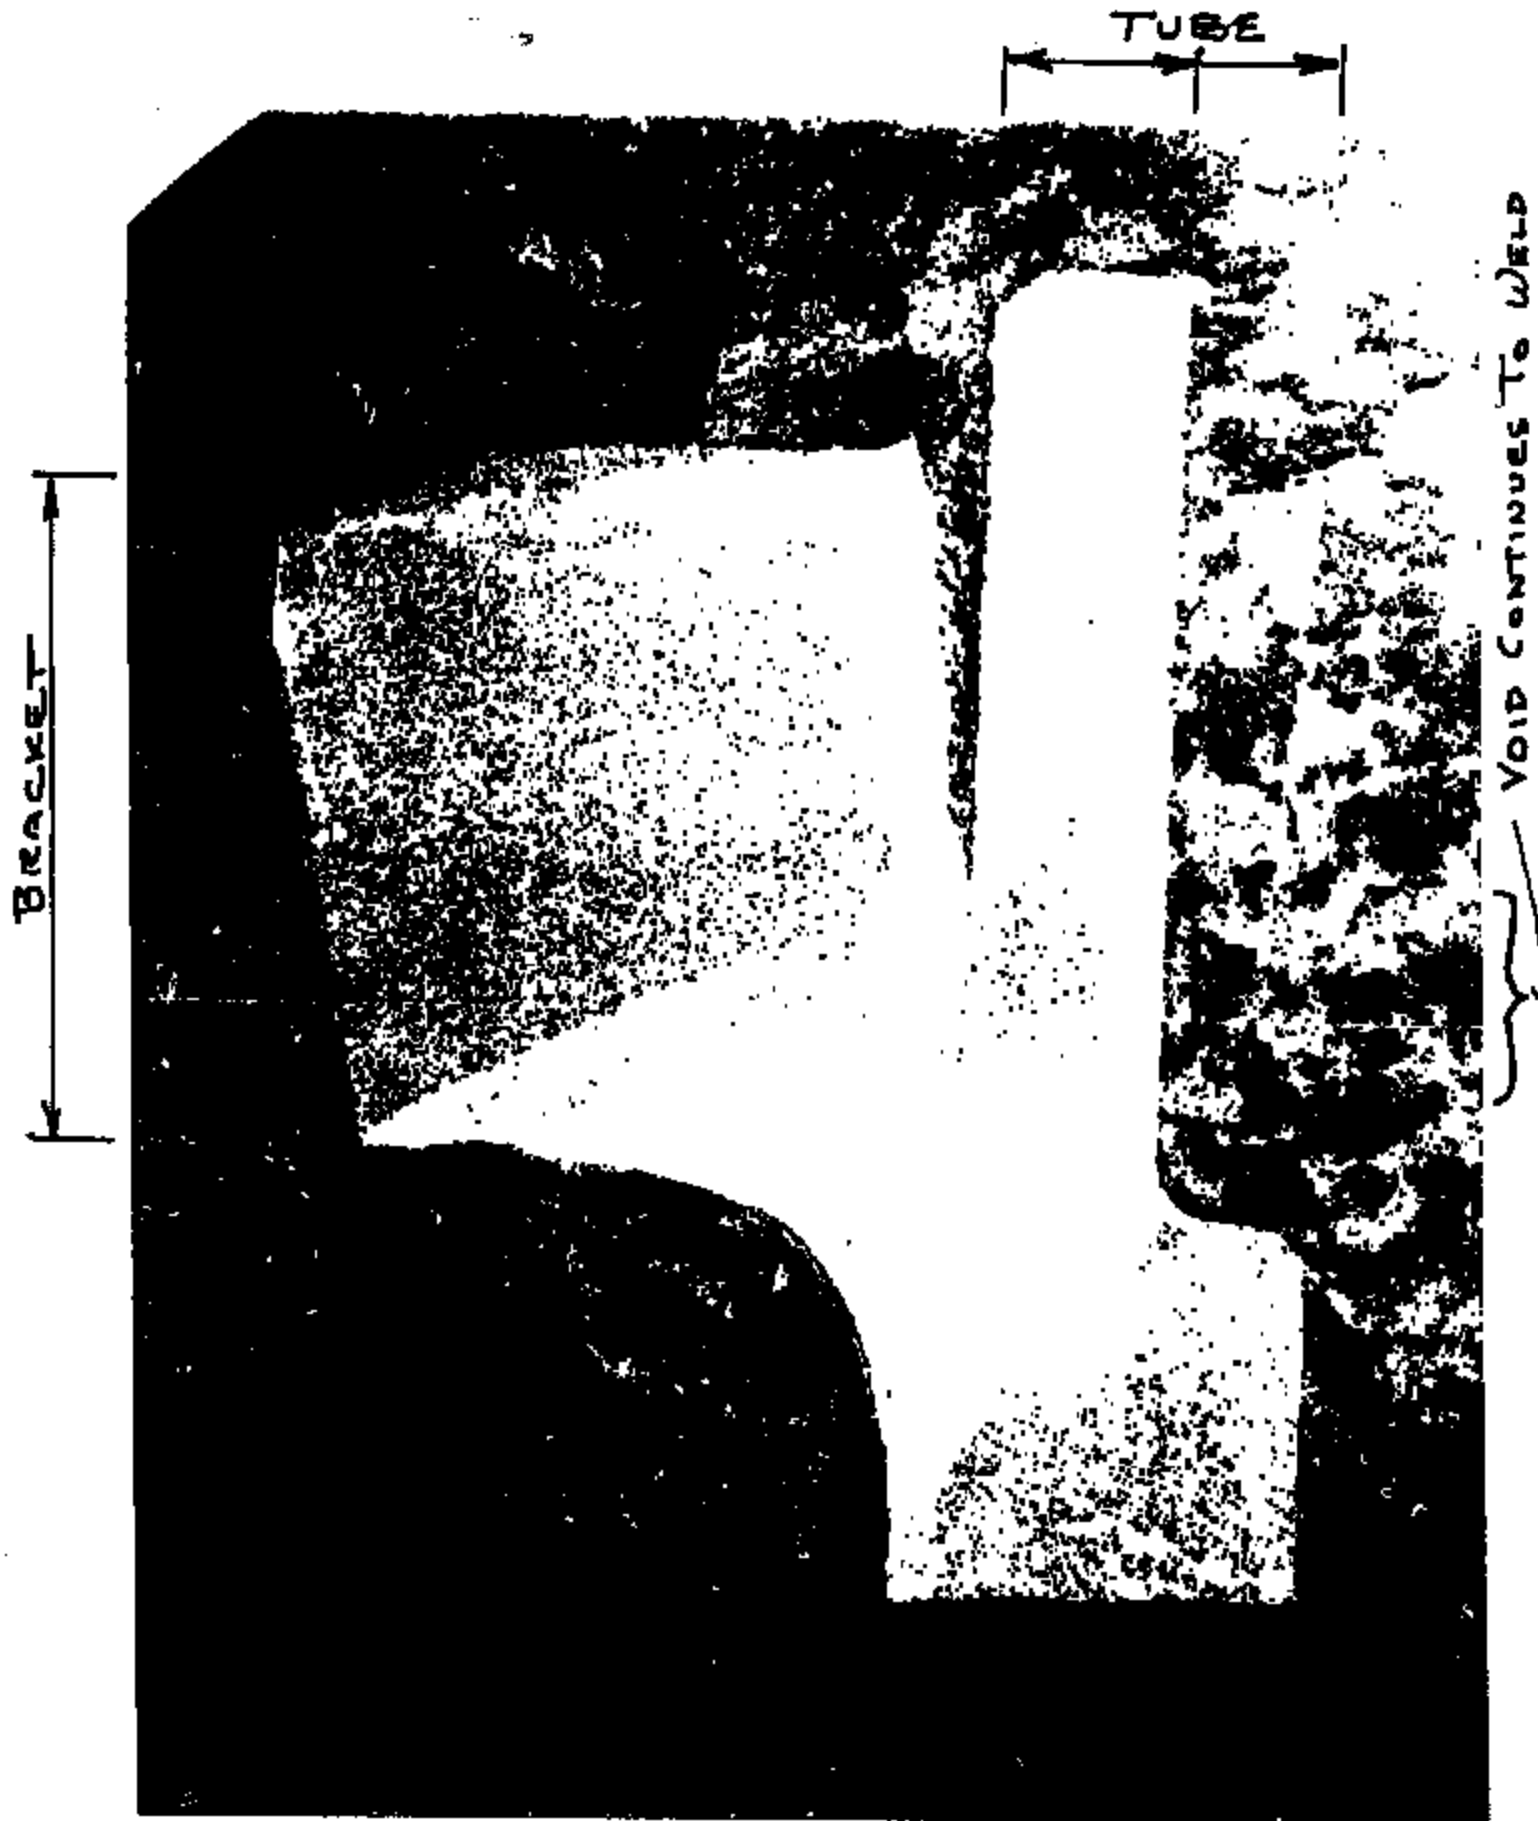
Cross section magnified 8.5 X approx. Original picture and sample prepared by Lehigh Laboratories.
