# DOT Auto Safety Hotline

**Vehicle Owner's Questionnaire**  
To Report Vehicle Safety Defects  
1-888-DASH-2-DOT  
(1-888-327-4236)  
INTERNET: www.nhtsa.dot.gov/hotline

17 digit Vehicle Identification Number Located at bottom of windshield on driver's side  
2FACP74F2MX149619  
Make FORD Model CROWN VICTORIA Model Year 1991  
4 Dr Sedan  
Date Purchased 3-20-91 Dealer's Name and Telephone Number Joe Gartin Ford 256-350-2120  
Engine: 5 Liter No. Cylinders V8 Fuel Type: Unleaded Regular  
Original Owner ☒ Dealer's City Decatur State Alabama Zip Code 35603  
Transmission Type ☐ Antilock Brakes Powertrain  
4 speed ☒ Cruise Control  
Vehicle Component Code 081000 ENGINE AND ENGINE COOLING:ENGINE  
Multiple Failure: 1

# Extract from Letter To FMC

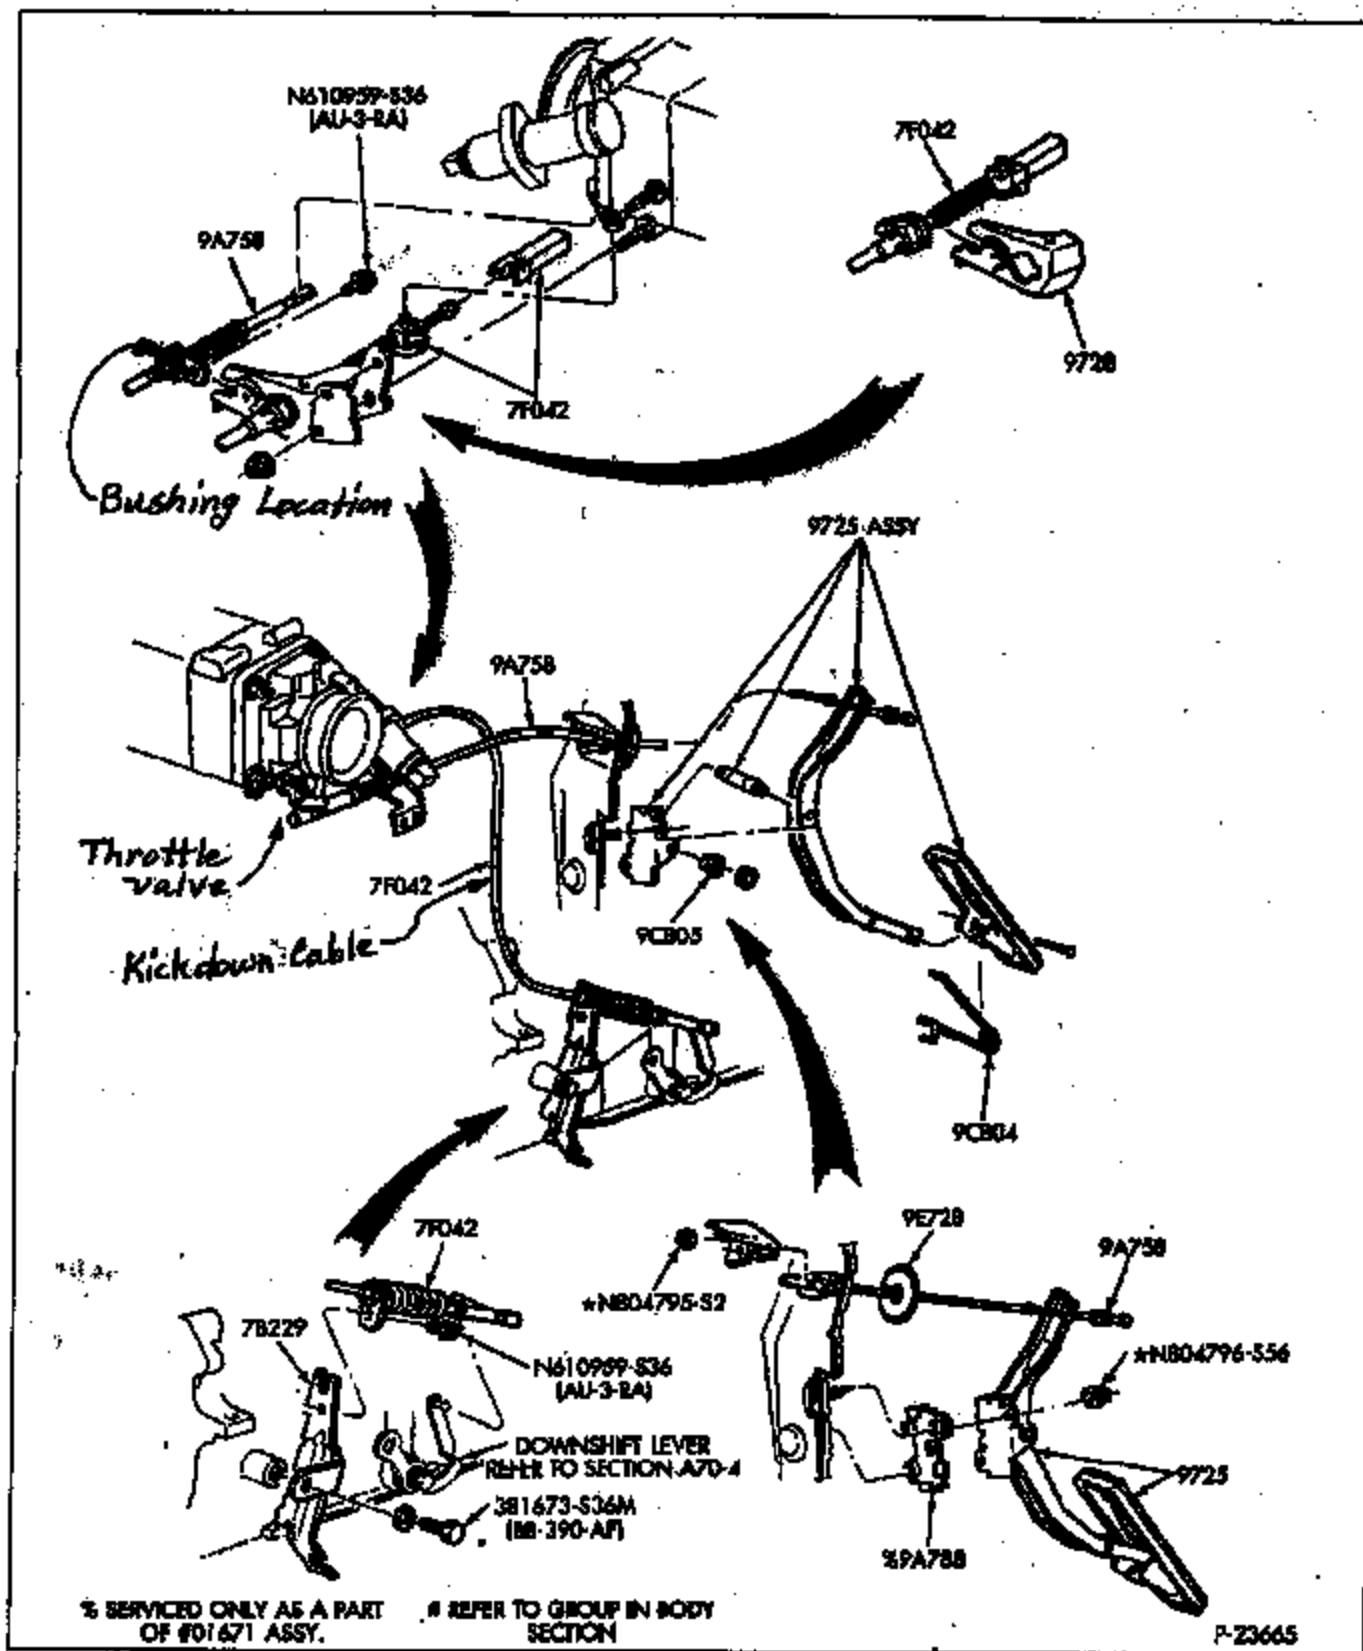
Accelerator linkage - AOT

I can say with confidence the cause of this failure was due to a material selection of a plastic bushing/grommet on the kickdown cable linkage at the accelerator end attaching the cable to the carburetor (see Attachment *page 5* showing schematic of this linkage). This car was purchased from Joe Sartain Ford (see Attachment *page 6*). It's been used as a personal car only, serving reliably with no major problems other than herein described. A phone call was made on 13 Oct 03 to your customer service number 1-800-392-3673, however the party on the line held out little hope that Ford would acknowledge its responsibility. The evidence shows failure was due to a poor choice of material for this bushing. When Ford issued an upgrade kit, they made the replacement out of metal. This is factual evidence the original material was inferior and unsuitable.

I found Pegus-Hurst Motor Co. in Longview. I drove into their shop and sought out their transmission mechanic, Mr. Ric Crum. He promised to look into the problem as soon as he could. *See Invoice on page 3*. I waited to hear his analysis. It was closing time when he reported the unwelcome news. The clutch for 3rd and 4th gears were not functioning, disabling those two gears. That's when I was told of the failure of the bushing and, as shown on the invoice, he replaced it. When they separated, the appropriate hydraulic pressure failed to lockup this high speed clutch. The clutch assembly did not hold tight enough allowing heat to destroy these metal plates due to friction. The clutch being inactive, the higher gears are disabled. Normally the higher pressure can hold the clutch locked but with the linkage disconnected, insufficient force was available to perform the lockup function.

Ford had me on record as an owner yet I was still not informed. The upgrade part only cost \$4.65 and would have been the best insurance against transmission breakdown. The upgrade part number is FMC F3SZ7H303B. Checking the bushing Longview Ford installed in my car they used the newer metal version. Until repairs are made this car of mine is unserviceable. I am asking Ford to make the transmission workable and place it in drivable condition. We still do not know the full ramifications of this chain of events.
