DOT Auto Safety Hotline  
**Vehicle Owner's Questionnaire**  
To Report Vehicle Safety Defects  
1-888-DASH-2-DOT  
(1-888-327-4236)  
INTERNET [www.nhtsa.dot.gov/hotline](http://www.nhtsa.dot.gov/hotline)

17 digit Vehicle Identification Number Located at bottom of windshield on driver's side: KM-JF25F5- [Redacted]  
Make: HYUNDAI Model: ELANTRA Model Year: 1999  
Date Purchased: July, 1999 Dealer's Name and Telephone Number: Mit/Hyundai on West Hillsborough  
Original Owner:  Dealer's City: Tampa State: FL Zip Code: 33615 Engine: No. Cylinders: 4 Fuel Type: Unleaded  
Transmission Type: AUTOMATIC  Antilock Brakes  Cruise Control Powertrain: \_\_\_\_\_  
Vehicle Component Code: 071100 FUEL SYSTEM, GASOLINE-STORAGE-TANK ASSEMBLY  
Multiple Failure: 1

# GENERAL DIAGNOSTIC PROCEDURE: HARD-TO-FILL FUEL TANK

Model(s): 1999 Hyundai, All Models  
Group: Fuel System  
Bulletin No.: 99-30-002  
Date: August, 1999

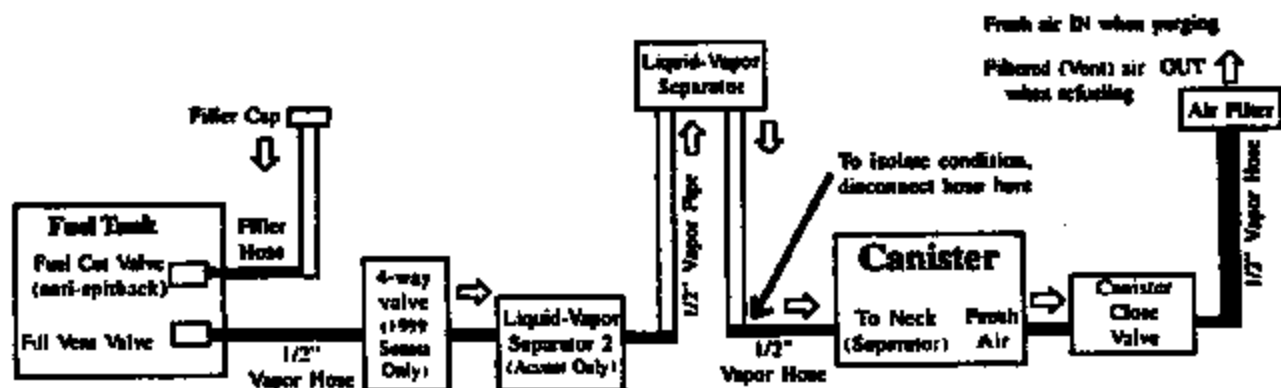
Fig. 1: On-Board Refueling Vapor Recovery (ORVR) Schematic

All 1999 and later Hyundai vehicles incorporate a new emission control system known as On-Board Refueling Vapor Recovery (ORVR). A general schematic of the system is provided in Fig. 1.

- 1) Disconnect the hose connected to the canister side of the liquid-vapor separator. See Fig. 1.
- 2) Take the vehicle to a known "good" or major brand gas station.
  - A) If the vehicle readily accepts fuel, the restriction is located between the liquid-vapor separator and the air filter.
  - B) If the vehicle does not easily accept fuel, the restriction is located between the liquid-vapor separator and the fuel tank.

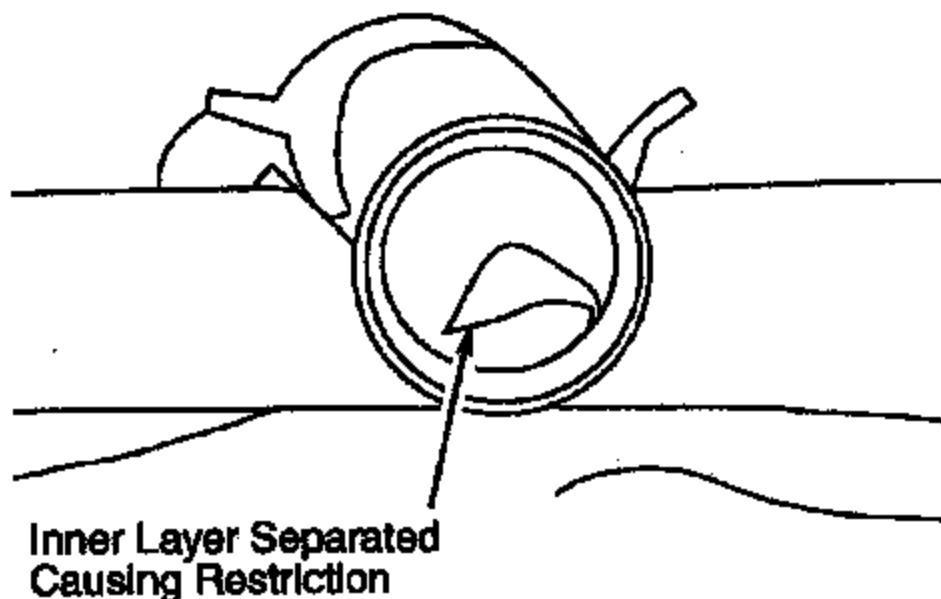
Fig. 2: Inner Layer Separation Causing Restriction

After the restriction has been isolated to either half of the system, inspect each component to make sure it is free and clear of any restrictions. See Figs. 2 and 3. Verify that no back pressure can be felt anywhere between the fill vent valve and the air filter at the canister.

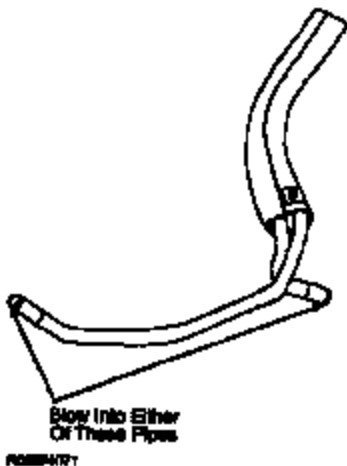
Fig. 4: Checking Liquid-Vapor Separator

When checking the liquid-vapor separator, blow through one end of the pipe using lung pressure. See Fig. 4. No back pressure should be felt.

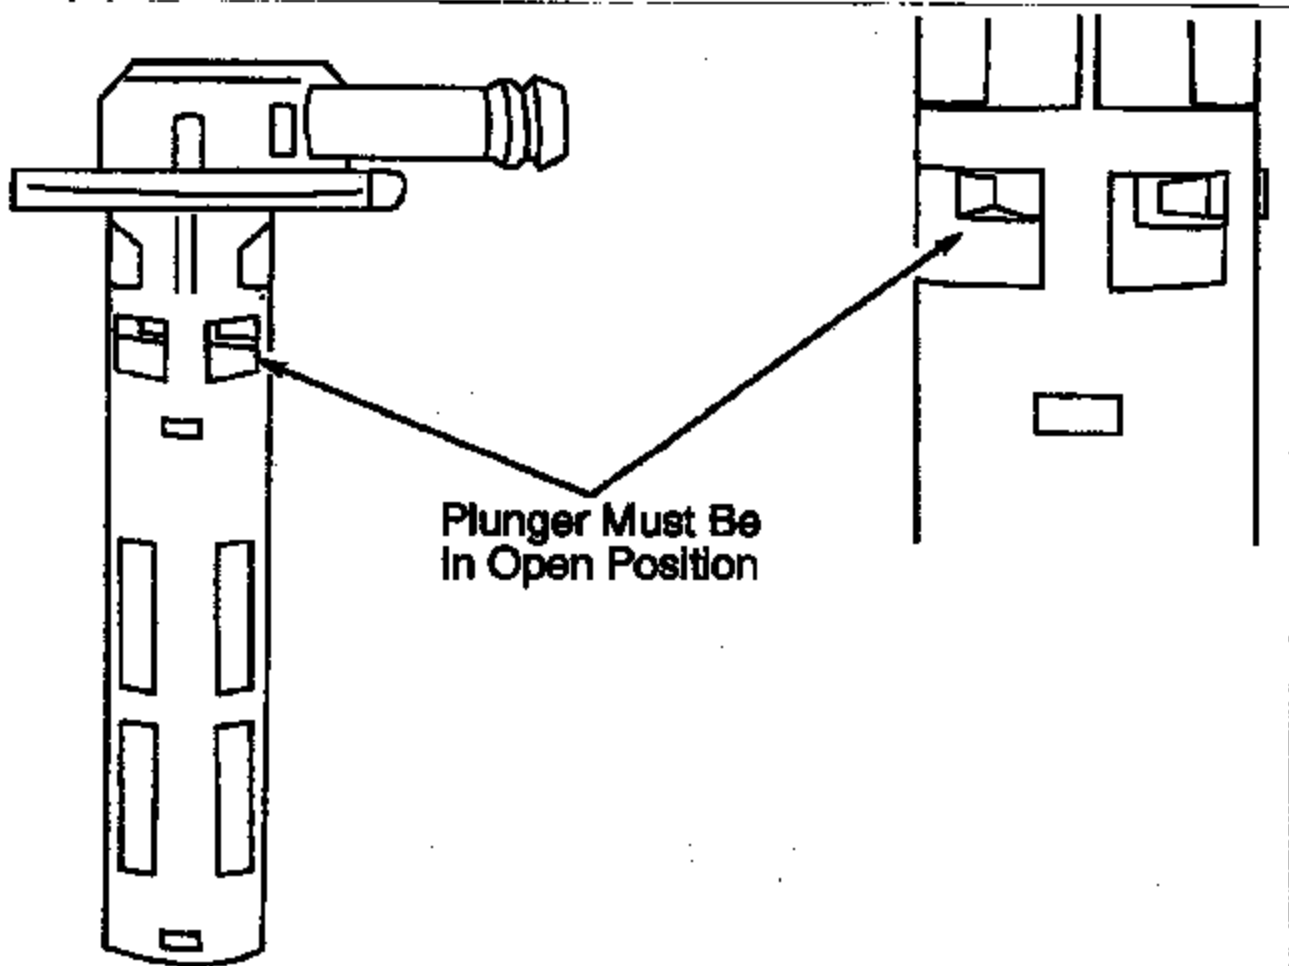
Fig. 5: Verifying Fill Vent Valve Is Open

Verify that the Fill Vent Valve is open by carefully removing the valve and confirming that the white plastic shut-off plunger moves freely inside its cage. See Fig. 5.

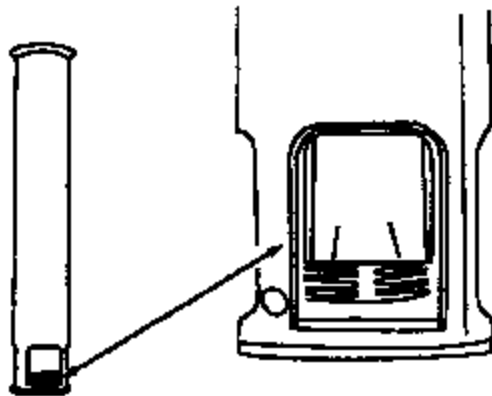
Fig. 6: Shut-Off Plunger Pushed Open

If the fuel cut valve plunger is stuck closed, a hard-to-fill condition may result. Verify that the plunger moves up and down freely allowing fuel to enter the tank, but does not allow fuel to travel up the neck (under pressure). See Fig. 6. The plunger should be "up" (closed) in its free state.

Fuel cut valve and close up of shut-off plunger being pushed open.

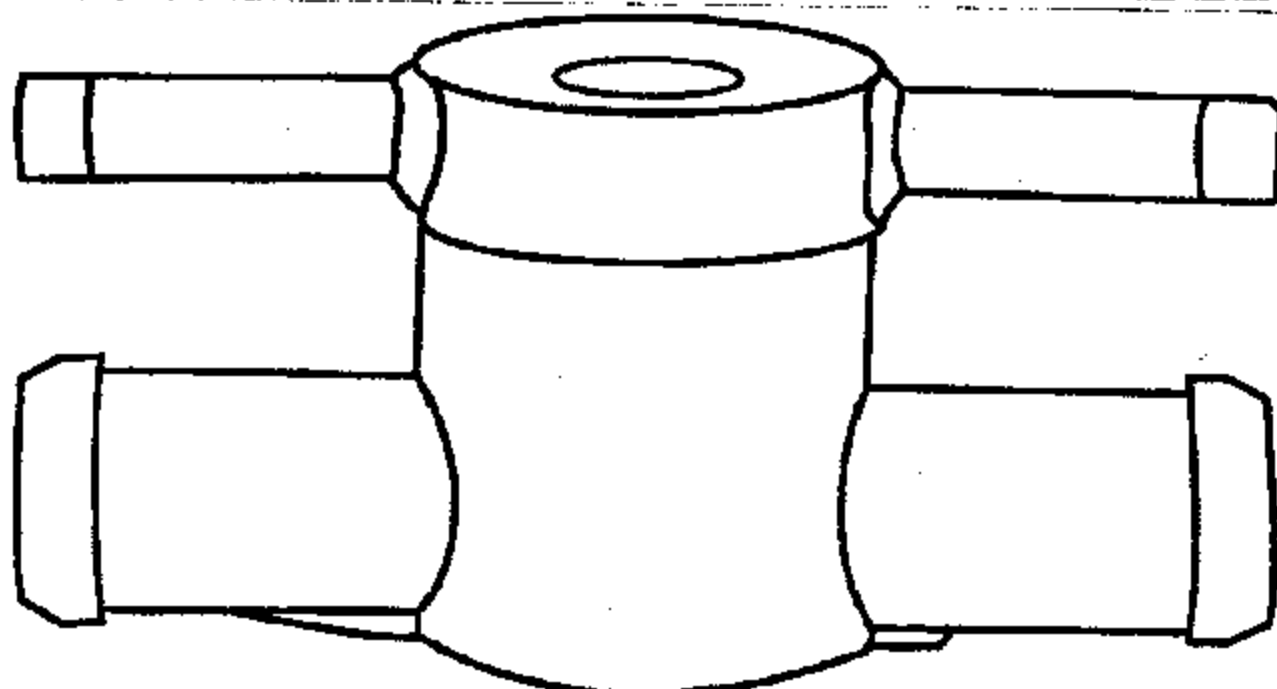
Fig. 7: Four Way Valve

**Purpose:** The Four Way Valve provides an additional vapor path to the canister during refueling.

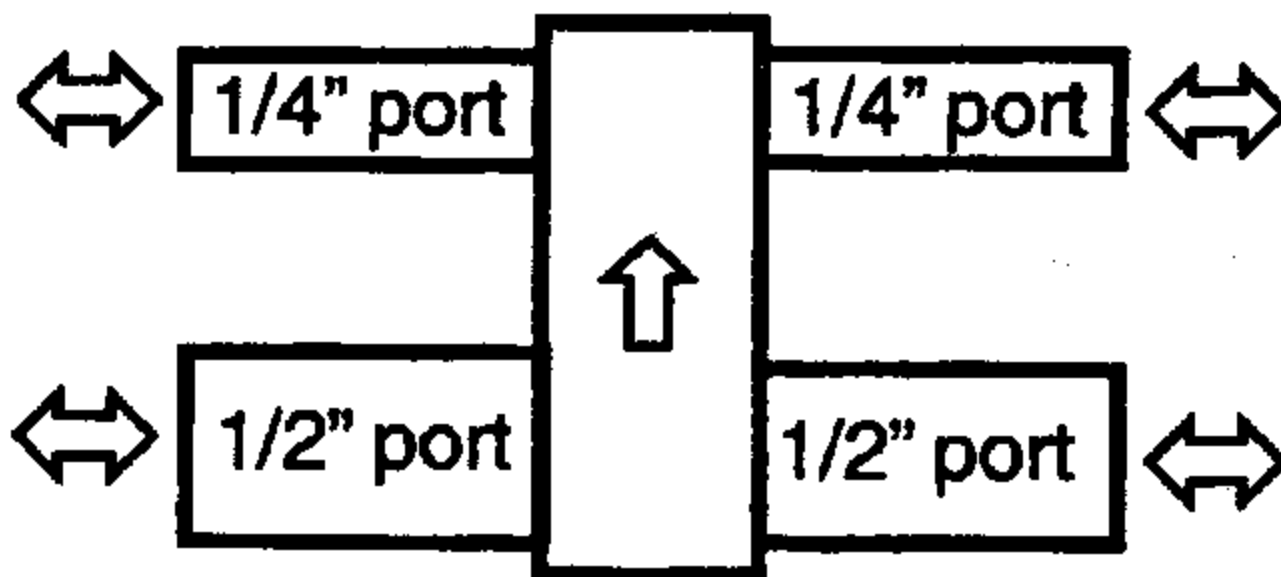
Fig. 8: Proper Operation Of Four Way Valve

1). Air flows freely in either direction through the 1/2" ports.

- 2) Air flows freely in either direction through the 1/4" ports.
- 3) Air flows from 1/2" port to the 1/4" port when blowing into one of the 1/2" ports while plugging the other 1/2" port.
- 4) Air does not flow from 1/4" port to the 1/2" port when blowing into one of the 1/4" ports while plugging the other 1/4" port.
