## DOT Auto Safety Hotline

Vehicle Owner's Questionnaire  
To Report Vehicle Safety Defects  
1-888-DASH-2-DDT  
(1-888-327-4238)  
INTERNET: www.nhtsa.dot.gov/hotline

17 digit Vehicle Identification Number Located at bottom of windshield on driver's side  
2B3ND48R2X  
Make DODGE Model INTREPID Model Year 1998  
Date Purchased 12/31/99 Dealer's Name and Telephone Number Northwind Dodge  
Original Owner ☒ Dealer's City HOUSTON State TX Zip Code 77065  
Engine: 2.7L No. Cylinders 6 Fuel Type: GAS  
Transmission Type AUTOMATIC ☐ Antilock Brakes ☒ Cruise Control Powertrain 200 HP  
Vehicle Component Code 103700 POWER TRAIN: AUTOMATIC TRANSMISSION: TORQUE CONV  
Multiple Failure: 2

Re: CASE # [REDACTED]  
1999 Dodge Intrepid  
Purchased at Northwest Dodge, Houston, Tx on 12/31/99  
VIN #2B3HD46RZD [REDACTED]

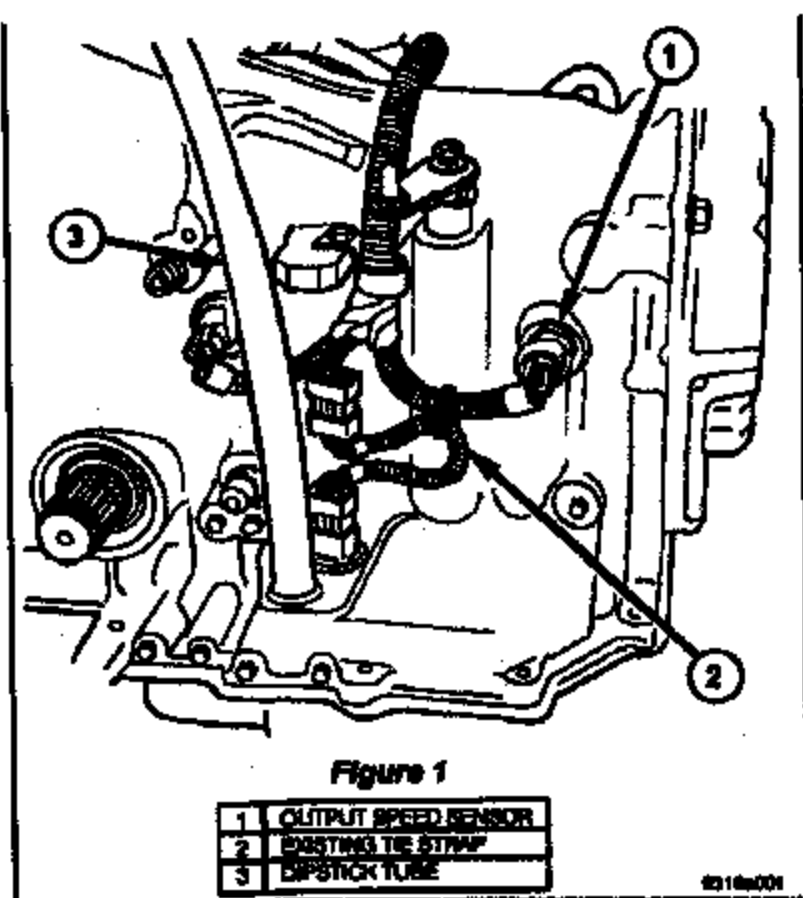
Transmission wires either breaking or pulling out of the output speed sensor connector.

**DIAGNOSIS:**A jumper harness was added to the Transmission Range Sensor (TRS) connector early in the 1999 model year to adapt a new TRS to the existing transmission harness. Inspect the wires at the output speed sensor connector for damage and repair as necessary. If the jumper harness is tie strapped to the output speed sensor wires perform the Repair Procedure.**PARTS REQUIRED:**

1. Remove the existing tie strap (Figure 1).
2. Attach the convolute covered section of the jumper to the transmission dipstick tube with the new tie strap, p/n 04856500.
