Vehicle Owner's Questionnaire

OLDSMOBILE

INTRIGUE

Info - Low Voltage Display on IP Gauge, Lights Dim at Stop Lights, Battery Discharged, No Start, Slow Cranking, Dim Lights at Idle, Low Generator Output #02-06-03-008 - (08/21/2002)

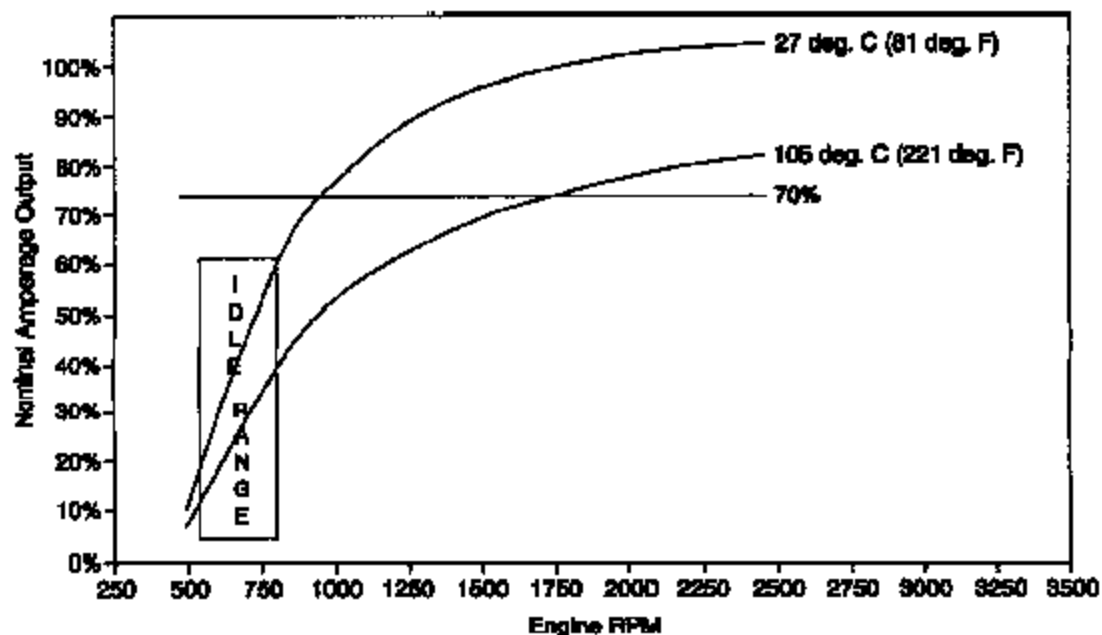
Typical Generator Performance for Cold and Operating Temperatures

- At idle, vehicle electrical loads may exceed the low speed current (amperage) output of the generator and when this happens the shortfall comes from the battery. This will result in a drop in the electrical system voltage as the battery delivers the additional electrical current to meet the demand. This is equivalent to the brown outs experienced by homes and businesses when the electrical demand is more than the supply. See Figure 1.

Depending on the vehicle application, generator current (amperage) output at engine idle speeds of 600-700 RPM can be as low as 35 percent of the full rated output. With enough electrical loads "ON", it is easy to exceed the generator current (amperage) output when the engine is at an idle of 600-700 RPM.

This is a normal condition. The battery supplements for short periods of time. Items that affect the vehicle's electrical system current and voltage at idle are the number of electrical loads being used, including add-on accessories, and extended idle times. When the vehicle speed is above approximately 24 km/h (15 mph), the engine/generator RPM is high enough and the generator current (amperage) output is sufficient to supply the current (amperage) requirements of the vehicle as originally equipped and recharge the battery.

For diagnosis of the battery and or the generator, refer to the appropriate Service Information or Corporate Bulletin Number 02-06-03-006.

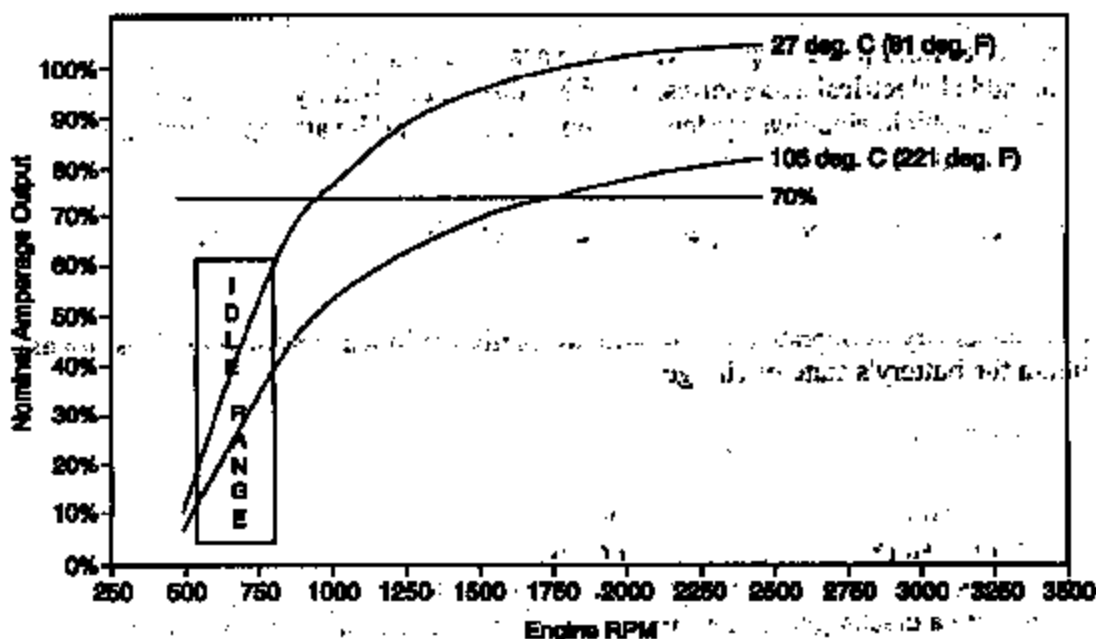
Typical Generator Performance for Cold and Operating Temperatures

Depending on the vehicle application, generator current (amperage) output at engine idle speeds of 600-700 RPM can be as low as 35 percent of the full rated output. With enough electrical loads "ON", it is easy to exceed the generator current (amperage) output when the engine is at an idle of 600-700 RPM.

This is a normal condition. The battery supplements for short periods of time. Items that affect the vehicle's electrical system current and voltage at idle are the number of electrical loads being used, including add-on accessories, and extended idle times. When the vehicle speed is above approximately 24 km/h (15 mph), the engine/generator RPM is high enough and the generator current (amperage) output is sufficient to supply the current (amperage) requirements of the vehicle as originally equipped and recharge the battery.

For diagnosis of the battery and or the generator, refer to the appropriate Service Information or Corporate Bulletin Number 02-06-03-006.
