| <p>U.S. Department of Transportation<br/>National Highway Traffic Safety Administration</p> | | <p>DOT Auto Safety Hotline<br/>Vehicle Owner's Questionnaire<br/>To Report Vehicle Safety Defects<br/>1-888-DASH-2-DOT<br/>(1-888-327-4236)<br/>INTERNET: www.nhtsa.dot.gov/hotline</p> | | <p>FOR AGENCY USE ONLY 1001B4</p> | |
| <p>17 digit Vehicle Identification Number Located at bottom of windshield on driver's side:<br/>2FALP74W7V [REDACTED]</p> | | <p>Makes: FORD</p> | | <p>Model: CROWN VICTORIA</p> | |
| <p>Model Year: 1997</p> | | <p>Engine: 4.6 L<br/>No. of Cylinders: 8</p> | | <p>Fuel Type: REG.</p> | |
| <p>Vehicle Component Code: 162000 STRUCTURE: BODY</p> | | <p>Multiple Failures: 1</p> | | | |

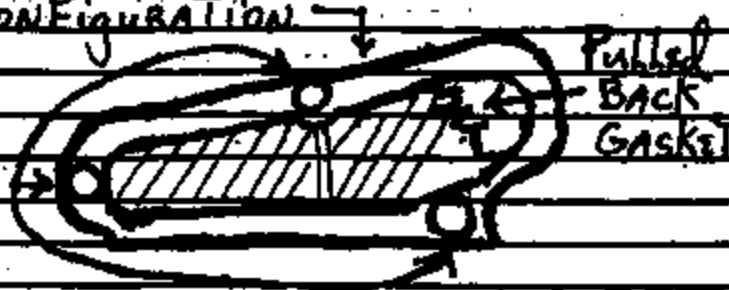
MORE COMMENTS: LEAF SCREEN CONFIGURATION

| <p>MY COMMENTS: LEAF SCREEN GASKET DEFECT WAS PRINCIPAL CAUSE OF MAJOR LEAK DOWN INTO DUCT (PART #FSVY-19C590-A) THAT FILLED AND THEN EMPTIED INTO VEHICLE INTERIOR. I BELIEVE THIS GASKET WAS IMPROPERLY ALIGNED FROM FACTORY BUILD, AS EVIDENCED BY THE PHYSICAL APPEARANCE AT THE <del>MANUFACTURER</del> END OF LEAF SCREEN. IT (GASKET) WAS PULLED BACK SHORT AT 'FAT' END OF SCREEN AND WAS CRACKED, SHOWN, SHOWN, ETC. (SEE REAR OF SHEET FOR MORE.)</p> | | | | | |

Plastic Gasket Pins

AS YOU CAN SEE, THE 'FAT' END OF THE LEAF SCREEN GASKET DOES NOT HAVE A HOLE FOR PLACEMENT OF A PLASTIC GASKET PIN. THIS LACK OF GASKET RESTRAINT RESULTED IN THE MIS-ALIGNMENT OF THE 'FAT' END GASKET WITH RESULTING LEAKAGE INTO & DOWN THE DIRT AND, THEN, INTO THE CAR'S INTERIOR. ALTHOUGH I DID NOT FIND THIS COSTLY PROBLEM UNTIL CHRISTMAS, 2003, I BELIEVE ATTACH ADDITIONAL SHEETS IF NECESSARY THIS WAS A MANUFACTURERS DEFECT FROM THE ASSEMBLY LINE WHEN BUILT!
