DOT Auto Safety Hotline
Vehicle Owner's Questionnaire
To Report Vehicle Safety Defects
1-888-DASH-2-DOT
(1-888-327-4236)
INTERNET: www.nhtsa.dot.gov/hotline

Reference No.
10067103

17 digit Vehicle Identification Number Located at bottom of windshield on driver's side
PLEASE FILL IN 4Y4AN41S64E012164
Make MITSUBISHI Model ENDEAVOR Model Year 2004

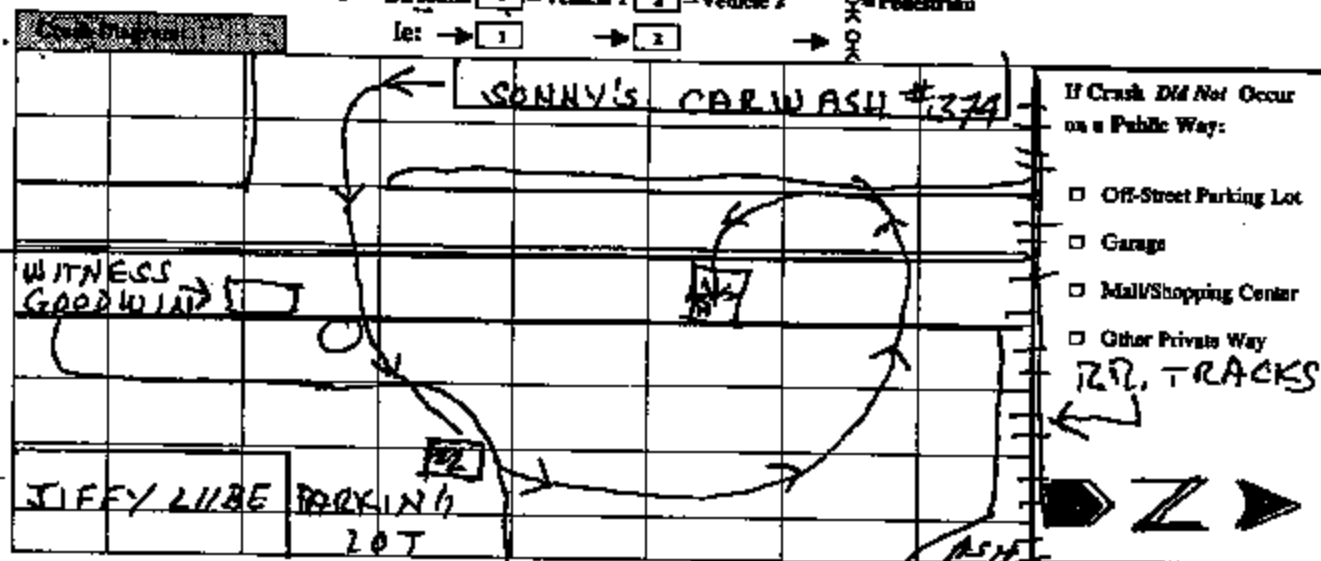
Crash Narrative: THE OPERATOR OF THE MV WAS EXITING THE TUNNEL AT THE SONNY'S CAR WASH #1374 MAIN ST) WHEN SHE PUT THE VEHICLE IN DRIVE THE ACCELERATOR STUCK AND THE MV LURCHED FORWARD. SHE TURNED LEFT, EXITED THE CARWASH, CROSSED RT #28, HIT A CURB, GRAZED A TELEPHONE POLE, PROCEEDED INTO THE TIFFY LUBE PARKING LOT, GRAZED A PARKED CAR (MA 989608), TURNED HARD TO THE LEFT INTO A GRASSY AREA WENT BACK ONTO RT #28 WHERE SHE TURNED 180 DEGREES AND FINALLY CAME TO REST AGAINST THE CURB FACING EAST IN THE NORTHBOUND LANE. THE OPERATOR WAS UNABLE TO DIS-ENGAGE THE ACCELERATOR THE WHOLE TIME AND MANAGED TO STOP THE VEHICLE BY TURNING OFF THE IGNITION WHILE STEERING TO AVOID A COLLISION. THE WITNESS, MR KEITH GOODWIN, WAS HEADING NORTHBOUND ON RT #28 AND WITNESSED THE WHOLE EVENT AND STATED THAT THE OPERATOR DID A REMARKABLE JOB AVOIDING COLLISIONS DURING THIS WHOLE EPISODE. THERE WAS A MOTORCYCLE PARKED IN THE TIFFY LUBE LOT, MA REG FZ7814. ALTHOUGH THE MC WAS NOT STRUCK THE OWNER STATED THAT LARGE AMOUNT OF DIRT AND TURF HAD BEEN THROWN AGAINST HIS BIKE AND WANTED THIS FACT NOTED. IT SHOULD BE NOTED THAT BOTH THE FRONT AND REAR WHEELS STRUCK CURBING DURING THE COURSE OF THIS ACCIDENT.
