## ODI RESUME

INVESTIGATION: EA99-021

SUBJECT: Alleged Parking Brake Malfunction

## ENGINEERING ANALYSIS CLOSING REPORT

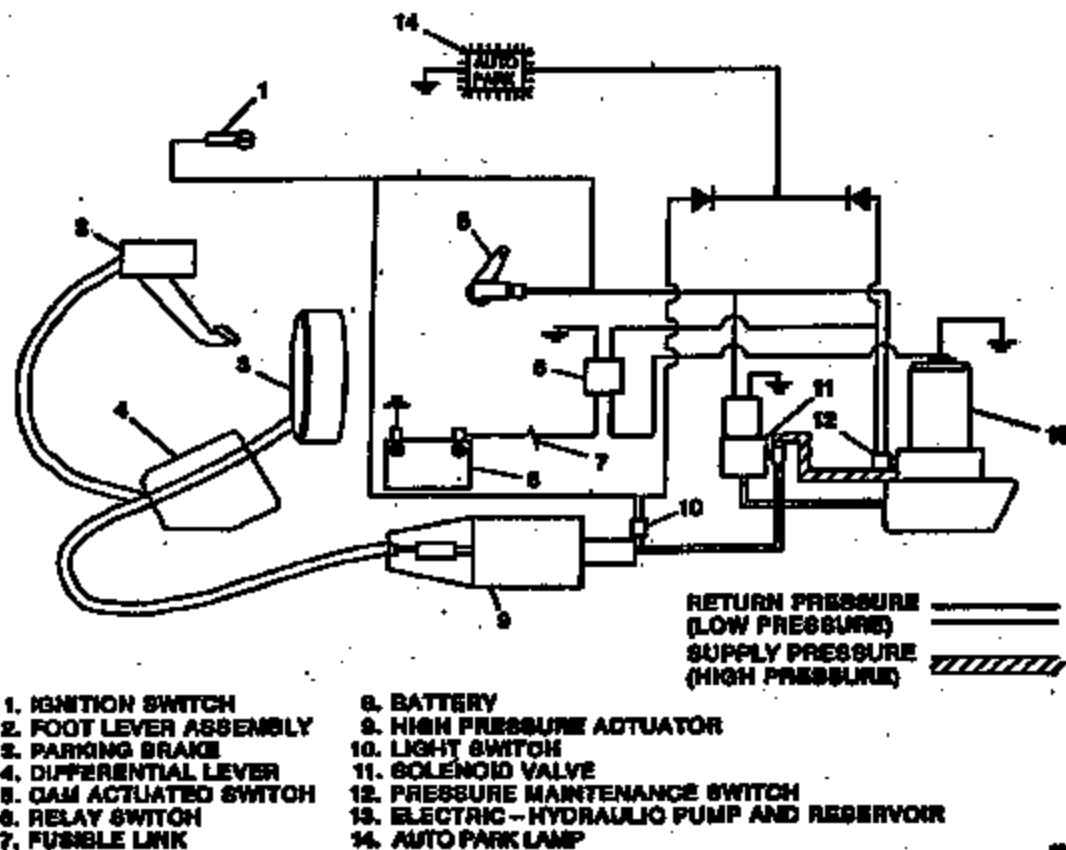
**Figure 6**

Figure 6 is a schematic drawing of the Auto-Park system. This system is considerably more complicated than a traditional passenger car parking brake system and almost all other truck parking brake systems. As such, it also has many more critical components that require adjustment.
