# ODI RESUME

INVESTIGATION: EA99-021  
SUBJECT: Alleged Parking Brake Malfunction  
PROMPTED BY: PE99-006  
PRINCIPAL ENGINEER: June 97- Feb 01, Bob Young; Feb 01 - June 01, S. B. York

## ENGINEERING ANALYSIS CLOSING REPORT

**SUBJECT:** 1995 - 1998 General Motors P-3 Motorhome Chassis with the J71 "Auto-Park"

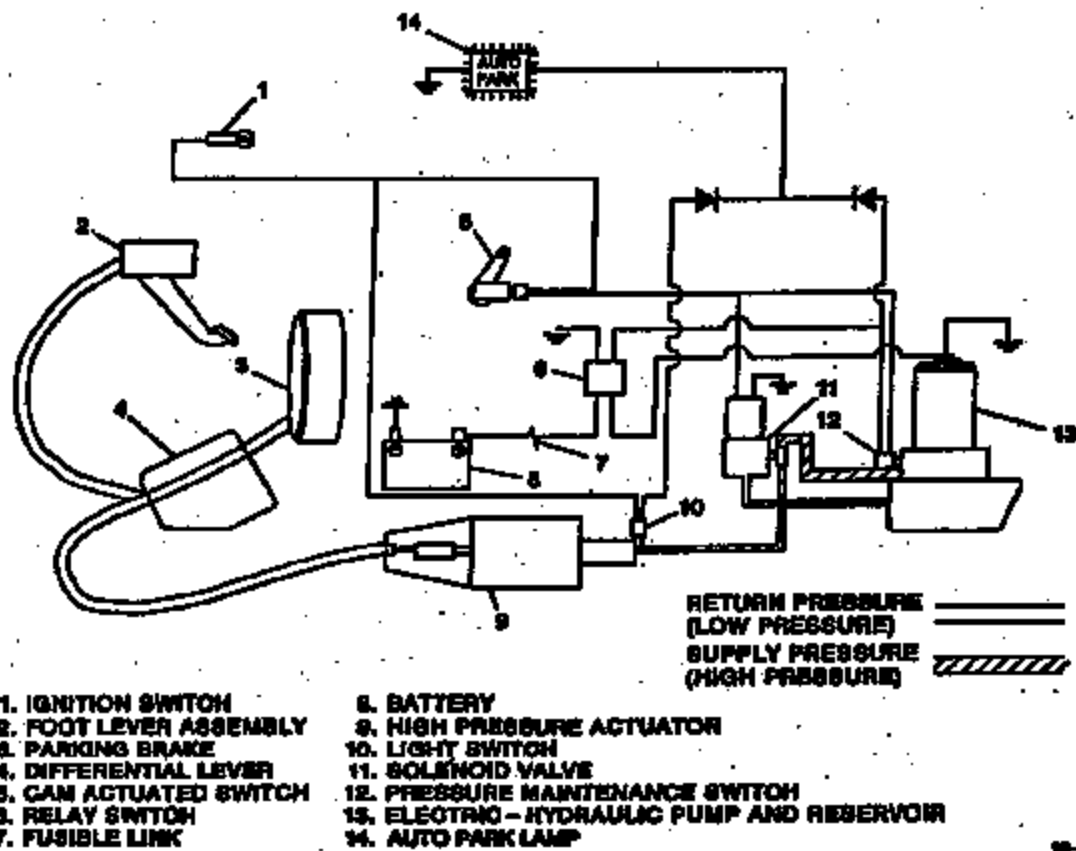
Figure 6 is a schematic drawing of the Auto-Park system. This system is considerably more complicated than a traditional passenger car parking brake system and almost all other truck parking brake systems. As such, it also has many more critical components that require adjustment.
