DOT Auto Safety Hotline  
**Vehicle Owner's Questionnaire**  
To Report Vehicle Safety Defects  
1-888-DASH-2-DOT  
(1-888-327-4236)  
INTERNET: www.nhtsa.dot.gov/hotline

JAYCO

DESIGNER

WELD DISCONNECTED FROM THE FRAME OF THE TRAILER WHILE DRIVING. MANUFACTURER WAS CONTACTED. \*AK

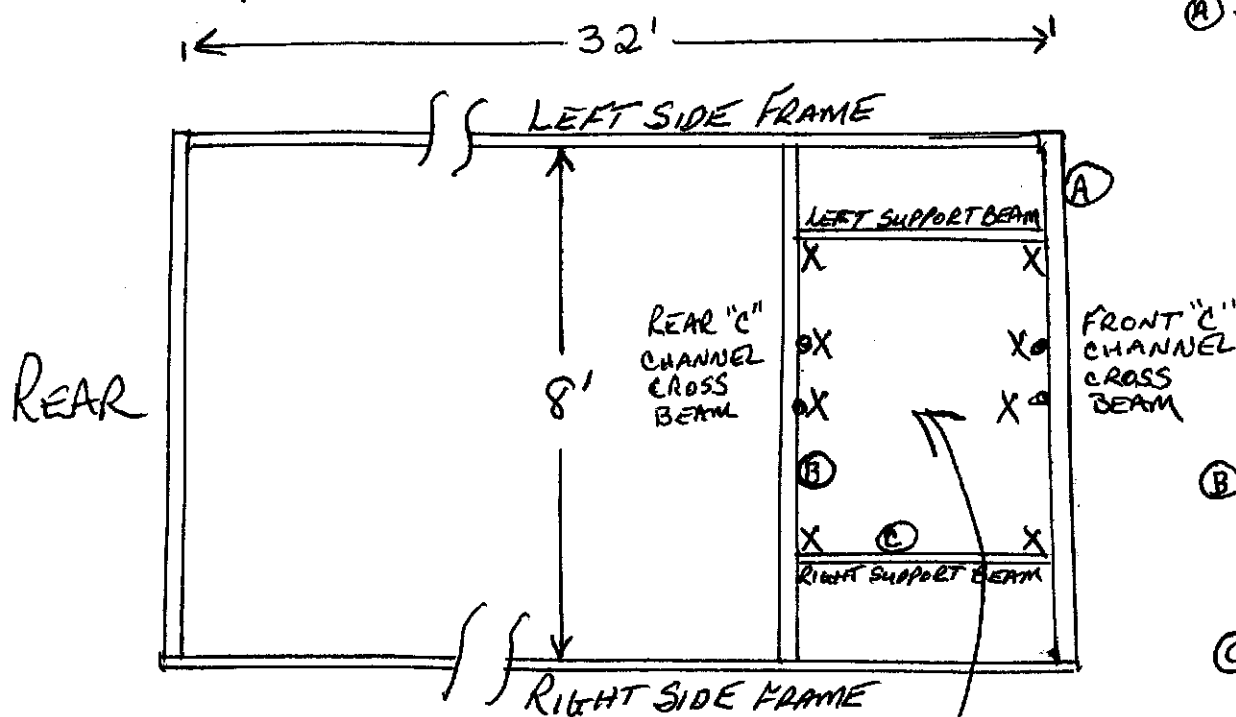
Sketch of Jayco Designer model 3230, year 2000  
5th wheel trailer front frame structure where  
pinbox is welded.

This front hitch area is enclosed on all sides and sheet metal must be removed from the bottom for inspection or to view for damage and broken welds.

Pinbox is welded to Jayco front and rear "C" channel cross beam structure.

• - the dot indicates weld area, pinbox to Jayco structure

X - This indicates Broken, fractured, and defective factory welds.

A - This "C" channel beam bent upwards and was replaced with a stronger closed beam by Austin Enterprises

B - This "C" channel beam was re-inforced by Austin Enterprises

C - Right and Left support beams were replaced by Austin Enterprises

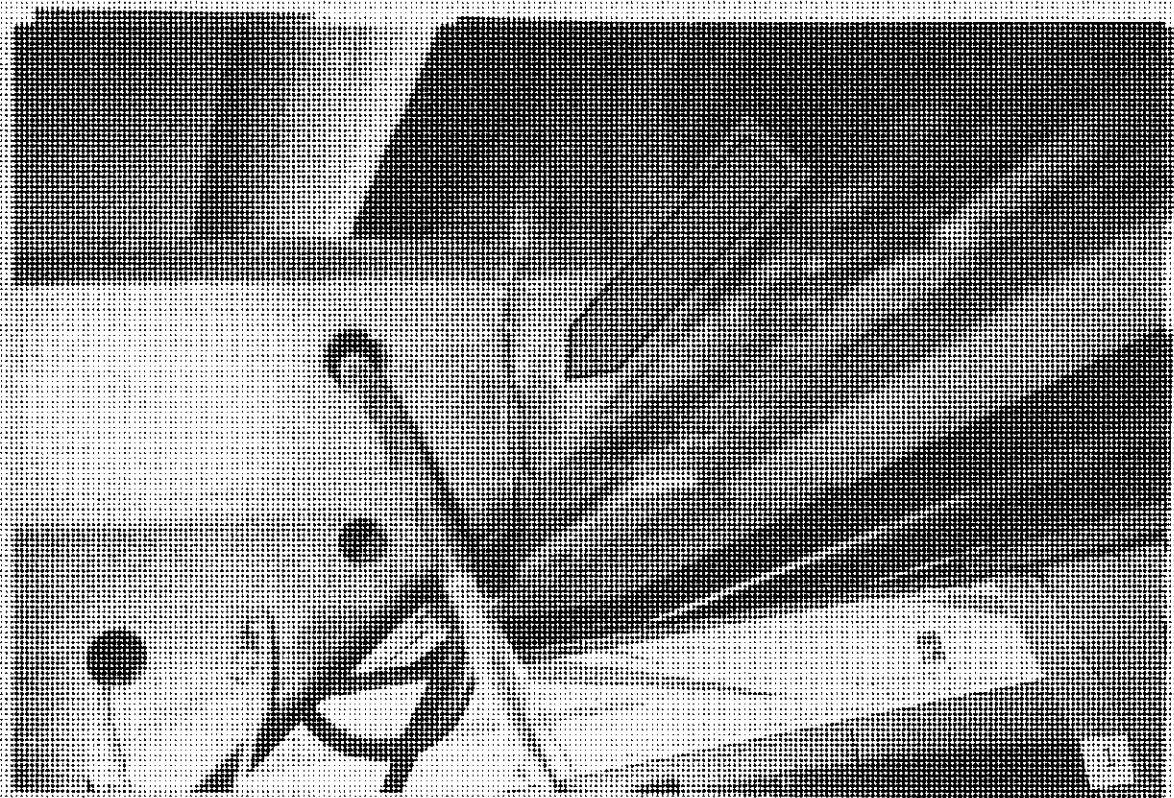
Broken, (accurred), poor weld with no penetration to rear main support cross beam, left side, rear of pinbox.

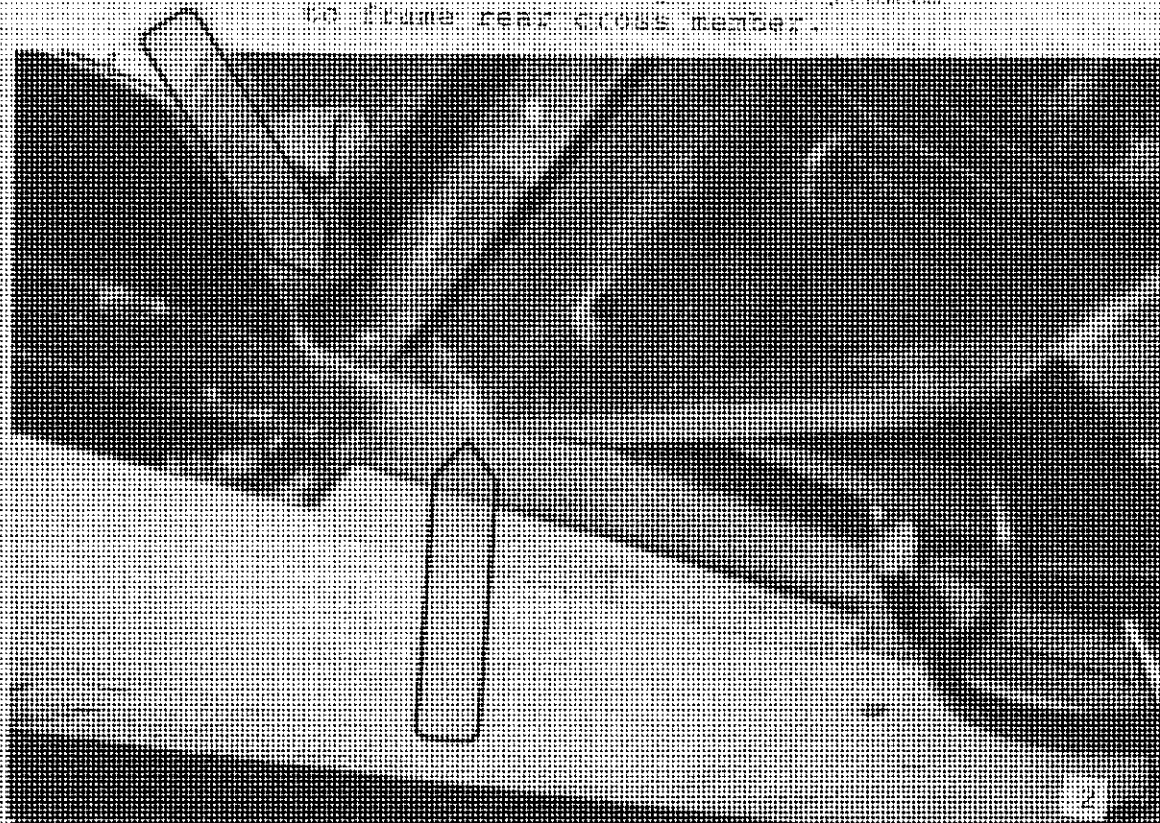
2. Poor, fractured, cracked and welds with no penetration, right side pinbox to frame rear cross member.

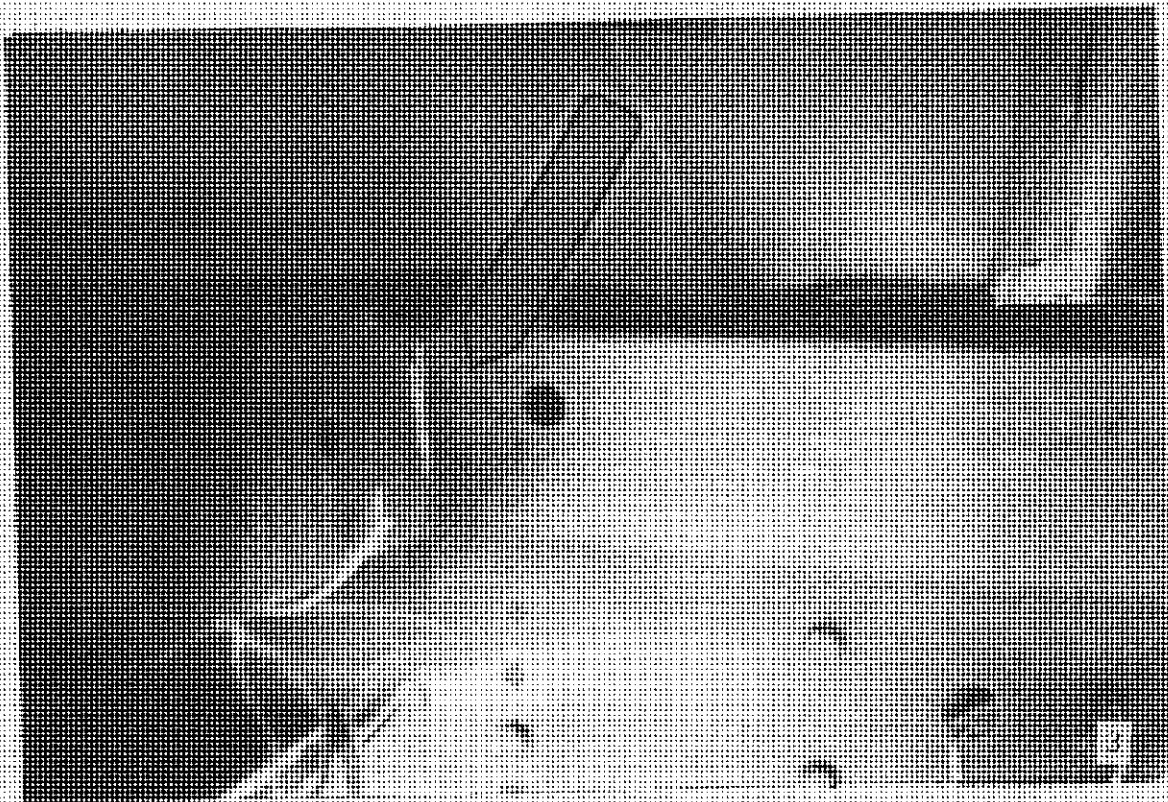
Defective weld on trailer frame main support cross member, to rear of pin box, right side.

3. Cracked and broken weld, pin box  
attaching structure left side, front.

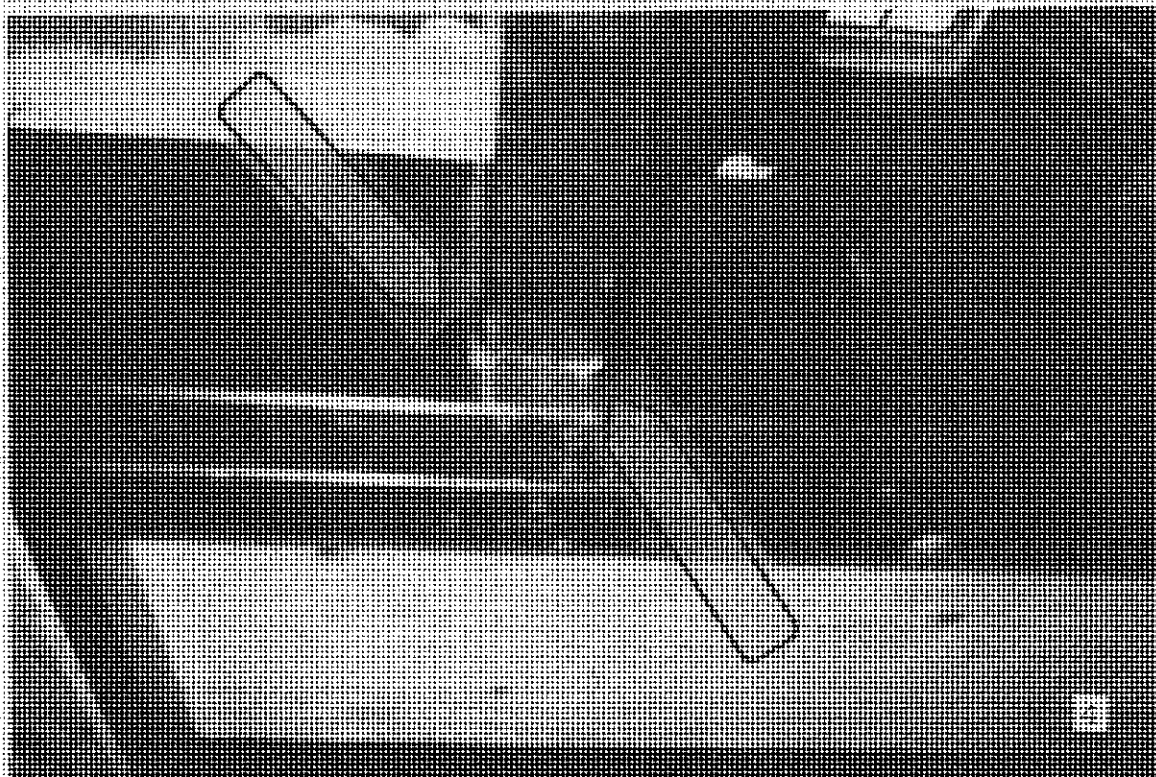
4. Cracked weld, poor weld, no penetration  
on frame structure support brace, rear  
brace.

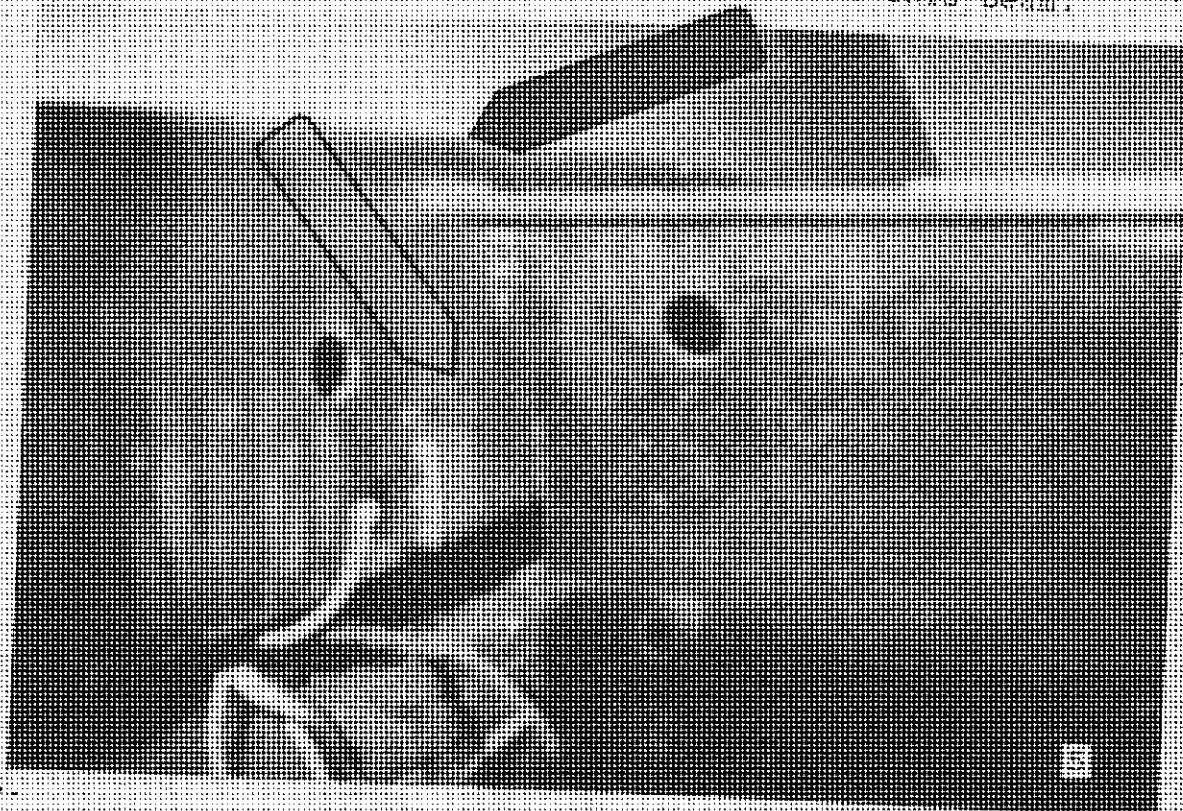
4. Fractured poor weld, no penetration,  
support brace of rear main beam, right  
side.

5. POOR WELD, NO PENETRATION

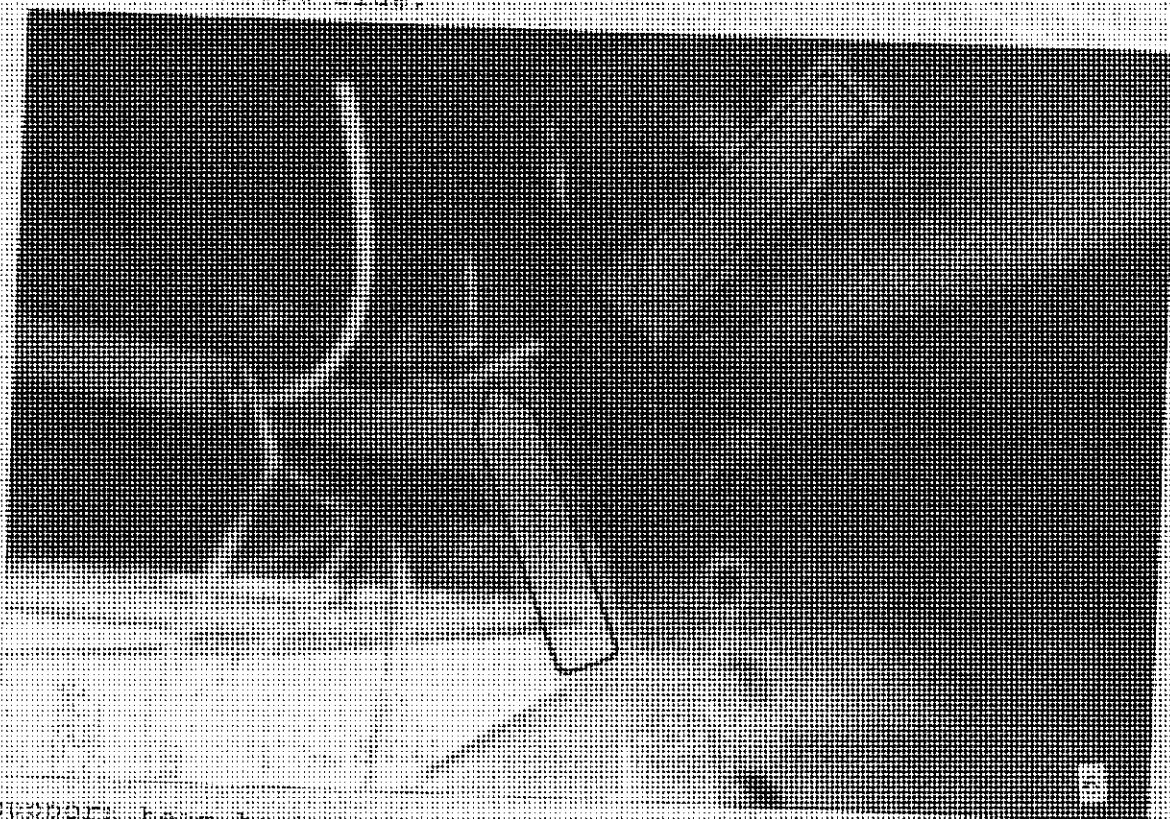
5. Buckled main support "C" channel beam running across front of trailer, pin box is welded to this beam.

Broken cracked weld on trailer frame main support cross member to front of pin box, left side.
