DOT Auto Safety Hotline  
**Vehicle Owner's Questionnaire**  
To Report Vehicle Safety Defects  
1-888-DASH-2-DOT  
(1-888-327-4236)  
INTERNET: www.nhtsa.dot.gov/hotline

Reference No.  
10106888

Vehicle Component Code Front Passenger  
021540 SUSPENSION:FRONT:CONTROL ARM:LOWER BALL JOINT

Multiple Failure: 1 Ball Joint Stud Broke

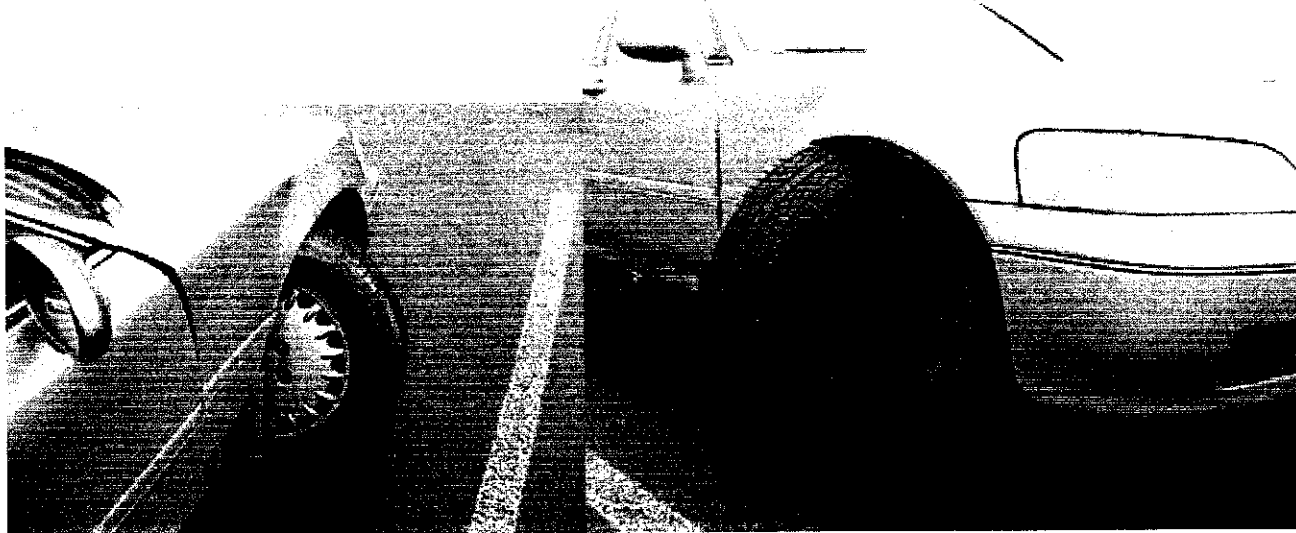
WHILE CONSUMER WAS TRAVELING VEHICLE STOPPED. CONSUMER HAD THE VEHICLE TOWED TO THE DEALER, AND MECHANIC DETERMINED THAT THE METAL STUB SHEARED OFF FROM THE LOWER BALL JOINT. MECHANIC INFORMED CONSUMER THAT THE LEFT AND RIGHT BALL JOINTS NEEDED TO BE REPLACED. \*AK

Mechanic informed me that the passenger front ball joint stud had broken off. The car had been worked on in this same shop only two weeks earlier (replaced upper control arm). The mechanic said that he had looked at the passenger front lower ball joint and saw no indication of any safety concern. That, coupled with no warning noise, constitutes a major safety concern.

Here are the pictures of [REDACTED]'s 97 Acura RL. Thanks
