RE: General Motors Corporate

File # 200120385

Bulletin No.: 02-08-61-001

Bulletin No.: 01-02-32-001B

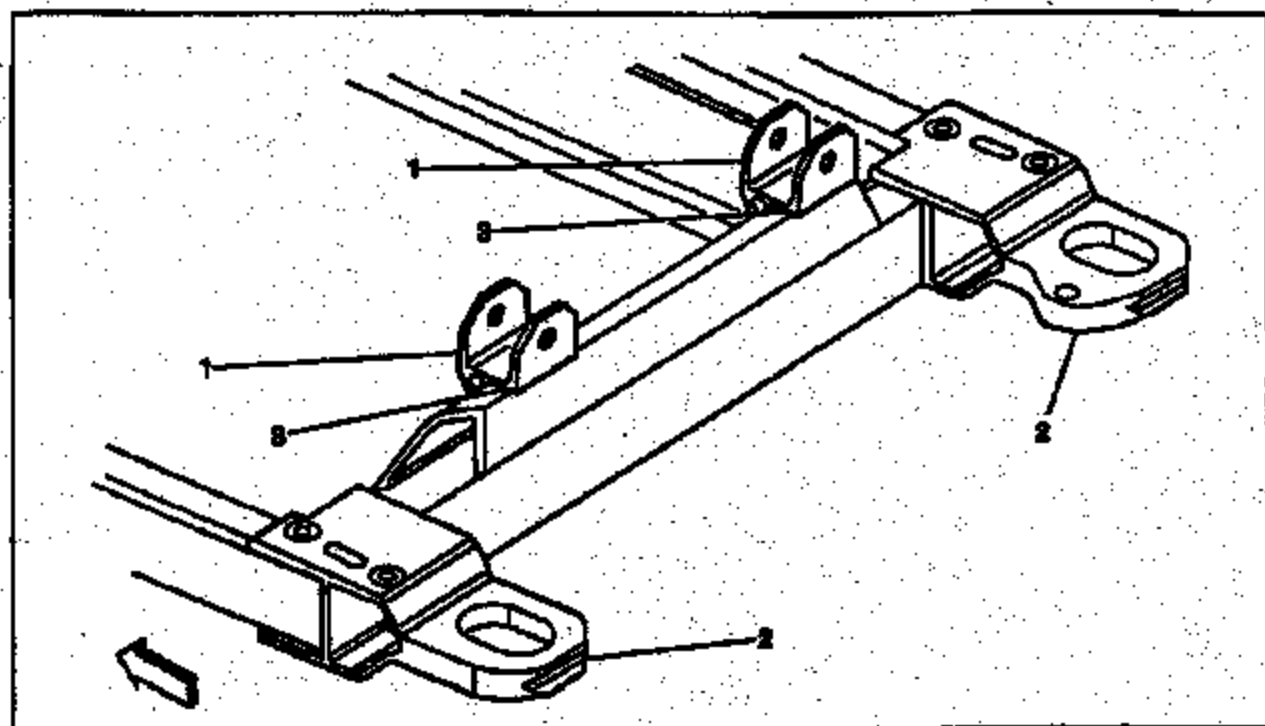
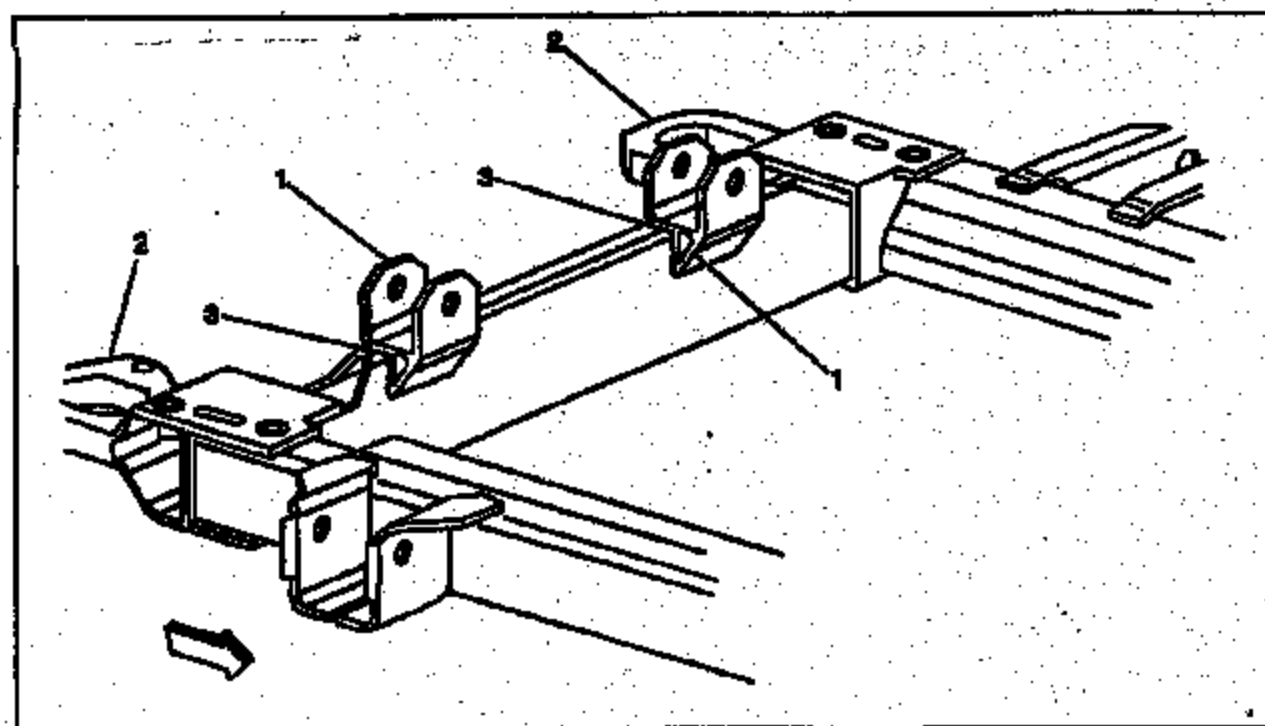
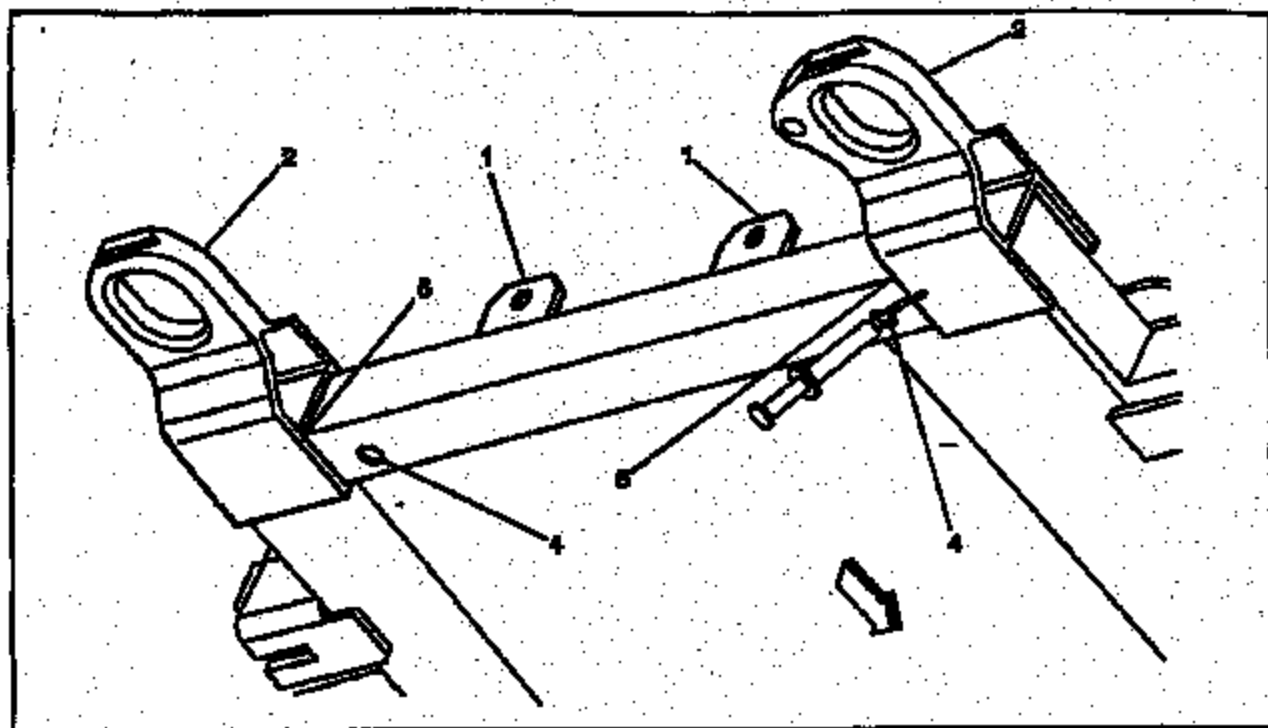
Do not spray the Brake Parts Cleaner between the steering gear mounting brackets (1) and the frame (3). The Brake Parts Cleaner may dilute the threadlocker.

2. Using Brake Parts Cleaner, P/N 12346139 (in Canada, use P/N 10933463) or equivalent, thoroughly clean the exterior surfaces of the frame in the area of the steering gear mounting brackets (1) and both the rear body mount brackets (2) ensuring all dust, dirt and oil are removed.
3. Utilizing a heat gun and clean rags, completely dry off the areas of the frame that were cleaned.
4. On the top surface of the frame rear crossmember at location (3), pool approximately 1/4 ml of threadlocker material on each side of both the steering gear brackets (1).

5. Slowly, apply the threadlocker material to each of the four welds on both of the steering gear attaching brackets (1).
6. Locate the two holes (4) in the lower surface of the rear crossmember.
7. With syringe positioned through each hole (4) and aimed at the upper outboard corners, pivot the syringe while rapidly depressing the plunger and apply approximately 6 ml of threadlocker material per hole.
8. At the location (5) where there is a gap between the rear body mount brackets and the frame rear crossmember, insert the syringe tip and inject approximately 10 ml of threadlocker material into each gap.
9. Slowly, apply material to each of the ten welds that secure the rear right and left side body mount brackets (2) to the frame side rails and rear crossmember.
10. Lower the vehicle.
