RE: 1998 FORD EXPLORER RECALL

**DOT Auto Safety Hotline**  
**Vehicle Owner's Questionnaire**  
To Report Vehicle Safety Defects  
1-888-DASH-2-DOT  
(1-888-327-4236)  
INTERNET: [www.nhtsa.dot.gov/hotline](http://www.nhtsa.dot.gov/hotline)

Reference No.  
10113057

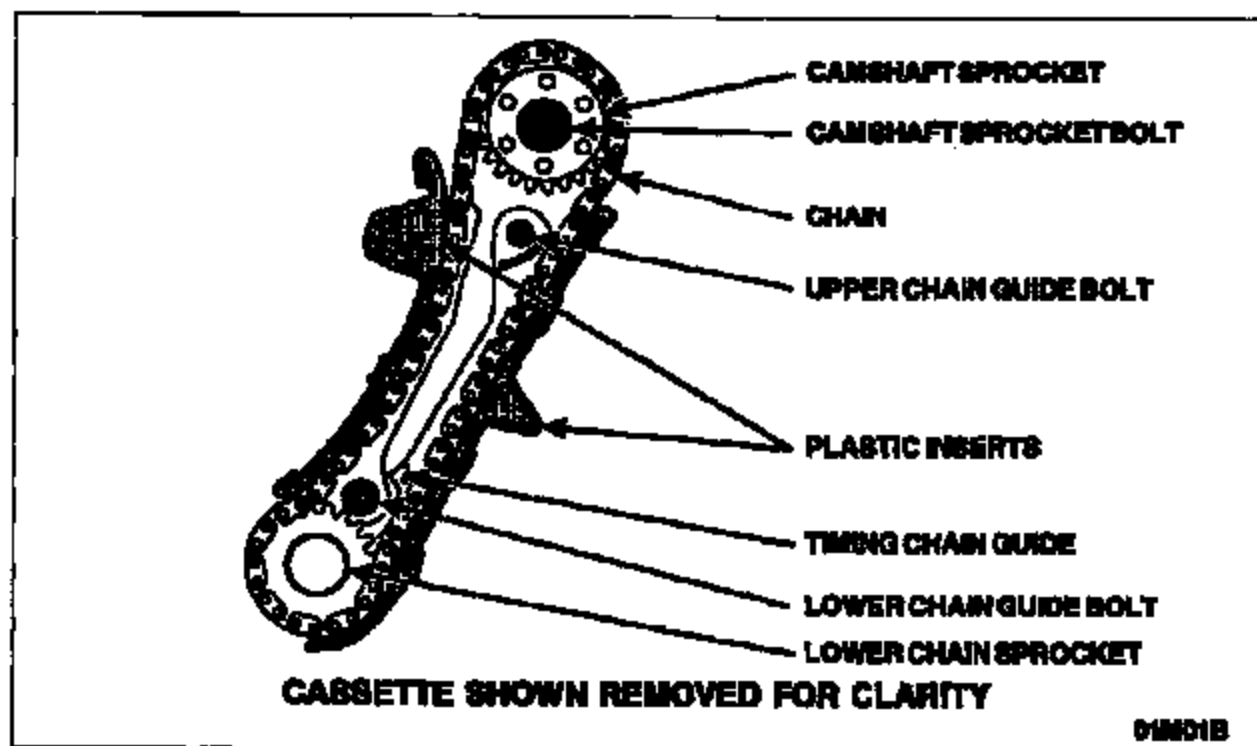
**FIGURE 1**

5. Inspect the LH camshaft cassette for damage to the plastic inserts of the chain guide; look for any cracks, broken or missing pieces. See Figure 1.
  - ^ If the cassette is not damaged, continue the procedure.
  - ^ If the cassette is damaged, continue the procedure AND perform the Oil Pump Pickup Tube Replacement. DO NOT drain the engine oil until Oil Pump Pickup Tube Replacement is performed.
