### Recall Detail

| Subject: VW/FRONT CONTROL ARM BRACKET | | Remedy Type: | RF Num: | FMVSS Num: |

**Subject: 1998-2000 Model Year Volkswagen Passat Vehicles  
Check/Replace Front Suspension Lower Control Arms**

**Subject: Service Action VM  
1996-2000 Model Year Volkswagen Passat Vehicles  
Check/Replace Front Suspension Lower Control Arms**

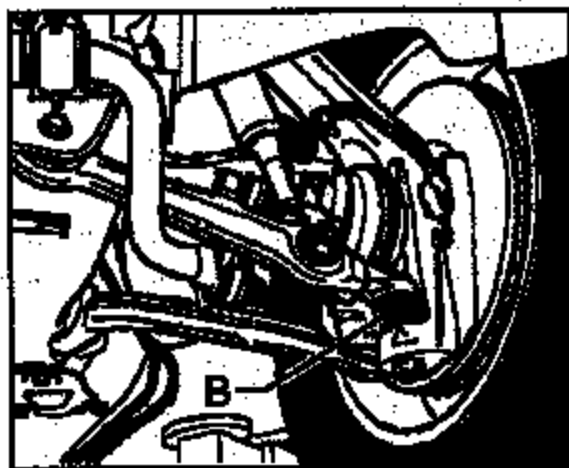
**#1 Check**

← Physically and visibly check around the rubber boot -B- on both the right and left control arms for damage when wheel is in straight ahead position, in the 10° -15° wheel turned left position and 10° -15° wheel turned right position

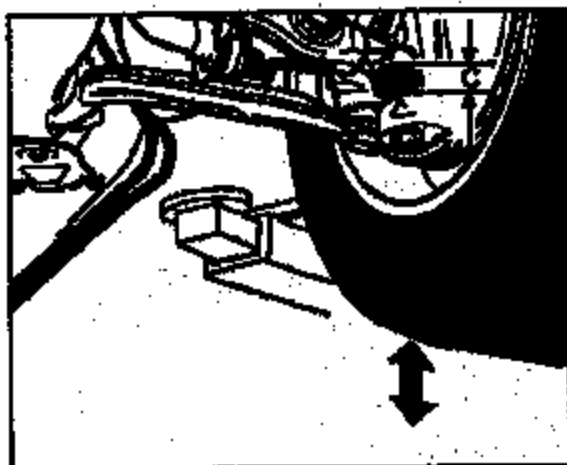
## #2 Check

- ⇄ Check for free play or movement -C- in the left and right control arm ball joint by lifting wheel up and lowering several times when wheel is in straight ahead position, in the 10°-15° wheel turned left position and 10°-15° wheel turned right position

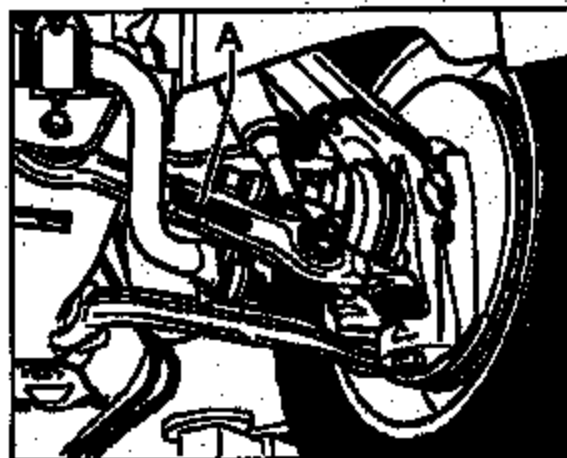
## #3 Check

- ⇄ Check for part number on the left and right control arms (part number could appear on either side of control arm)
- If part number -A- on the control arm is 4D0 407 155\_, the part is a genuine Volkswagen part
  - If no part number is found on the control arm, this is not a genuine Volkswagen part

- If the control arm is not a genuine Volkswagen part and the ball joint has free play or the rubber boot is defective, the part needs to be replaced. In this circumstance, customer bears expense or customer can refuse repair
- If customer approves repair, proceed to Section B; otherwise, no further work is required
- If the control arm is not a genuine Volkswagen part and the ball joint has no free play, inform customer that no free play was found; however, a quality determination could not be made. No further work is required

- If a rubber boot on the ball joint is damaged and the damage is not material decomposition, the control arm must be replaced. In this circumstance, customer bears expense or customer can refuse repair
- If customer approves repair, proceed to Section B; otherwise, no further work is required
- If a rubber boot on the control arm is damaged by material decomposition and it is a genuine Volkswagen part, proceed to Section B
- If the rubber boot on the control arm ball joint is not damaged, there is free play in the ball joint, and the control arm is a genuine Volkswagen part, proceed to Section B

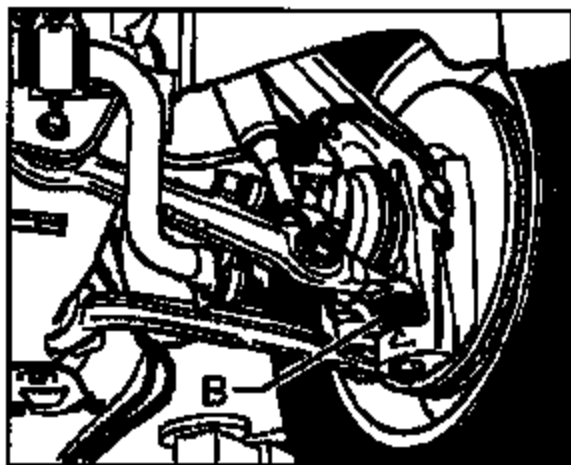
**#1 Check**

- ⇒ Physically and visibly check around the rubber boot -B- on both the right and left control arms for damage when wheel is in straight ahead position, in the 10° -15° wheel turned left position and 10° -15° wheel turned right position

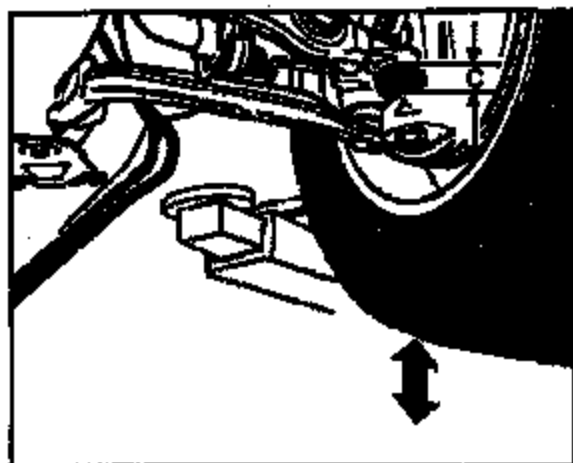
## #2 Check

- ⇐ Check for free play or movement -C- in the left and right control arm ball joint by lifting wheel up and lowering several times when wheel is in straight ahead position, in the 10°-15° wheel turned left position and 10°-15° wheel turned right position

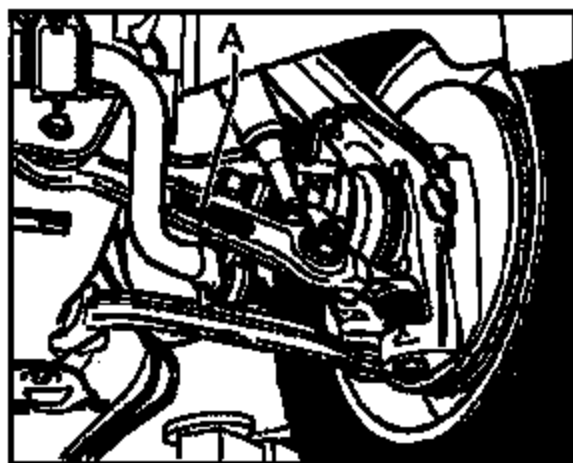
## #3 Check

- ⇐ Check for part number on the left and right control arms (part number could appear on either side of control arm)
- If part number -A- on the control arm is 4D0 407 155\_, the part is a genuine Volkswagen part
  - If no part number is found on the control arm, this is not a genuine Volkswagen part
