DOT Auto Safety Hotline
Vehicle Owner's Questionnaire
To Report Vehicle Safety Defects
1-888-DASH-2-DOT
(1-888-327-4236)
INTERNET: www.nhtsa.dot.gov/hotline

17 digit Vehicle Identification Number (located at bottom of windshield on driver's side): 1B7GG22Y7XS
Make: DODGE Model: DAKOTA Model Year: 1999
Date Purchased: 9-27-2001 Dealer's Name and Telephone Number: Paw Paw Motors - bought by SEALY WRIGHT
Original Owner: Dealer's City: Paw Paw, MI State: MI Zip Code: _____
Transmission Type: AUTOMATIC Antilock Brakes Cruise Control
Powertrain: FRONT WHEEL DRIVE REAR
Vehicle Component Code: 021520 SUSPENSION: FRONT: CONTROL ARM: UPPER BALL JOINT
Multiple Failures: 2

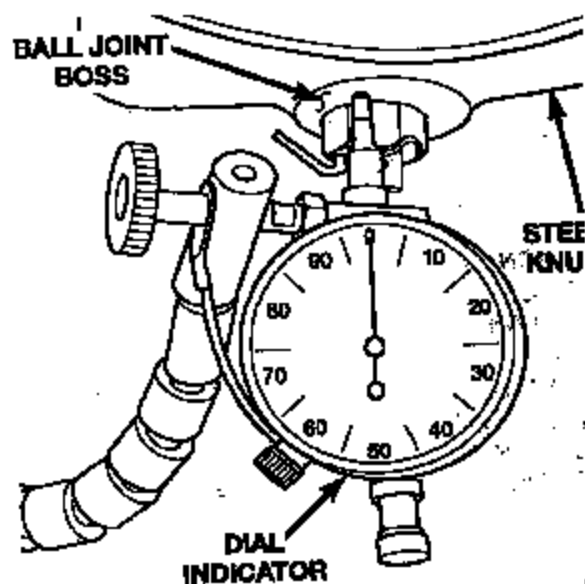
Fig. 2 Lower Ball Joint Boss

NOTE: The dial indicator plunger must be perpendicular to the machined surface of the steering knuckle lower ball joint boss (Fig. 2).

(7) If the travel exceeds 1.52 mm (0.060 in.), replace the lower control arm.

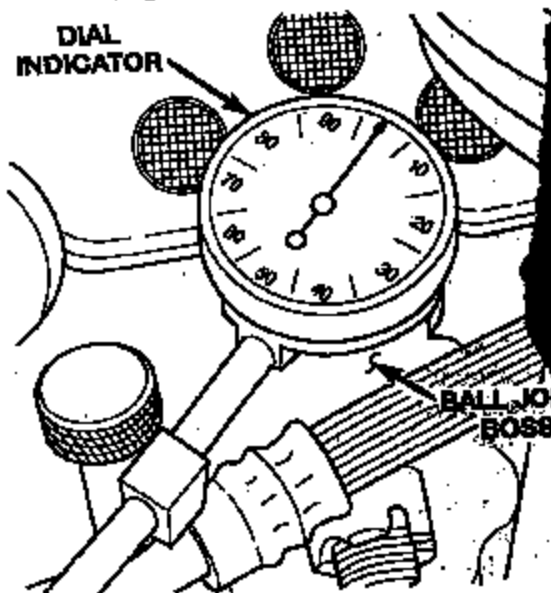
Fig. 3 Upper Ball Joint Boss

(3) Position the indicator plunger against the side of the upper ball joint boss of the knuckle (Fig. 3).

(6) If lateral movement is greater than (0.060 in.), replace upper suspension arm.
