IS ANYONE ELSE OUT THERE, AWARE THAT THE ORIGINAL COMPOSITE (CAST IRON & STEEL) FRONT BRAKE ROTORS ON "98" TAHOE'S CAN SEPARATE UNDER NORMAL BRAKING CONDITIONS, WITHOUT WARNING!?

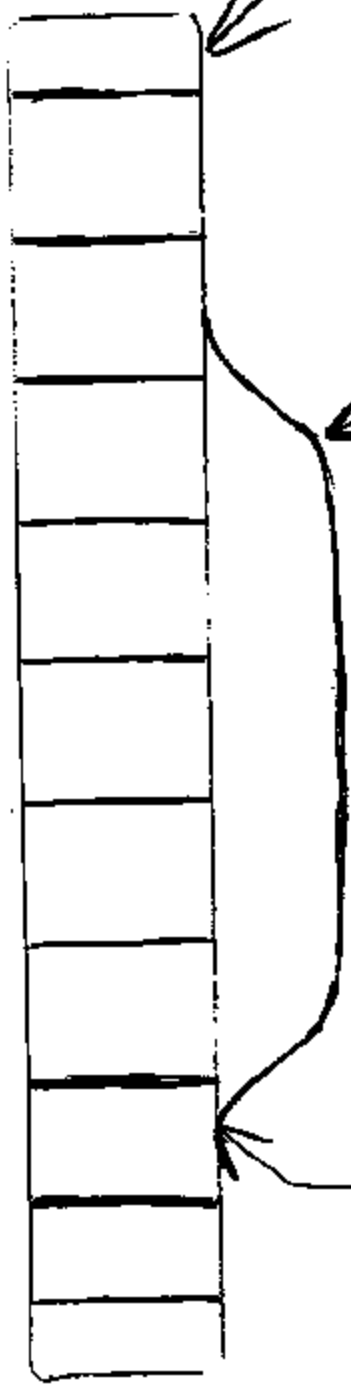
-Composite Rotor.-

CONTACTED CHEVROLET @ CUSTOMER ASSIST CENTER, WAS TOLD THIS WAS DUE TO AGE AND OR WEAR. I DO NOT BELIEVE THIS IS THE CAUSE OF SEPARATION. THIS ROTOR FAILED AT THE POINT THE STEEL HUB SECTION WAS ATTACHED TO THE CAST-IRON SECTION, AND BLEW APART.

CAST-IRON Pad clamping  
SECTION  
SEPARATED  
FROM

STEEL HUB SECTION.

POINT OF SEPARATION.
