DOT Auto Safety Hotline  
**Vehicle Owner's Questionnaire**  
To Report Vehicle Safety Defects  
1-888-DASH-2-DOT  
(1-888-327-4236)  
INTERNET: www.nhtsa.dot.gov/hotline

LS 430

180000 TIRES:PRESSURE MONITORING AND REGULATING SYSTEMS

THE TIRE PRESSURE WARNING SYSTEM FAILED. AS A RESULT, THE VEHICLE EXPERIENCED A FLAT TIRE WHILE DRIVING. THE CAUSE HAS YET TO BE DETERMINED. \*AK

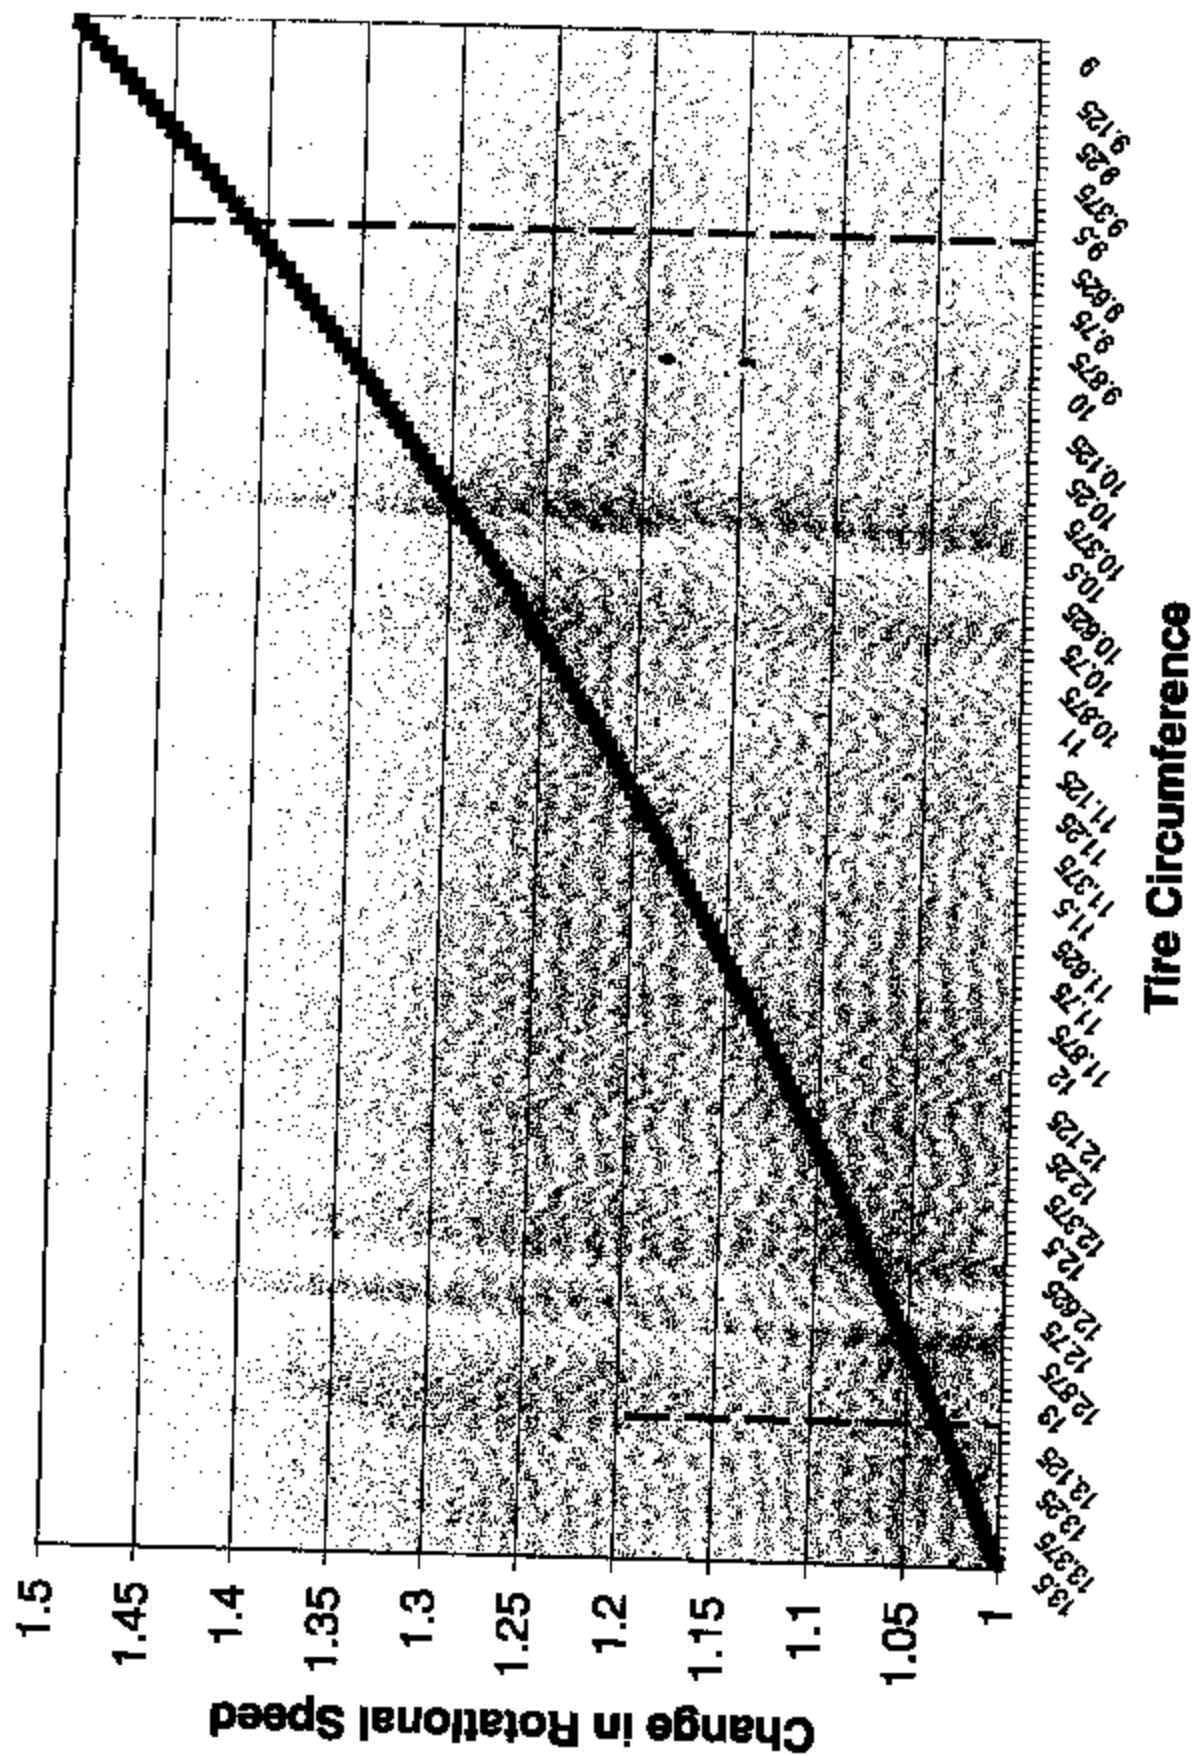
I introduced my graph of the Tire Pressure Warning System (see attached) and expressed to Mr. Biven that I wanted to understand at what level of deflation the TPWS sent a signal, what that signal strength needed to be in electrical units of measure, what reference value that was going to be compared to and what the time and signal tolerance were around that measure. Mr. Biven indicated that not only didn't he have that knowledge but that it was unavailable. I opined that the information would be made available if they thought it was sufficiently important to customer satisfaction to go obtain it. Both individuals indicated that this wasn't going to happen.
