# **FIRE INVESTIGATION REPORT**

[REDACTED]  
**Macon, Georgia** [REDACTED]  
**November 24, 2004**  
**CLAIM NO: 77777**  
**EFI JOB NO: 98** [REDACTED]

Engineering and Fire  
Investigations, Inc.

**On November 23, 2004, EFI Inc. received a request to conduct an origin and cause investigation on a fire loss that occurred on September 4, 2004. The loss was a 1995 Cadillac Eldorado vin number 1G6E112Y4S. The insured was reported to be**

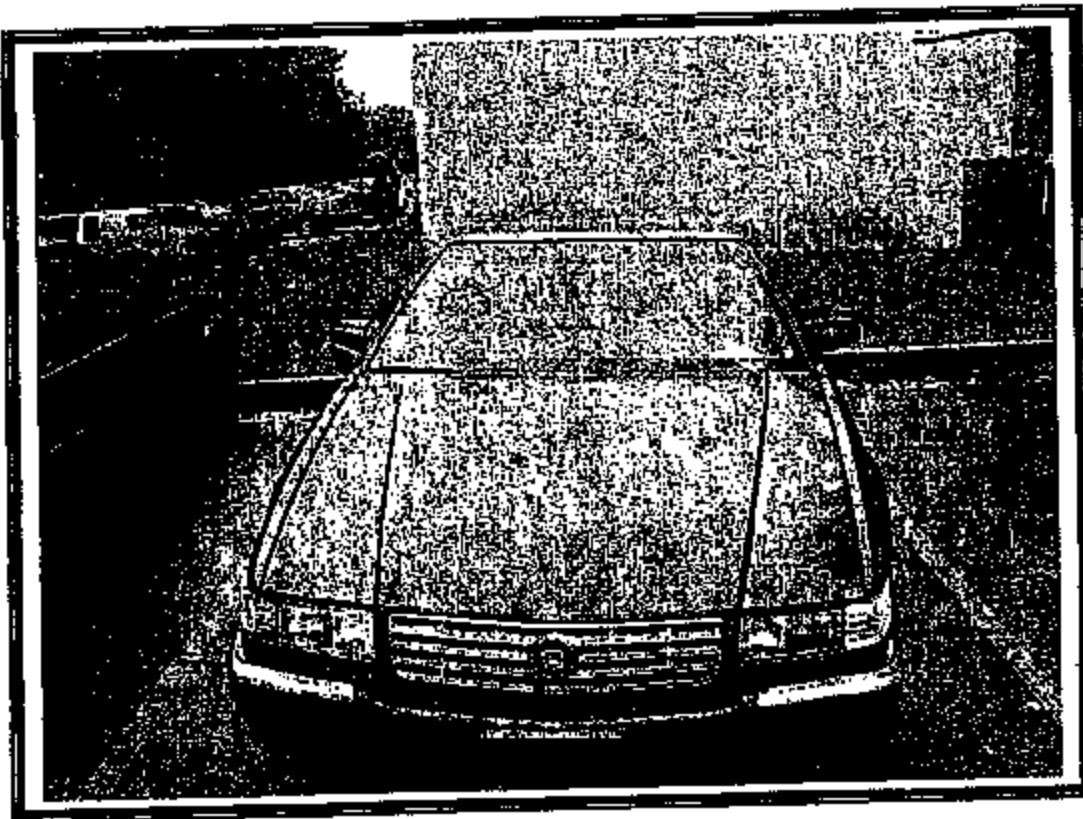
**FIGURE 1**  
View of the front  
of the vehicle.

The investigation was begun with a walk-a-round of the vehicle. The front of the vehicle had no visible fire damage. The driver's side of the vehicle had no visible fire damage. The rear of the vehicle had no visible fire damage. The passenger side of the vehicle had no visible fire damage. The roof of the vehicle had no visible fire damage.

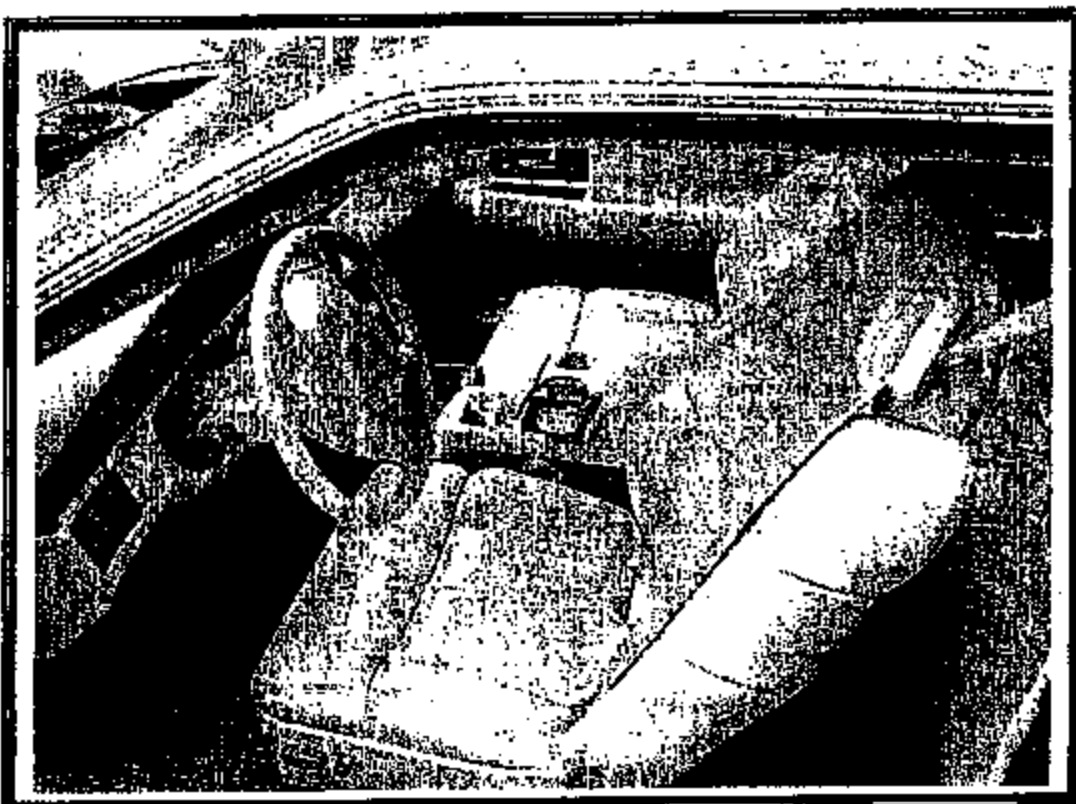
**FIGURE 8**

I examined the interior of the vehicle. There was no visible fire damage to the interior of the car. The dashboard was intact with no visible fire damage. The rear trunk compartment area had no visible fire damage.

The entire front  
seat area of the  
interior of the car.

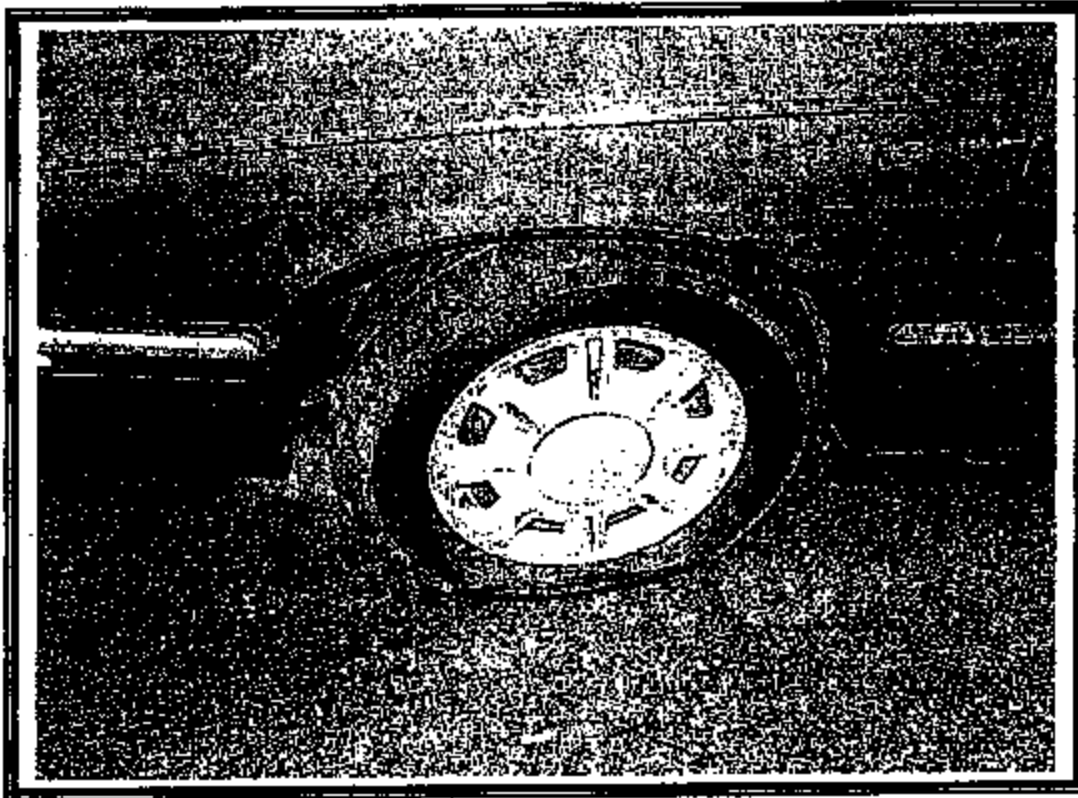
**FIGURE 11**

This vehicle was equipped with Toyo Ultra Premium Touring Tires in size P225 60R 16 97T. There was no visible fire damage to the tires or wheels. The tires were worn and were flat at the time of this investigation.

View of the flat  
tire and wheel at  
the front driver's  
side of the car.

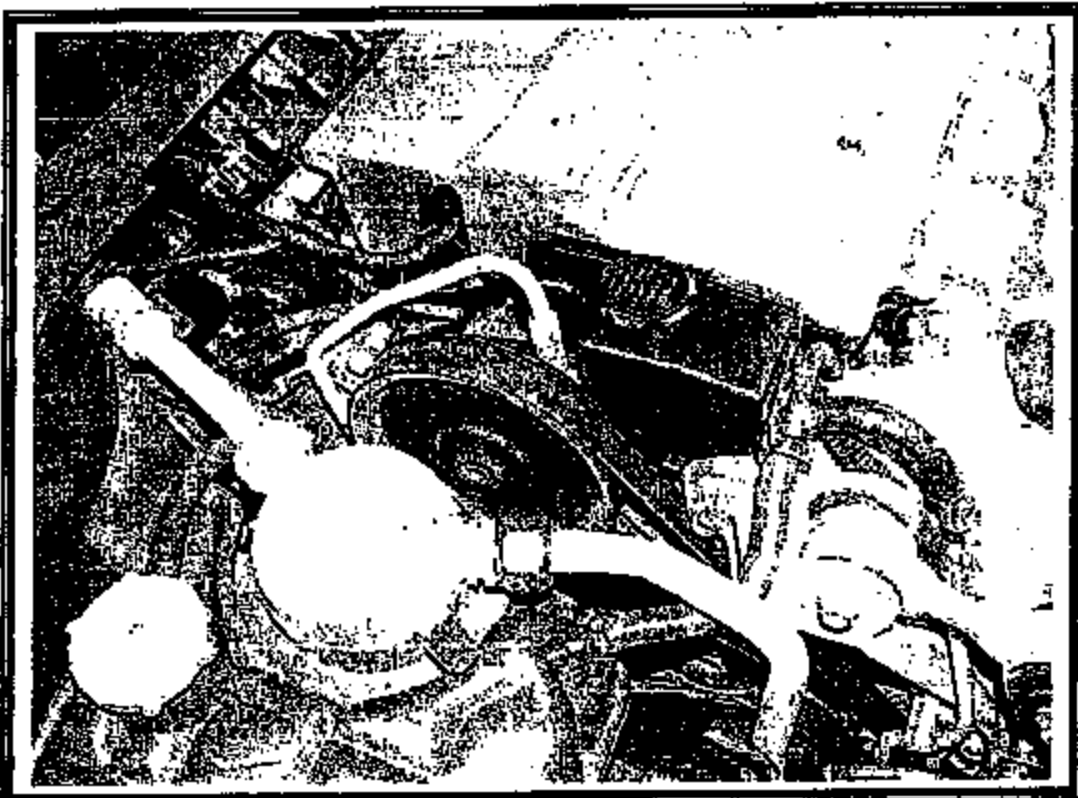
**FIGURE 12**

There was no visible fire damage to the front radiator area of the engine compartment.

View of the front  
fan belt area of  
the engine.

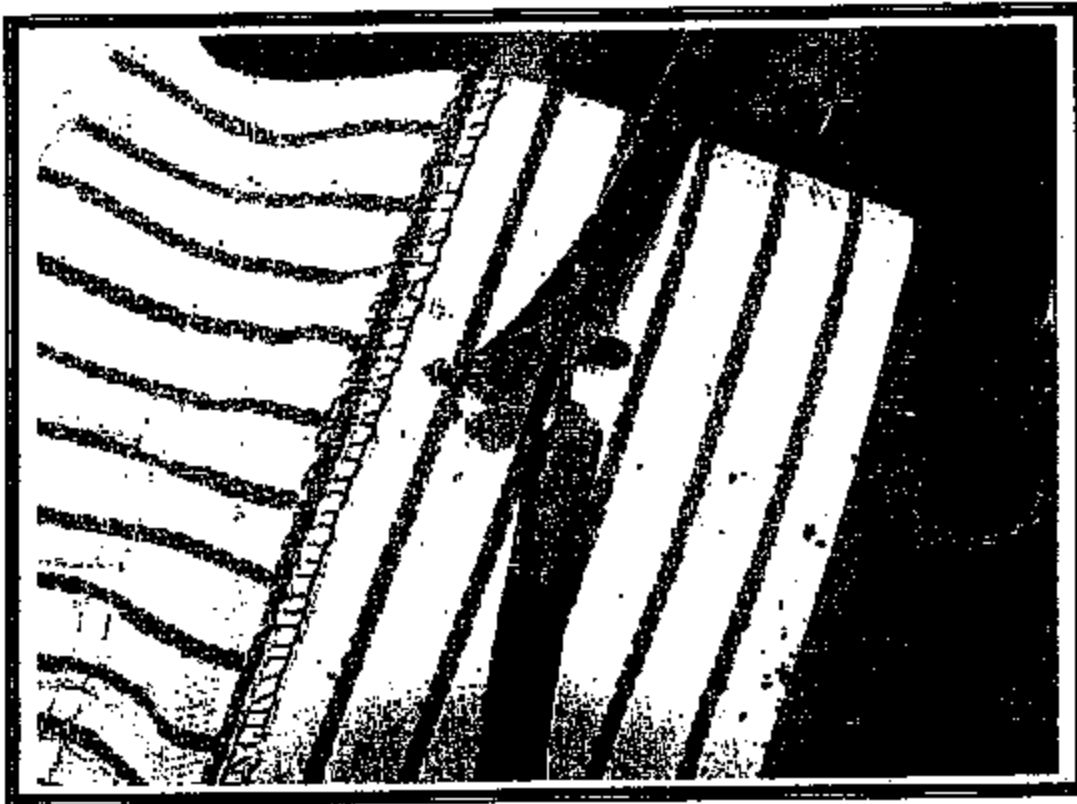
**FIGURE 21**

I examined the area of origin for any possible ignition sources. There was some electrical wiring in the area of origin, but I found no indications on the wires of arcing occurring. I examined the spark plug wires that ran across the top of the engine and found the wire closest to the fire origin area broken in mid line. This break did not appear to be burned in the cable although the rubber break area was charred from the fire. This wire was sitting on top of the engine. It is possible that this spark plug wire was arcing to the metal engine parts creating enough heat to ignite the fuel mist.

This fire originated on the top of the engine at the point where the main fuel line meets the fuel harness. The only fire cause that I found was a possible small leak occurring in the fuel line from the main line to the harness. This leak was most likely ignited by arcing in the spark plug cable.

The break in the spark plug line that could have been arcing to the top engine metal components.
