# NHTSA Complete Record Information

**Subject: CERTIFIED LTR REQUESTING NHTSA INITIATE A DEFECT INVESTIGATION RE SELECTED FORD MOTOR COMPANY VEHICLES LEFT FRONT INNER BEARINGS FOR ADVANCE FATIGUE CRACKS**

RE: Public safety concern

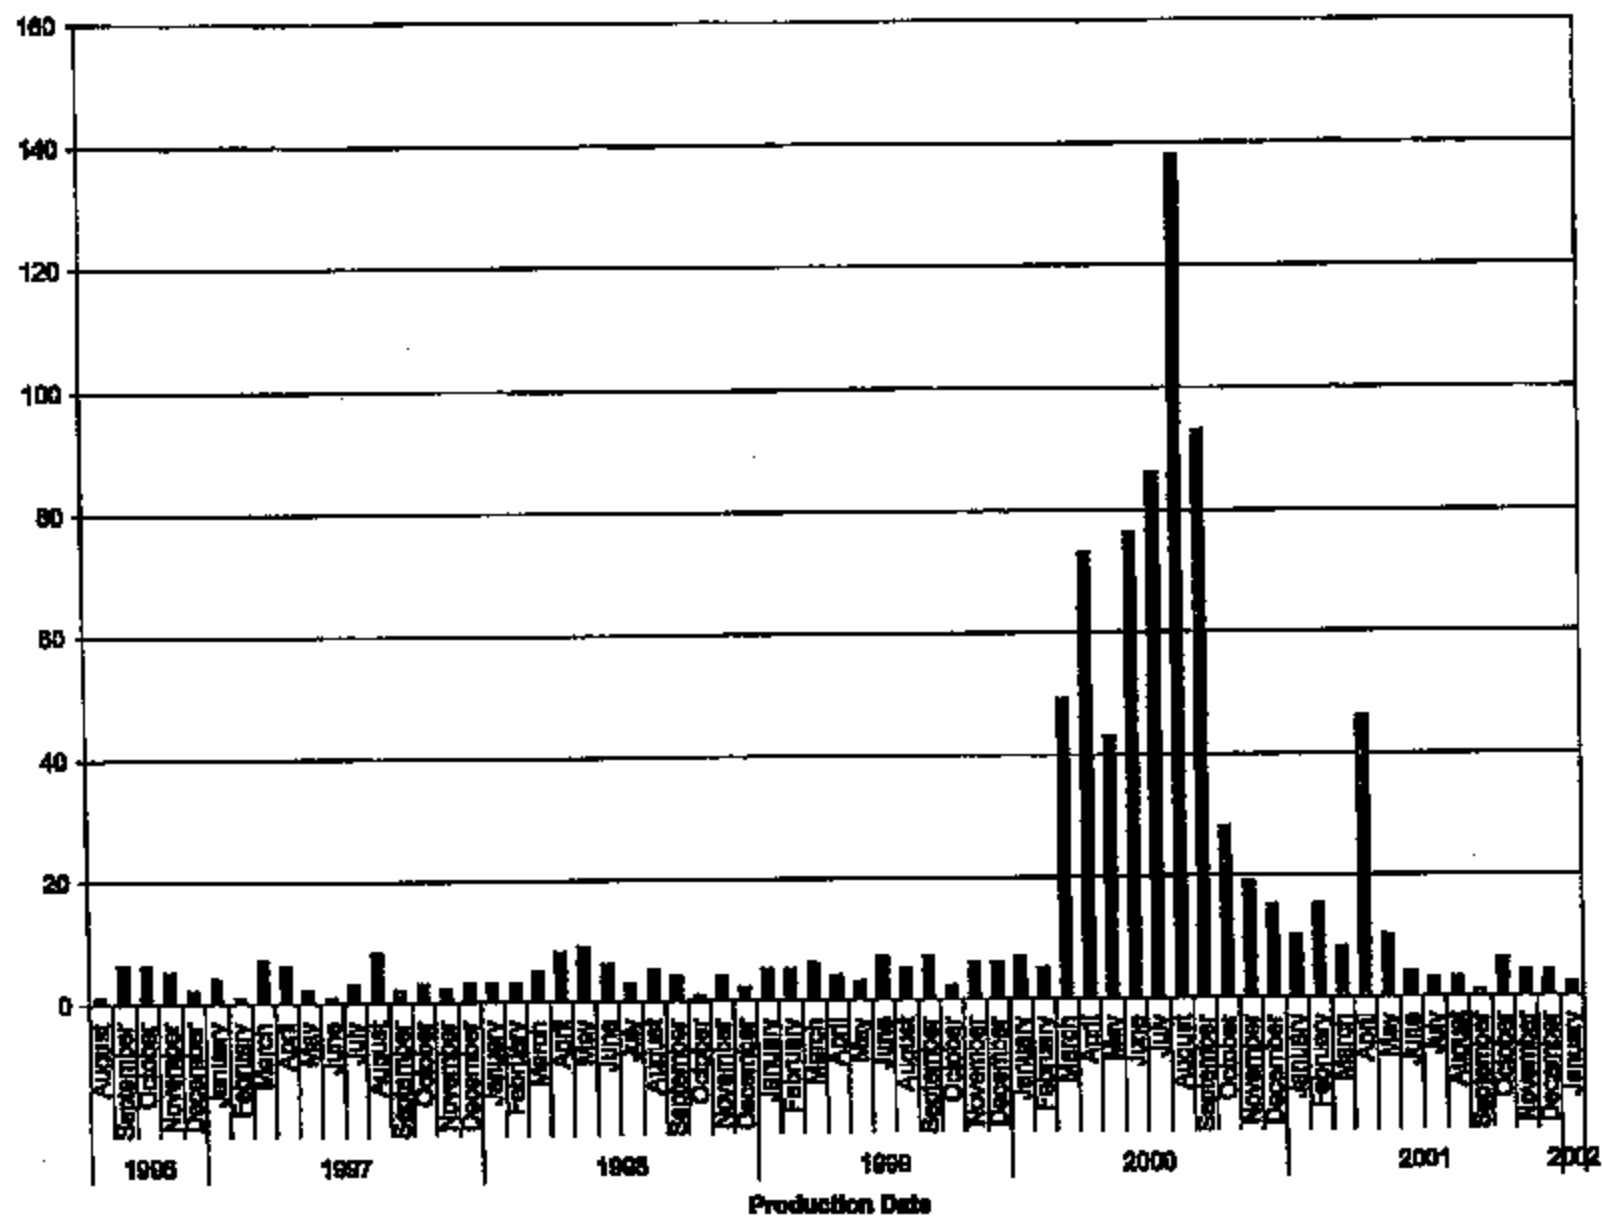
# **ATTACHMENT "D"**

Mr. Peter Lammon investigated internal Ford warranty claims involving Expeditions and vehicles with substantially similar front wheel/bearing assemblies (e.g., F-150s, F-250s, E-350s). See Attachment D. What he found was a substantial increase in reported bearing failures for particular manufacturing months. As you are aware, front bearings are safety components; in that, if a bearing catastrophically fails, steering is disrupted and brakes can be severely diminished. These types of claims were found in Ford's AWS (Analytical Warranty System) narratives of problems encountered by Ford customers, and actions undertaken by Ford technicians. While the charts indicate that Ford has gotten their problem under control, it is also apparent that Ford is treating this as a warranty and manufacturing issue, rather than a broad-based safety issue that puts the public at risk. Many, perhaps most, customers whose bearings fail will be able to safely move to the road shoulder and have their vehicle towed to the dealer. If a driver were traveling on a narrow two-lane roadway at highway speed, as was Mr. Brown, when the bearing fails, his or her vehicle may veer into the oncoming lane. Some of these incidents will lead to a fatal collision.

# Claims with "wheel" and "bearing" in Technician Comments
