NHTSA Complete Record Information

RE: Public safety concern

We have recently been asked to consult in the matter of a fatal two-vehicle collision. We believe, based upon physical evidence and internal industry documents, that an inherent vehicle defect that is present in selected Ford Motor Company vehicles precipitated the loss of directional control of the striking vehicle. Therefore, we are bringing this matter to your attention as the agency with the authority to investigate and direct national recalls.

ATTACHMENT "A"

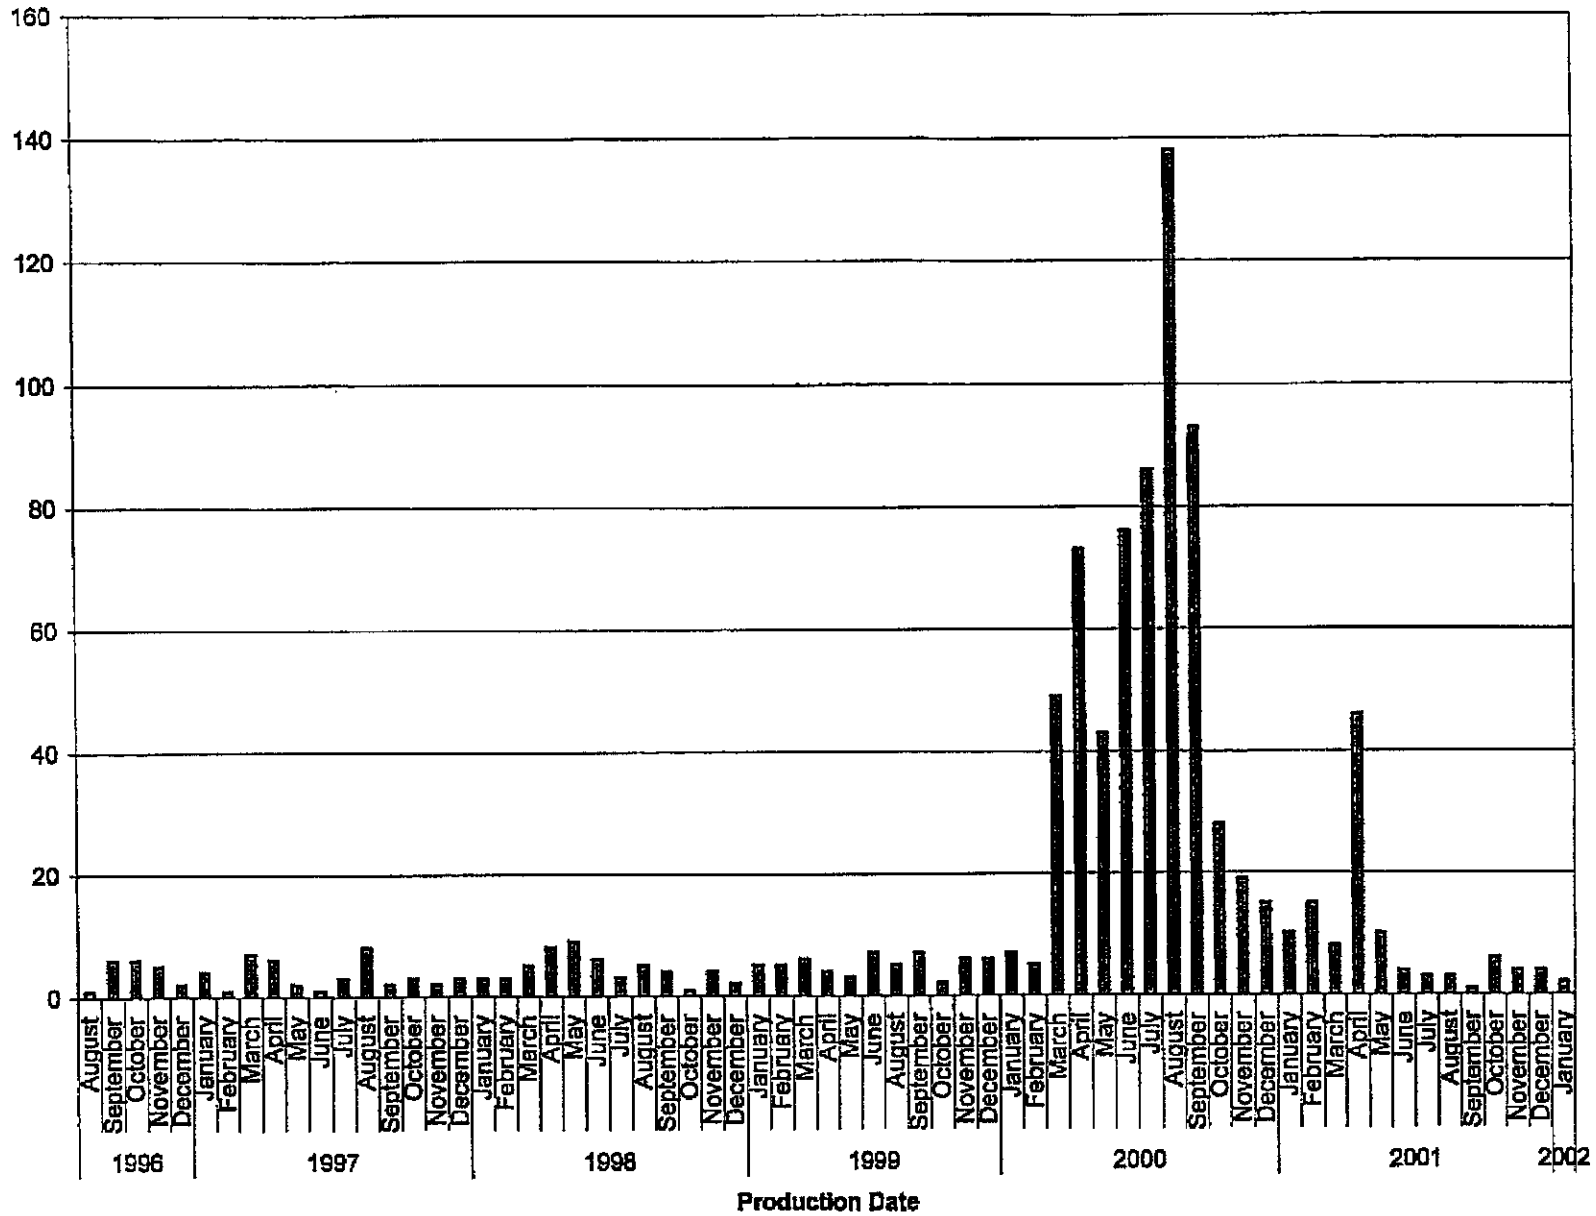
ATTACHMENT "D"

Mr. Peter Lemmon investigated internal Ford warranty claims involving Expeditions and vehicles with substantially similar front wheel/bearing assemblies (e.g., F-150s, F-250s, E-350s). See Attachment D. What he found was a substantial increase in reported bearing failures for particular manufacturing months. As you are aware, front bearings are safety components; in that, if a bearing catastrophically fails, steering is disrupted and brakes can be severely diminished. These types of claims were found in Ford's AWS (Analytical Warranty System) narratives of problems encountered by Ford customers, and actions undertaken by Ford technicians. While the charts indicate that Ford has gotten their problem under control; it is also apparent that Ford is treating this as a warranty and manufacturing issue, rather than a broad-based safety issue that puts the public at risk. Many, perhaps most, customers whose bearings fail will be able to safely move to the road shoulder and have their vehicle towed to the dealer. If a driver were traveling on a narrow two-lane roadway at highway speed, as was [REDACTED], when the bearing fails; his or her vehicle may veer into the oncoming lane. Some of these incidents will lead to a fatal collision.

Claims with "wheel" and "bearing" in Technician Comments
