DOT Auto Safety Hotline  
**Vehicle Owner's Questionnaire**  
To Report Vehicle Safety Defects  
1-888-DASH-2-DOT  
(1-888-327-4236)  
INTERNET: www.nhtsa.dot.gov/hotline

Vehicle Component Code  
141000 AIR BAGS:FRONTAL

DT: THE CONTACT STATED WHILE TRAVELING AT 45 MPH ANOTHER VEHICLE PULLED OUT IN FRONT OF THE CONTACT'S VEHICLE. THIS RESULTED IN A CRASH. UPON IMPACT, THE AIR BAGS DID NOT DEPLOY. ALSO, THE SEAT BELTS DID NOT RESTRAIN THE CONTACT PROPERLY. THE LAP PORTION OF THE BELT SEEMED TO WORK FINE, BUT THE SHOULDER STRAP DID NOT WORK PROPERLY. THE CONTACT SUSTAINED CHEST INJURIES. A POLICE REPORT WAS TAKEN AT THE SCENE. THE VEHICLE WAS TOTALED BY THE INSURANCE COMPANY. \*AK

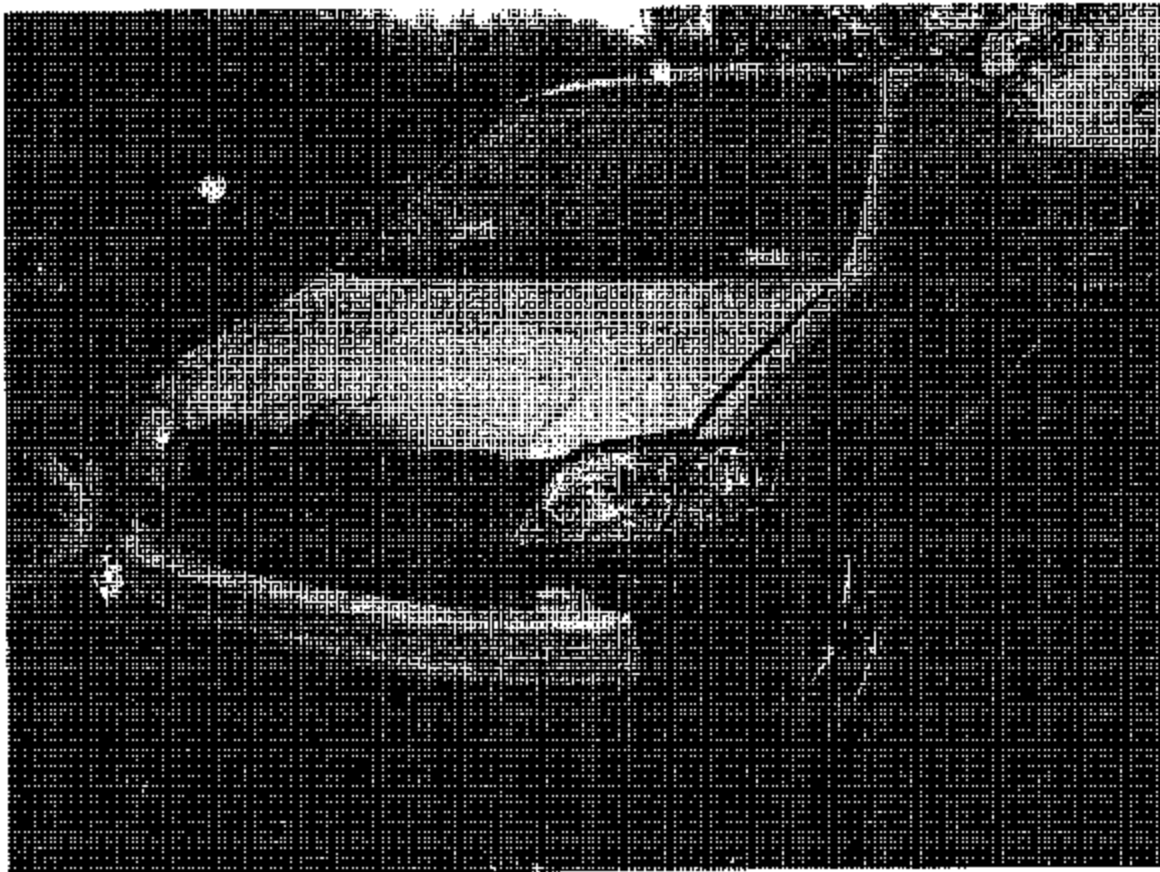
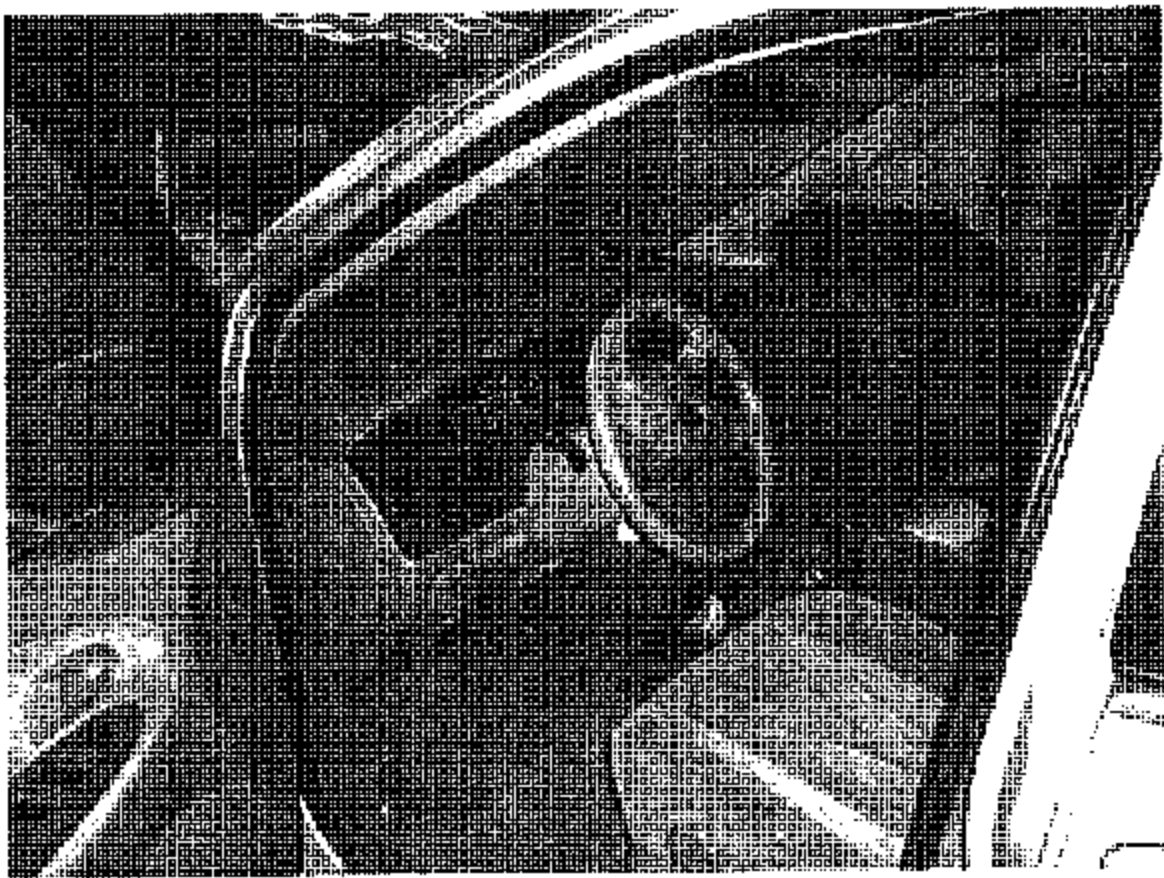
I spent one day in hospital and 5 weeks for recovery. I feel  
 that the failure of belt (upper portion) & non deployment of  
 air bag contributed to injuries. Also have two fractured teeth  
 Medical care at Strong Memorial Hospital.  
 Insurance co. has said they will assist with information you  
 may need to investigate.
