Ford Motor Co
Customer Assistance Center
300 Renaissance Ctr
P.O.Box 43360
Detroit Mich-48243
Attn Recall Complaints

Fig. 3: Page 3 of Bulletin
1997 Mercury Grand Marquis LS

Article No. 02-2-2 Cont'd.

<ul style="list-style-type: none"> • COOLANT—COOLANT SEEPAGE AT INTAKE MANIFOLD CROSS-OVER—VEHICLES EQUIPPED WITH 4.6L 2V ENGINE ONLY • ENGINE—4.6L 2V—COOLANT SEEPAGE AT INTAKE MANIFOLD CROSS-OVER 	Article No. 02-2-2
--	-------------------------------------

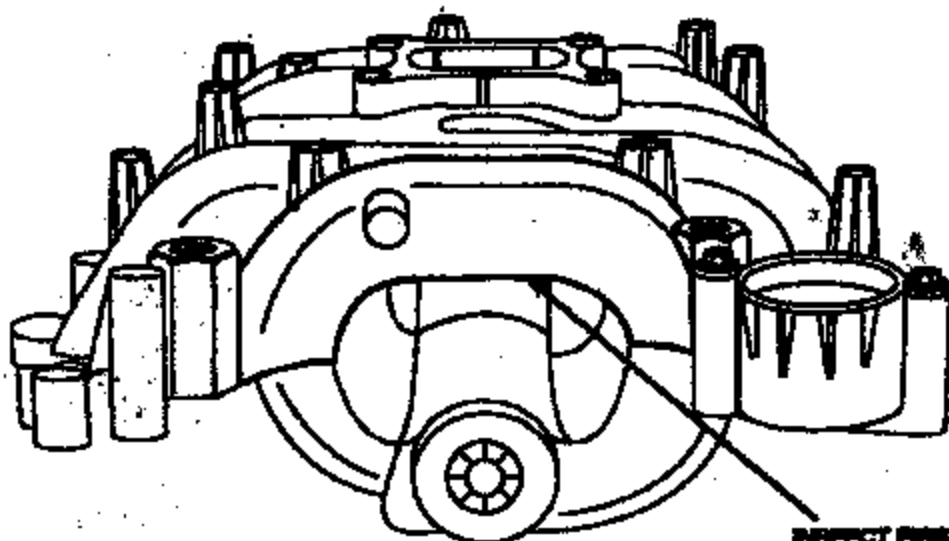
Figure 1 - Article 02-2-2

My name is [redacted] and have owned three mercury Grand marquis since the 1980,s. The latest is a 1997 LS purchased in Sept 1997 from Mc Cotter Ford in Titusville Fla. I have been extremely pleased with the Grand Marquis until today, but am extremely upset about a recall (of which I never received) in regards to possible COOLANT SEAPAGE AT THE INTAKE MANIFOLD CROSS-OVER. This design flaw was recognized by Ford as a serious matter some time ago and until today when my Automotive technician found it during a routine servicing oil change and then produced a Ford bulletin which clearly outlines the seriousness of the matter. A crack was found and the Intake manifold replaced at a cost of \$458.14 and labor of \$360. I had just returned from a trip to Georgia on Oct 31 and would have been very serious if the crack became more than just a seepage without any coolant.

ALTERNATOR REMOVED FOR CLARITY

INSPECT FIRST RUNNER
COOLANT CROSSOVER
FOR COOLANT SEEPAGE

*LEAKING 11/1/2005
71000 miles*

Some vehicles may exhibit an Intake Manifold crossover (first runner) coolant seepage condition. This may be caused by a crack in the Intake Manifold coolant crossover.

Inspect the suspect Intake Manifold for a coolant leak at the first runner cross-over area (Figure 1). If coolant seepage is found in this area, order the appropriate Service Kit and install parts, by referring to the appropriate Model Year Workshop Manual (Section 303-01).

Refer to Figure 1 for inspection of coolant seepage. If seepage is found, order one of the following Service Kits to repair.
