DOT Auto Safety Hotline
Vehicle Owner's Questionnaire
To Report Vehicle Safety Defects
1-888-DASH-2-DOT
(1-888-327-4236)
INTERNET: www.nhtsa.dot.gov/hotline

Reference No.
10145837

17 digit Vehicle Identification Number Located at bottom of windshield on driver's side
SAJHXJ041 [REDACTED] Make JAGUAR Model XJ8 Model Year 1999
Date Purchased 15-JUL-05 Dealer's Name and Telephone Number HORNBERG JAGUAR OF SANTA MONICA 310-453-3377 Engine: No. Cylinders 8 Fuel Type: Gas
Original Owner Dealer's City SANTA MONICA State CA Zip Code 90405 90404
Transmission Type AUTOMATIC Antilock Brakes Cruise Control Powertrain UNKNOWN Vehicle Component Code 081110 ENGINE AND ENGINE COOLING:ENGINE:GASOLINE:BELTS AJ
Multiple Failure: 1

RE: 1999 Jaguar XJ8, VIN#SAJHX10-[REDACTED]

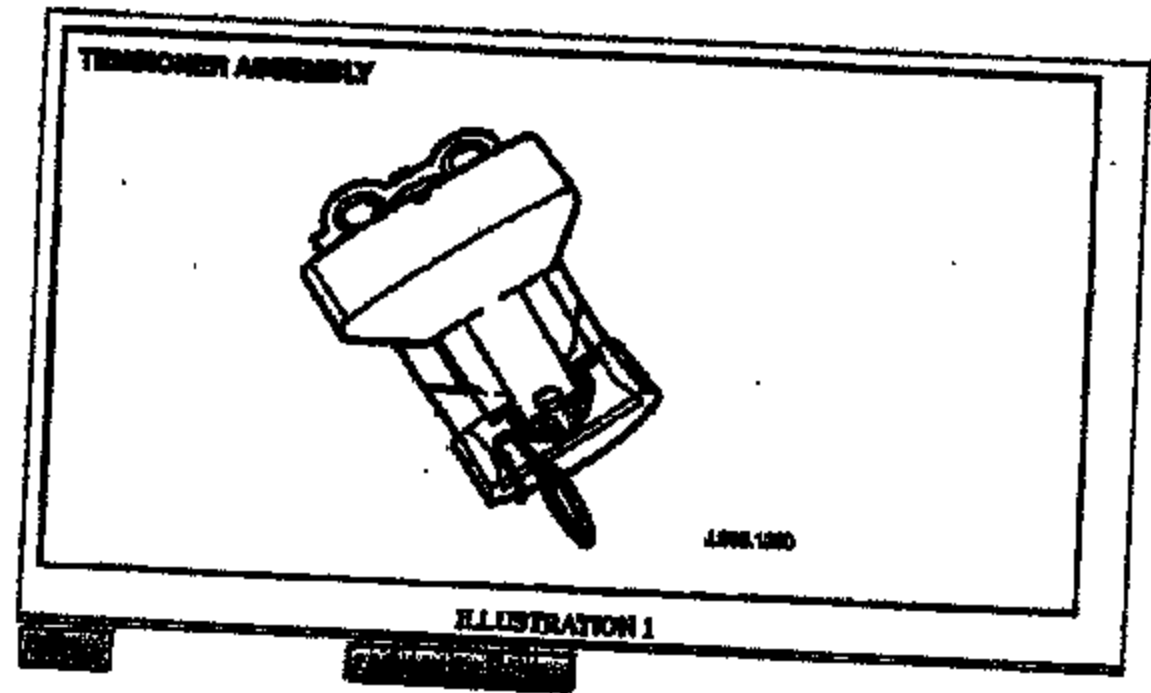
Some vehicles within the above VIN range may experience a rattling noise when the engine is started. This noise may be caused by the secondary timing chain tensioners. Research has shown that a noise can originate at the chain tensioners to cause a resonance in another part of the engine.

A revised, spring assisted, secondary timing chain tensioner has been introduced to eliminate this concern.

^ The revised tensioner has a coil spring that presses on the plate head to provide a damping effect.

In case of a customer complaint of start up noise, determine if the noise is caused by the secondary timing chain tensioners. If the secondary timing chain tensioners are the cause of the noise, they should be replaced by the revised tensioners (Illustration 1).
