NOTICE OF SAFETY DEFECT

BLOWOUTS/RUBBER VALVE-STEM CUTS/SHARP EDGES OF WHEEL COVERS

We own a 1996 Roadtrek 210 Popular, on a 1995 Chevy 30 Van extended chassis, VIN #1GBGG39K8 [REDACTED] delivered to us new, November 26, 1995, by Irvine RV, Irvine, California. We have accumulated 122,100 miles.

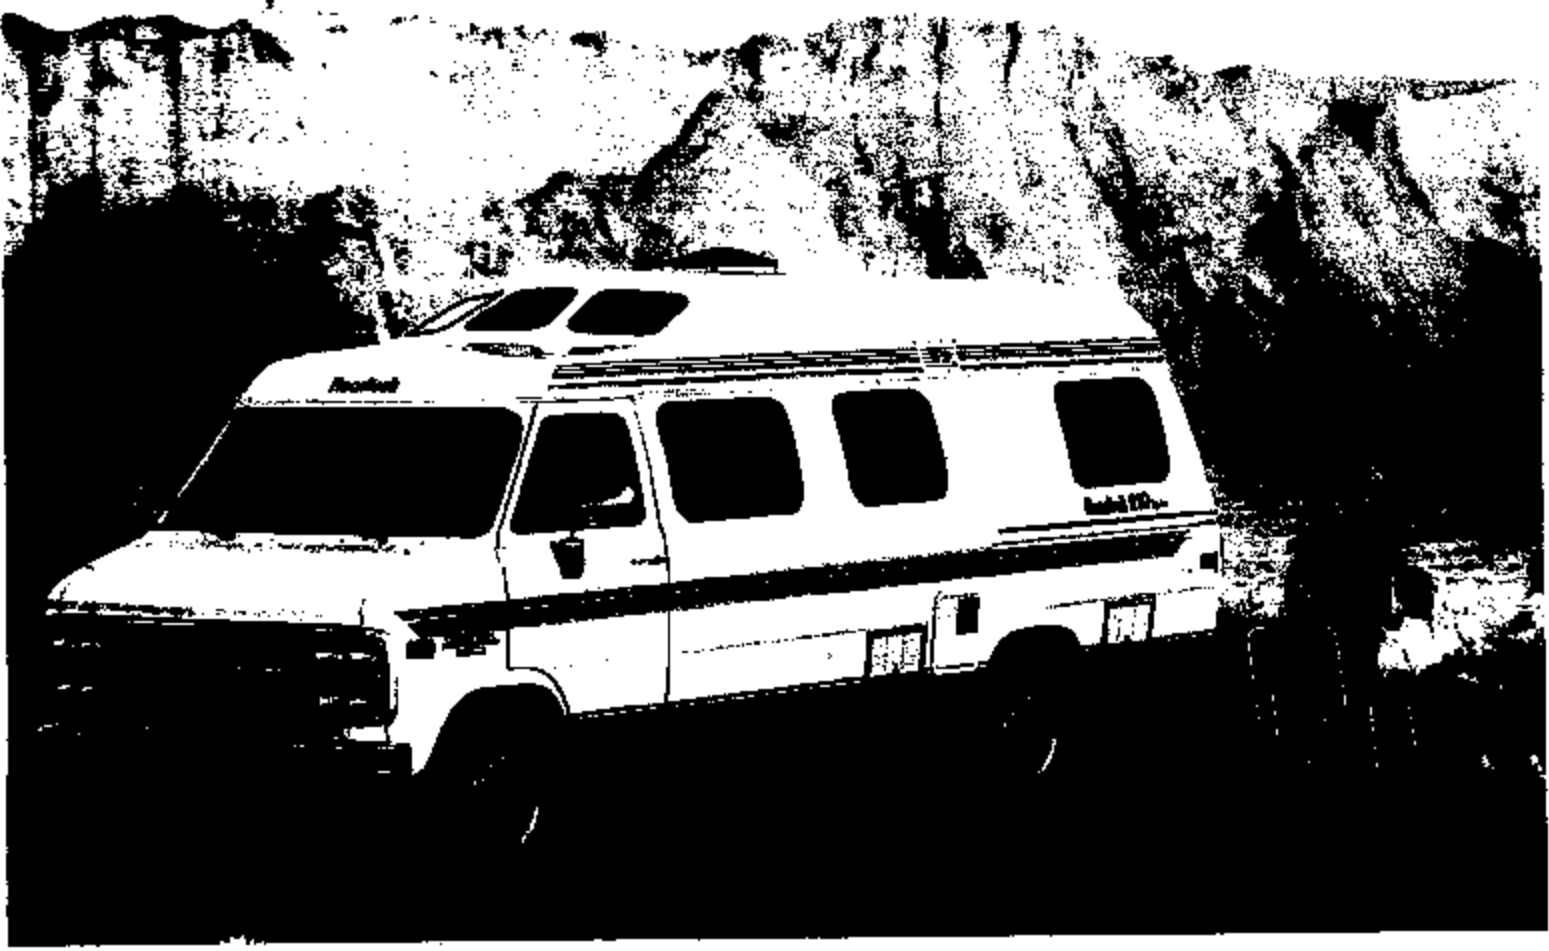
Photo of the full wheel cover style attached.

- (1) On December 20, 2001 I had a catastrophic blow out on the original set of Michelin tires on the left rear wheel while traveling at legal high speed on I-10 west of Phoenix, Arizona, near Tonapoh. At the time, I thought the tire failed, blaming myself for speed, age, heat, and mileage on the tire. The catastrophic explosion tore off the muffler, the tail pipe, and fender/fender skirt, doing \$1,000.00 in damages. I was lucky not to have lost control, rolled over, or collided with another vehicle or big rig. I purchased 5 new tires and high pressure rubber valve stems January 9, 2002 at my Michelin dealer in Santa Monica, California, at 70,000 miles. I inspect my tires frequently, and rotate all 5 every 12,000 miles in the factory manual rotation pattern. I do not rotate wheel covers.

- (2) On November 20, 2003 the left rear rubber valve stem exploded after the "low tire" was aired up to the recommend 80psi at the Panther Junction Chevron Station, in Big Bend National Park. The tire went flat instantly. I was grateful the failure occurred on the station tarmac, as there is no other service for hundreds of miles around. One new rubber high pressure valve stem was installed. The alert attendant noted sharp edges on the wheel cover hole where the valve stem sticks through, and he put heavy rubber hose, about one inch long, over each valve stem where they protrude through the wheel covers. The same wheel cover went back on the right rear tire/wheel. This second failure occurred at approximately 90,000 miles, and on my second set of 5 tires/valve stems.

- (3) On Sunday, April 31, 2006 after lunch in Chandler, Arizona, upon returning to my Roadtrek 210 Popular, I noticed the left rear tire looked "low." I went across the street to Freeway Chevrolet, 1154 N. 54th Street, Chandler, AZ 85226, where the Service Manager directed attendants to "air up" the tire to get me to a tire dealer, as it appeared I might have a slow leak requiring tire repair, not a service provided by the Chevrolet dealer. As the attendant began adding air, he exclaimed, "here is the problem - the valve stem!" Air began jetting out of the side of the valve stem and the tire went flat. A second attendant examined the wheel cover, and said, "here is the problem - the sharp edges are cutting the stem!" Apparently the rubber hose was adding little protection. He bent and rounded off the sharp edge on the one left rear wheel cover. They installed an automobile (low pressure) rubber valve stem, and graciously sent me on my way without charge. This incident occurred at approximately 121,000 miles.

I now believe all my left rear tire failures, the only tire failures I have had, were caused by the same sharp edges on one of the factory installed flat-full-wheel covers that came with my Chevy Van. The way the rubber high pressure (not automobile) valve stems failed, suddenly, causing instant deflation, and slowly, allowing for low pressure high-speed tire failure, leads me to believe that the public safety is in jeopardy from possible catastrophic tire failure caused by the rubber valve stems rubbing against, and being cut or damaged somehow by the sharp edges of the holes in the full wheel covers. Since I rotate the tires it is not the one wheel cutting the valves. The only thing constant at the left rear wheel location has been the same wheel cover as the likely cause of the valve stem failures.

On May 22, 2006 I replaced all 5 of my rubber Light Truck valve stems with 120psi brass valve stems still having a rubber base. Now I am shopping for 5 new Michelin tires, and hope to find the completely metal brass or stainless steel bolt-in valve stems.
