SAFETY RECALL TO PROPERLY ROUTE YOUR VEHICLE'S ENGINE WIRING HARNESS

DEFECT INFORMATION REPORT FOR CHRYSLER RECALL #878

DEALER SERVICE INSTRUCTIONS Safety Recall #676 - Engine Wiring Harness Routing

Subject: Safety Recall #676 – Engine Wiring Harness Routing

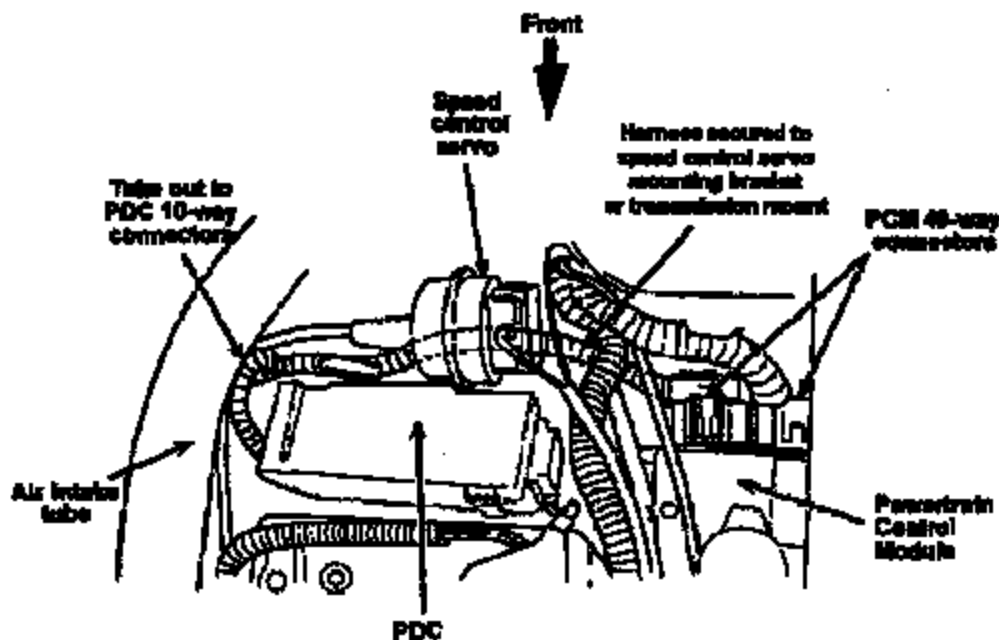
Figure 1

1. Locate the portion of the engine wiring harness which connects to the two (2) 10-way connectors on the bottom of the power distribution center (PDC) and to the 40-way connector on the powertrain control module (PCM) (Figure 1).

9. Route the PDC connector take-out through the clip molded on the inboard end of the PDC (Figure 3).
10. Snap the PDC into its mounting bracket.
11. Attach the locator clip on the 40-way PCM take-out to the speed control bracket (if equipped) or to the transmission mount support bracket, if necessary (Figure 1).
12. Reconnect the battery.

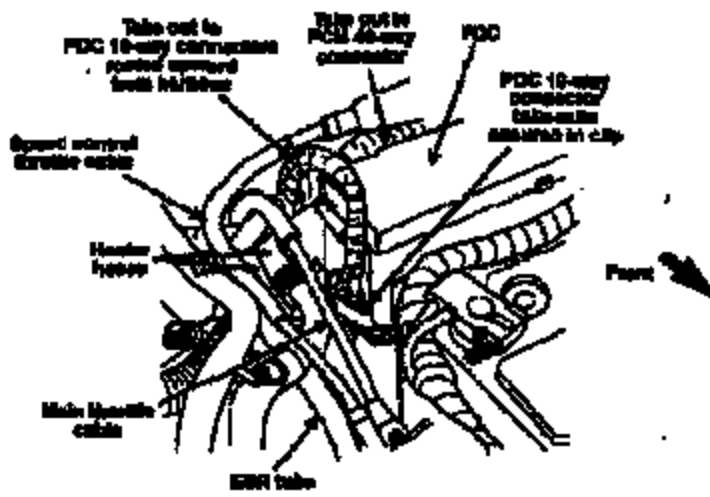
CORRECT ROUTING (DOHC ENGINE SHOWN)

2. Remove the PDC from its mounting bracket.
3. Inspect the harness routing as follows:
 - a. The take-outs for the two 10-way PDC connectors must be routed above the heater hoses and EGR tube and secured in the clip located on the inboard side of the PDC (Figure 2).
 - b. The take-out for the 40-way PCM connector must be attached to the speed control servo bracket (if equipped) or the transmission mount support bracket (Figure 1).

5. Inspect the two PDC 10-way connectors to ensure that all wire terminals are fully seated into the connector.
6. Rotate the heater hose spring clamps inboard to ensure that they do not contact the wiring harness.
7. Route the wiring harness so that the take-out for the two 10-way PDC connectors, is routed ABOVE the heater hoses and EGR tube, but below the speed control and main throttle cables (Figure 2).
8. The wiring take-out for the two 10-way PDC connectors should be routed in an upward, then forward direction from the 40-way connector harness as shown in Figure 2. Connect the two 10-way connectors to the bottom of the PDC (Figure 3).

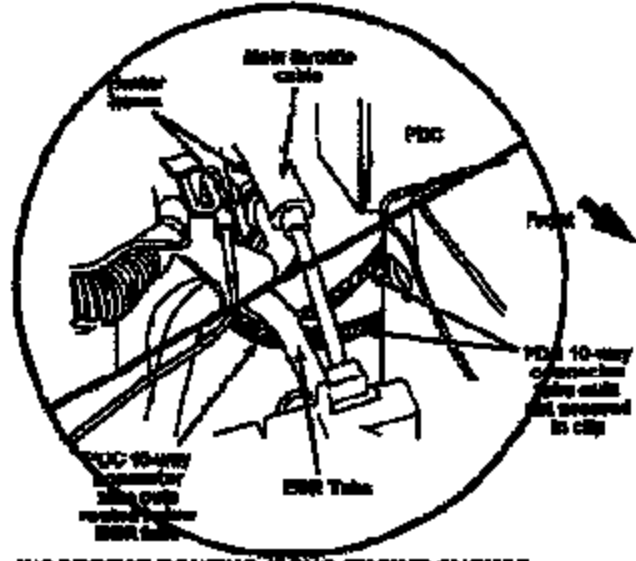
INCORRECT ROUTING (DOHC ENGINE SHOWN)

The portion of the engine wiring harness which connects to the power distribution center (PDC) and the powertrain control module (PCM) may be improperly routed. A mis-routed harness may short circuit due to contact with the exhaust gas recirculation (EGR) tube. Shorting of the harness may cause various electrical malfunctions, including engine die-out. To correct this condition, the wiring harness must be properly routed and any damaged wiring must be repaired.
