**DOT Auto Safety Hotline**  
**Vehicle Owner's Questionnaire**  
To Report Vehicle Safety Defects  
1-888-DASH-2-DOT  
(1-888-327-4236)  
INTERNET: www.nhtsa.dot.gov/hotline

Make CHEVROLET

Model ASTRO

015100 STEERING:HYDRAULIC POWER ASSIST:PUMP

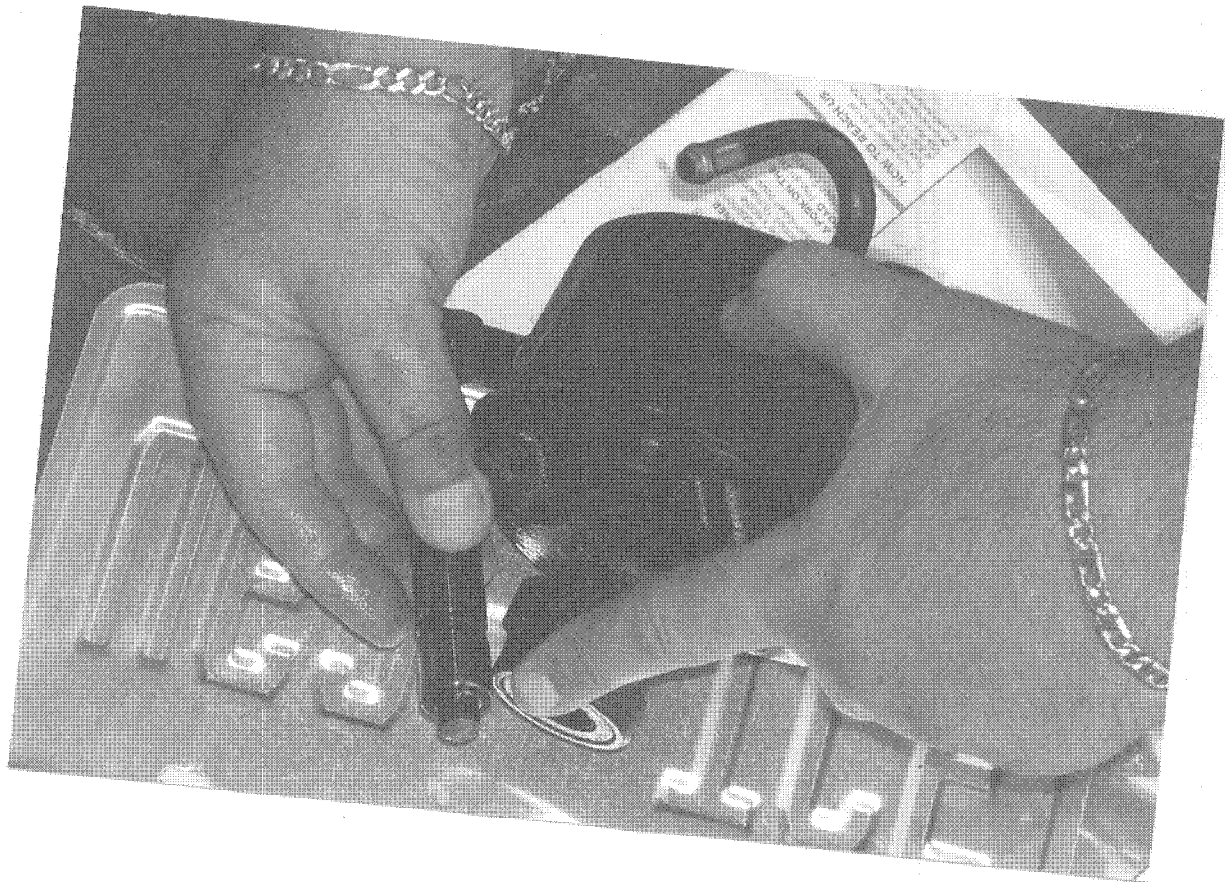
DT\*: THE CONTACT STATED THE VEHICLE LOST POWER ASSIST STEERING & POWER ASSIST BRAKES SIMULTANEOUSLY WHILE DRIVING 3 MPH. THERE WERE NO WARNINGS PRIOR TO THE INCIDENT. THE VEHICLE WAS NOT INSPECTED BY A DEALER, HOWEVER, AFTER SOME RESEARCH, THE CONTACT DISCOVERED THE POWER STEERING PUMP HAD FAILED, CAUSING LACK OF PRESSURE TO THE BRAKES AND STEERING.

He started reading and investigating to figure out what happened to this car. Upon taking out the power steering pump, he discovered **THAT THE SHAFT IN THE POWER STEERING PUMP JUST SNAPPED.** He was shocked to see this. He has never encountered anything like this in his life. He started talking to some of his other friends who are also mechanically inclined, and they all were startled to hear of something like this. He eventually repaired the car in approximately 12 hours, replacing the power steering pump, and the master cylinder (it took him this long because he was having problems reseating the hydraulic lines to the master cylinder, one of the lines did not want to seat correctly and it was leaking from this connection)

"Sheard" power steering  
pump shaft

Picture of power steering  
pump shaft - "sheared"

My husband discovered that the shaft in the power steering pump had snapped in two. We bought the parts & he replaced & repaired it. Copies of parts will enclosed. Picture of part broken enclosed. And we have the part if needed for inspection.

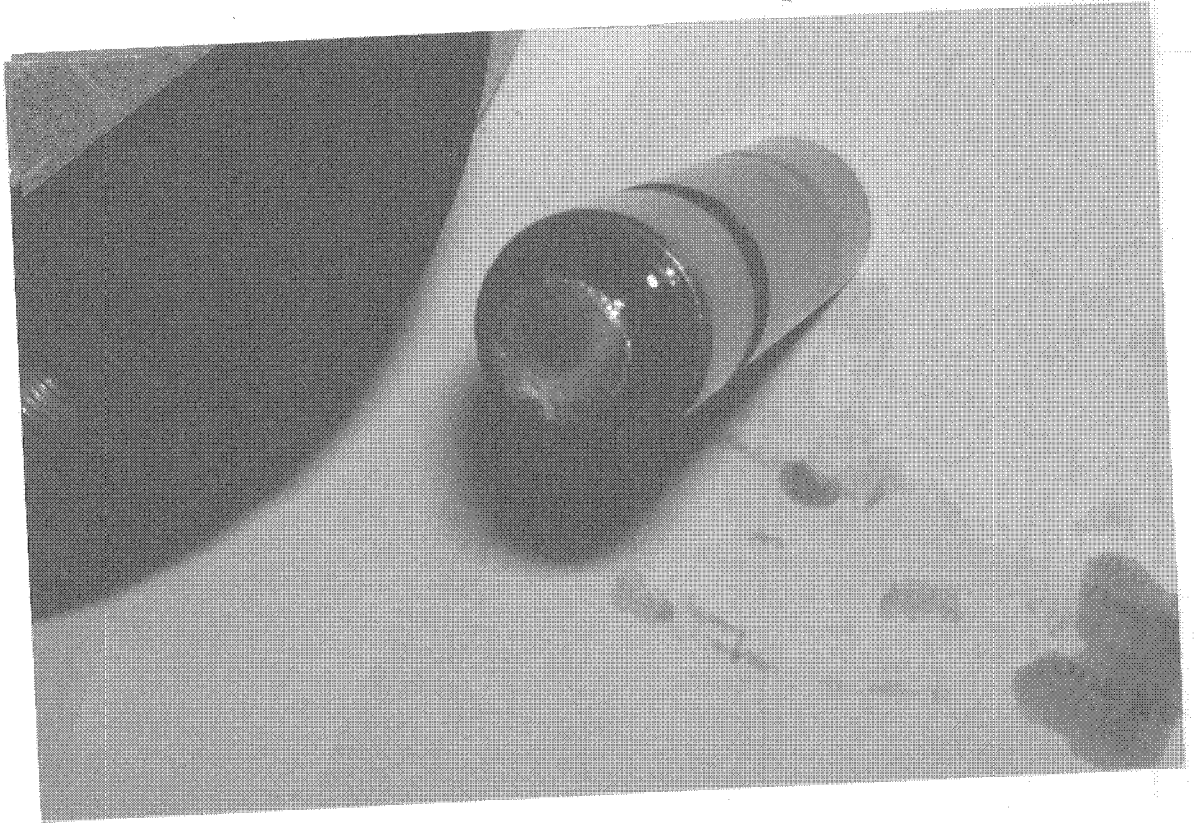
Picture of a sheered off  
power steering pump shaft

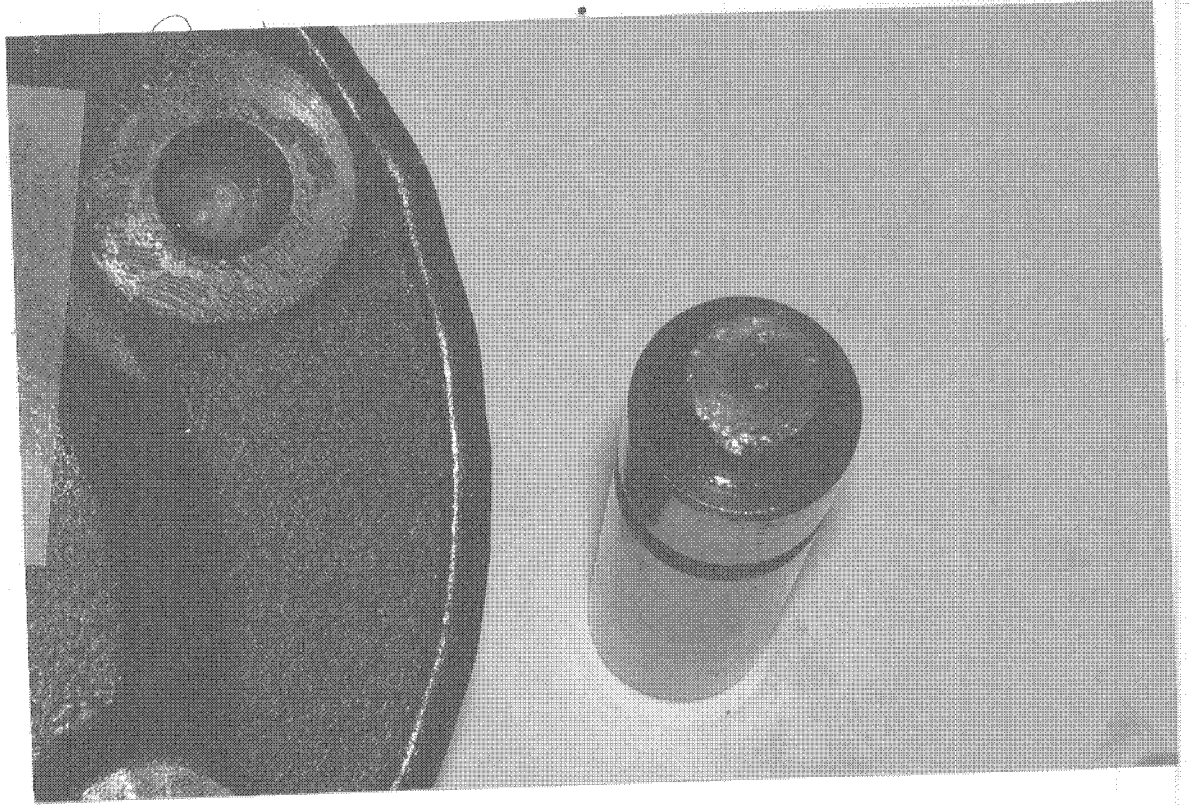
Picture of a sheared off  
power steering pump shaft

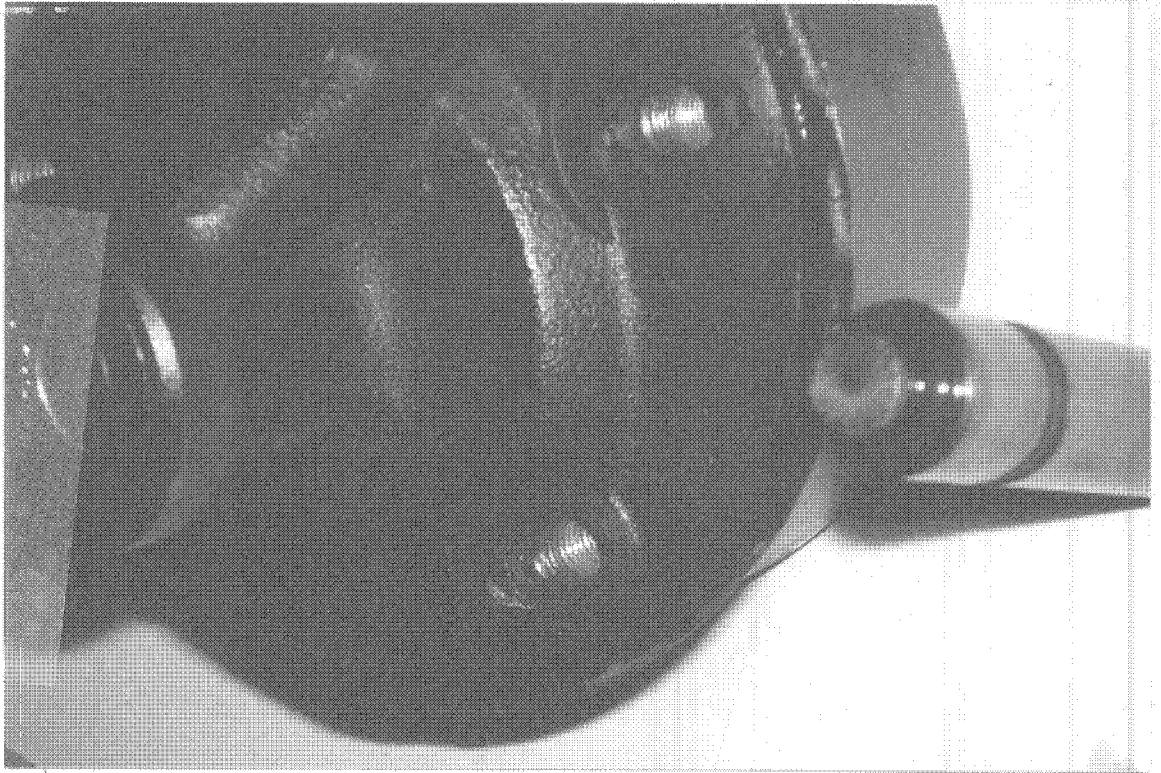
Picture of a sheared off  
power steering pump shaft
