**DOT Auto Safety Hotline**  
**Vehicle Owner's Questionnaire**  
**To Report Vehicle Safety Defects**  
1-888-DASH-2-DOT  
(1-888-327-4236)  
INTERNET [www.nhtsa.dot.gov/hotline](http://www.nhtsa.dot.gov/hotline)

# ARTI, LLC

Re: Claim #: [REDACTED]  
Insured: [REDACTED] 1999 Lincoln Town Car  
Loss: Unexpected Side Air Bag Deployment and  
Resulting Collision, 8/28/2006

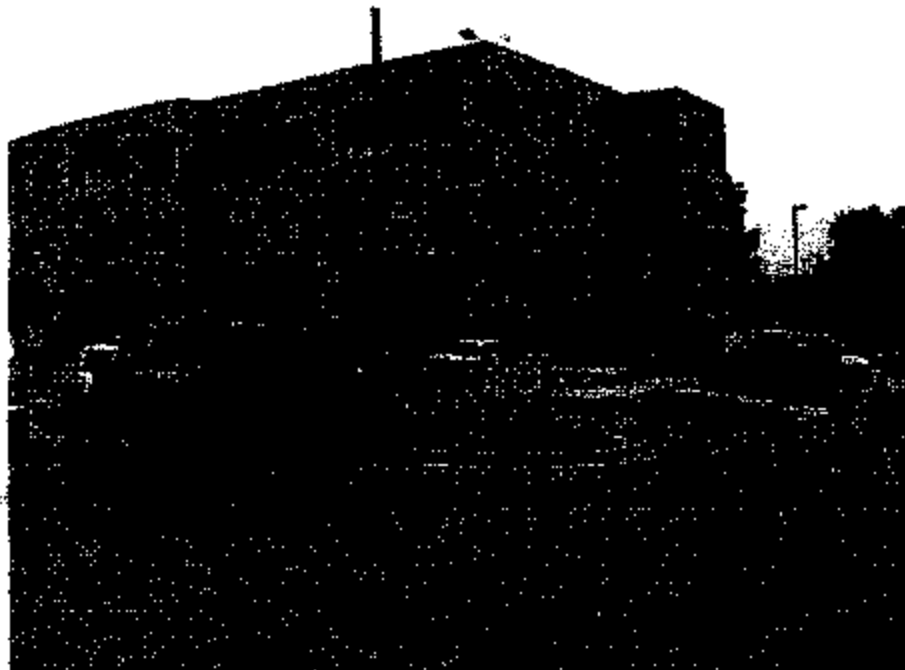
The car jumped a curb and came to rest against a pickup parked at the side of the medical building. Plate 1 shows the general scene, and Plate 3 shows the damage to the right front of the subject vehicle. A copy of Paragould Police Accident Report 06 08 0871 is provided in Appendix 1.

PLATE 1 :        The insured had been parked as the blue  
pick up on the left, the vehicle struck  
was parked as the red SUV on the right.

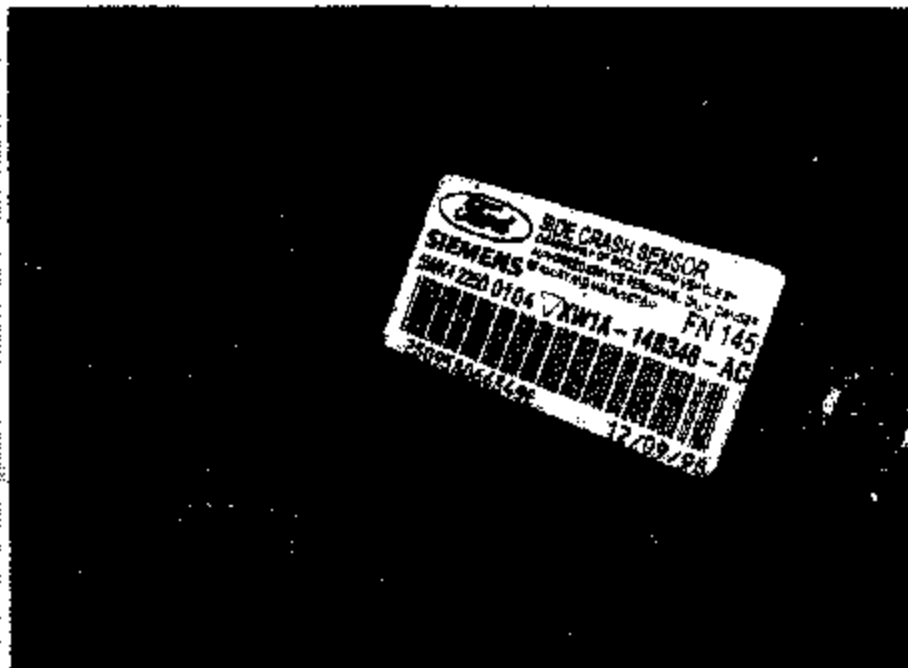
PLATE 7 : The driver's side crash sensor under the driver's seat and carpet.
