Ford Safety Recall No. 99S15 / NHTSA Recall #99V-124000

Subject: Vehicle recall neglect

1993 Mercury / Grand Marquis
VIN: 2ME1M75W4P [REDACTED]

Recall #99V-124 by the
National Highway Traffic Safety
Admin.
(Ford Number 99S15)

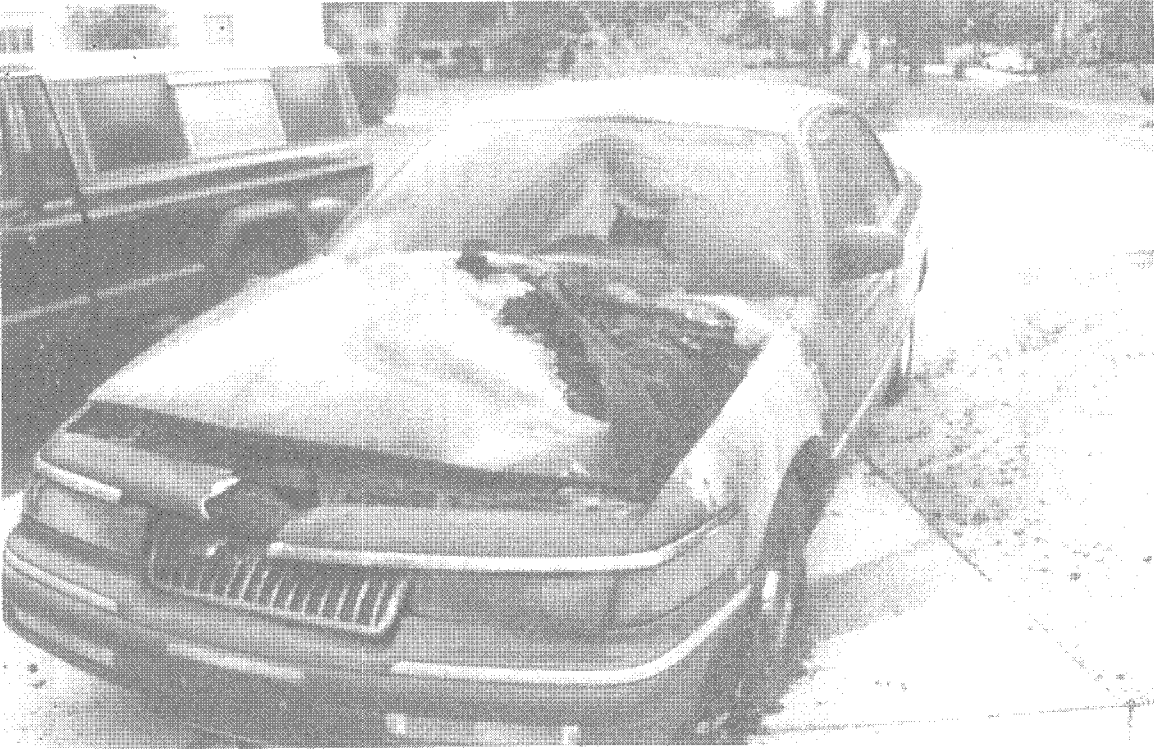
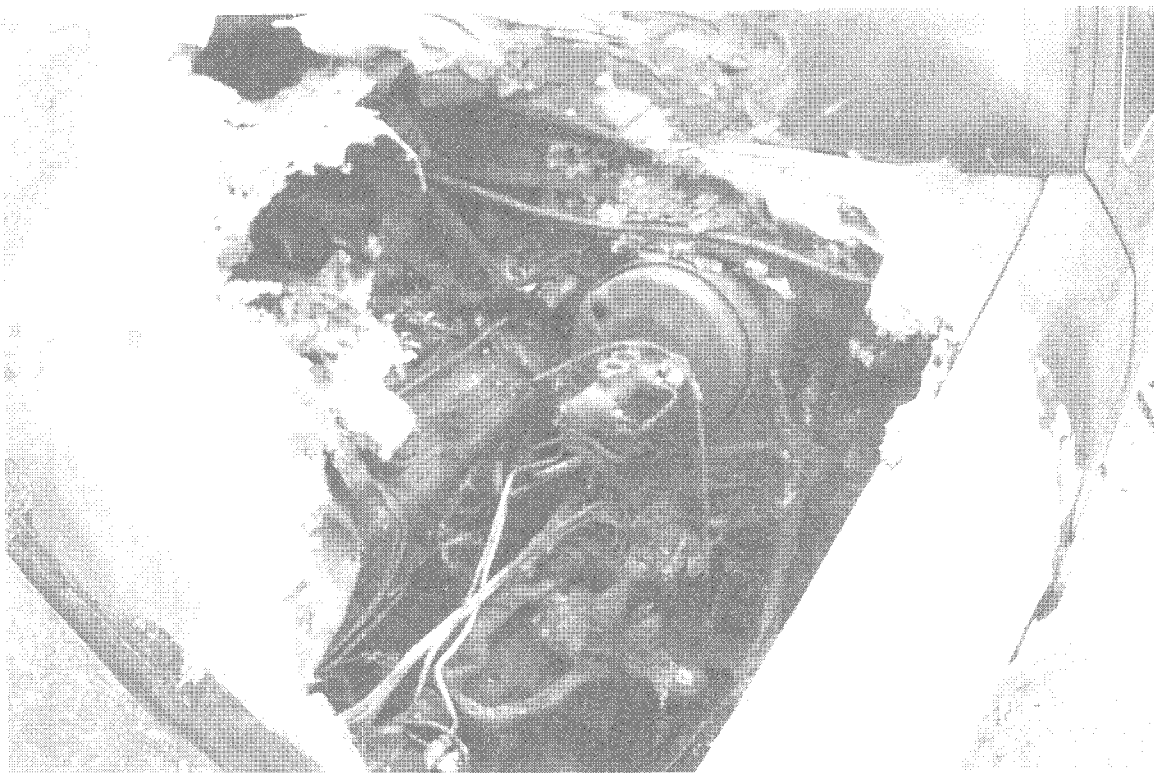
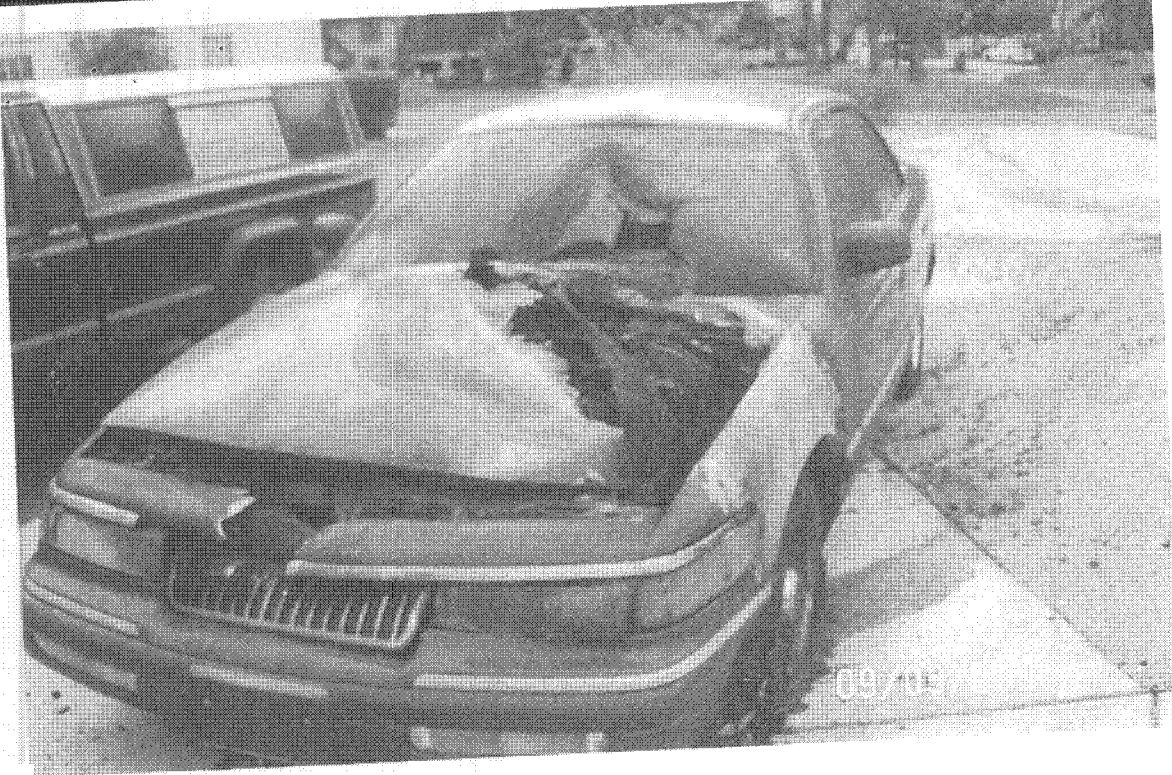
On Saturday Sept. 2, 2006 around 6:30PM, my wife parked our Mercury Grand Marquis in the driveway. Around 11:15PM I was awakened by a bang and a horn blast. When I looked outside I found this vehicle in flames. My pictures and the Fire Department report show the fire originated around the wiring harness on the left side of the engine compartment (the exact location of the deactivation switch).

EXPOSURE VEHICLE HAD NO DAMAGE. ENGINE COMPARTMENT DESTROYED IN FIRE. UNABLE TO DETERMINE EXACT CAUSE, DUE TO DAMAGE. APPEARED TO HAVE STARTED AROUND WIRING HARNESS ON LEFT SIDE OF THE ENGINE COMPARTMENT. MR. ACOSTA SAID THE VEHICLE HAD BEEN PARKED SINCE AROUND 1800 HRS. DID NOT NOTICE ANYTHING THAT APPEARED SUSPICIOUS OR UNUSUAL.
