**DOT Auto Safety Hotline**  
**Vehicle Owner's Questionnaire**  
To Report Vehicle Safety Defects  
1-888-DASH-2-DOT  
(1-888-327-4236)  
INTERNET: www.nhtsa.dot.gov/hotline

Reference No.  
10186268

106220 POWER TRAIN-AXLE ASSEMBLY-AXLE SHAFT:SEAL

Subject  
**TRANSFER CASE AIR BREATHER VENT HOSE**

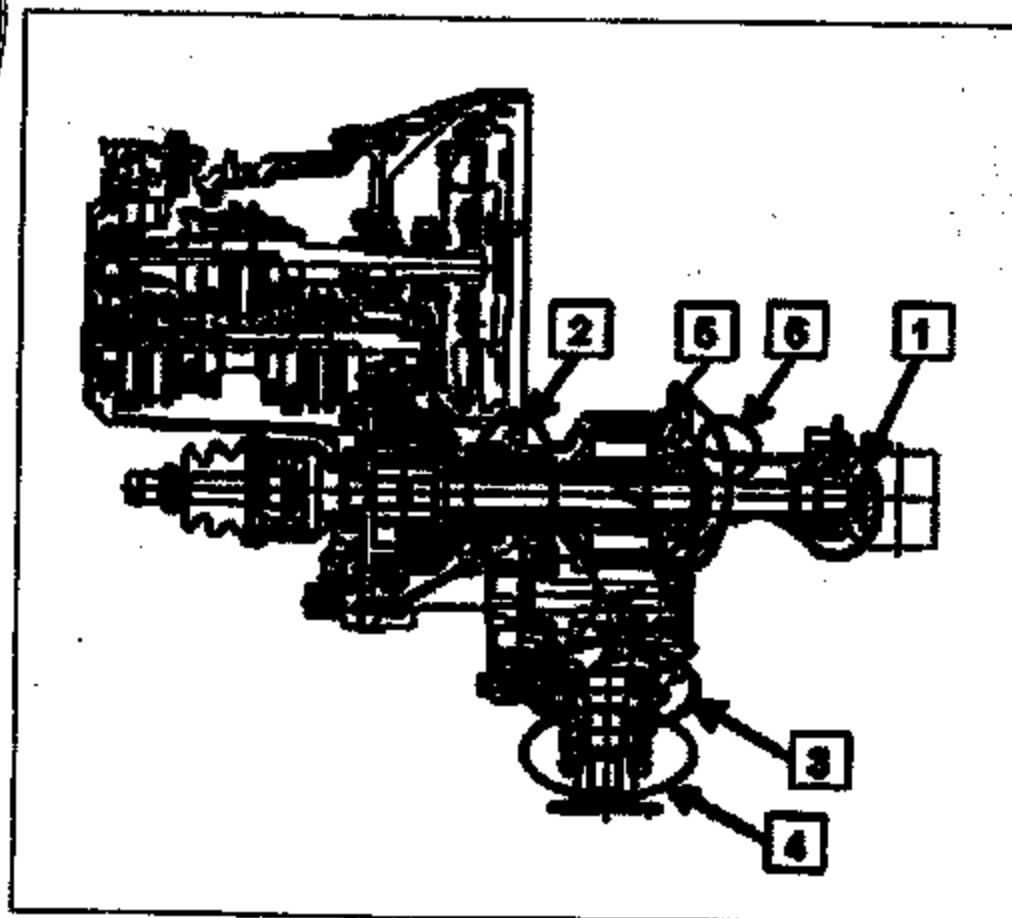
| LOCATION | DESCRIPTION | PROCEDURE |
|---|---|---|
| 1 | Leak from the right side axle seal | A |
| 2 | Leak between transfer case and transmission | B |
| 3 | Leak between pinion case and transfer case | C |
| 4 | Leak at end of pinion case | D |
| 5 | Leak between transfer case cover and housing | E |
| 6 | Leak from the vent tube | F |

If the vehicle returns to the dealer with the same condition after one of the above repairs, replace the transfer case.
