DOT Auto Safety Hotline
Vehicle Owner's Questionnaire
To Report Vehicle Safety Defects
1-888-DASH-2-DOT
(1-888-327-4236)
INTERNET: www.nhtsa.dot.gov/hotline

Repository 2007 JUN 26 PM 12:07
30-MAR-2007Reference No.
10180535

Start-up and Idle Rattle - Primary Or Secondary Chain Tensioner - Replace**Issue:**

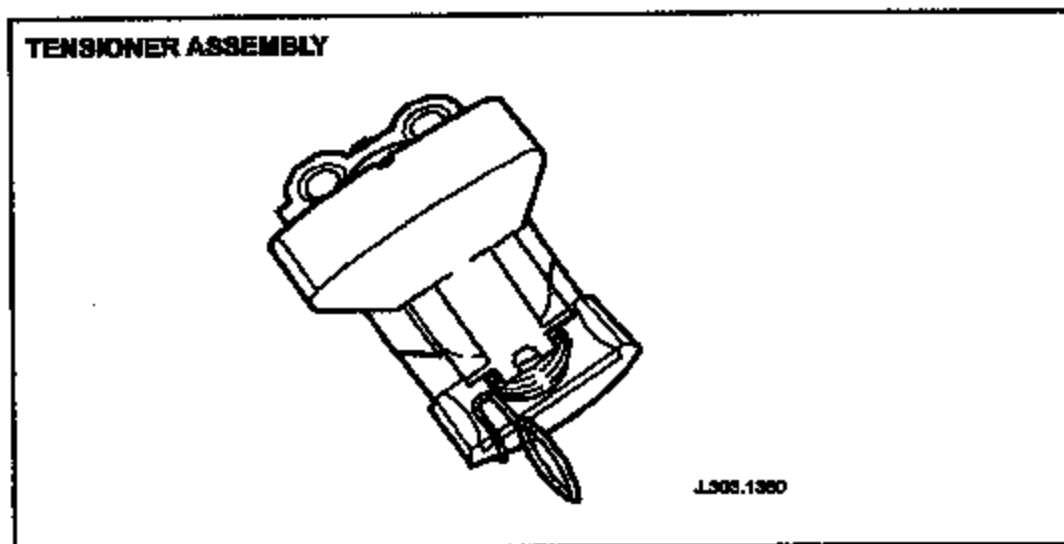
ILLUSTRATION 1

Some vehicles within the above VIN range may experience a rattling noise when the engine is started. This noise may be caused by the secondary timing chain tensioners. Research has shown that a noise can originate at the chain tensioners to cause a resonance in another part of the engine.

- The revised tensioner has a coil spring that presses on the piston head to provide a damping effect.
- To simplify the installation of the tensioner on the engine, a clip (shown in Illustration 2) is provided to hold the piston in a partly compressed position during assembly.

In case of a customer complaint of start up noise, determine if the noise is caused by the secondary timing chain tensioners. If the secondary timing chain tensioners are the cause of the noise, they should be replaced by the revised tensioners (Illustration 1).

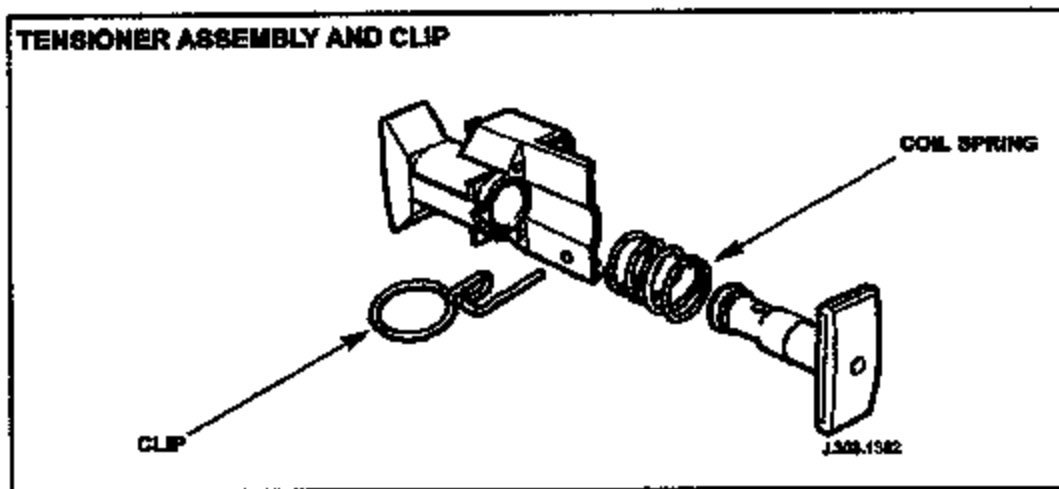
ILLUSTRATION 2

- When the piston and spring assembly is compressed to approximately half of its travel, the pin end of the clip is inserted into the hole in the tensioner body, in front of the piston head/slipper, with the finger ring of the clip positioned at the rear of the head, (as shown in Illustration 1).
- Installation of the tensioners is covered in JTIS 5, section 303-01, Basic Engine, Removal and Installation, Timing Chain Tensioner (Secondary) - A-Bank (12.65.63) or Timing Chain Tensioner (Secondary) - B-Bank (12.65.64).
- The method of removing and reinstalling the secondary timing chain tensioners has been simplified by the use of a ball-end drive bit as described in Technical Bulletin 303-28, dated 8/98.

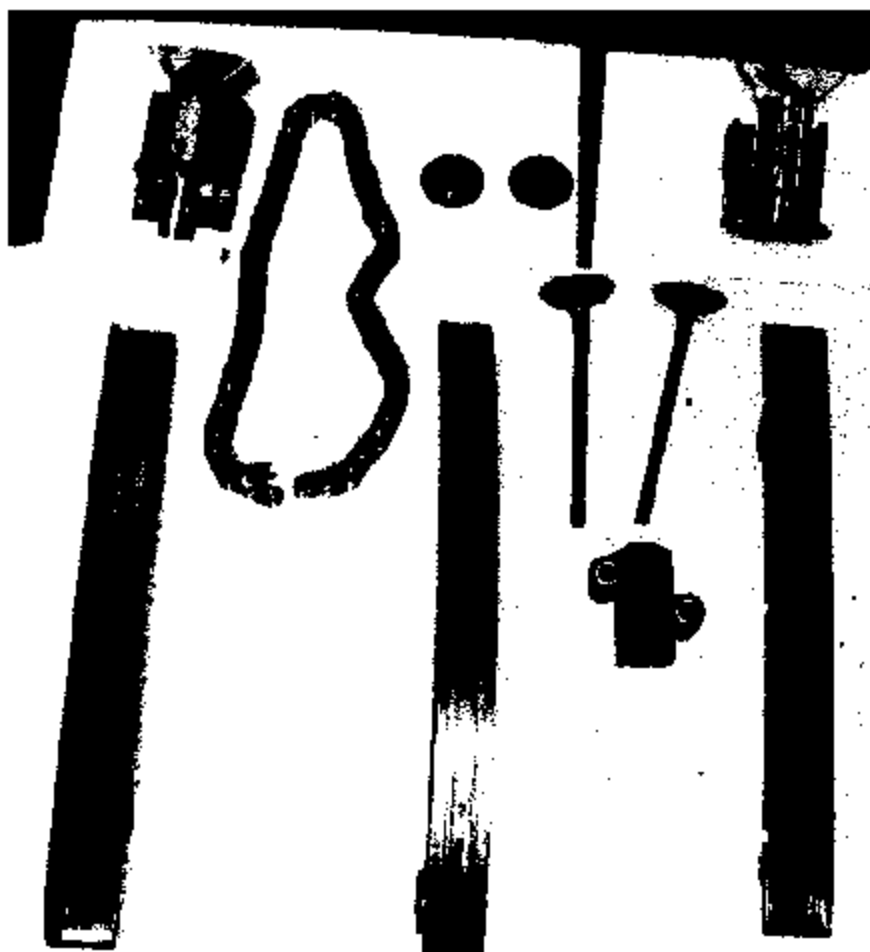
When the worst happens: This 1999 XJ6's tensioners both cracked. When the one at the top left broke, its timing chain (shown) snapped and the valves collided with the pistons. Two of the bent valves are shown in this photo. Though such damage requires significant shop time to repair, engine

replacement is usually NOT indicated, and the parts required are reasonable in quantity and cost.

If the worst happens and the valves contact the pistons due to tensioner failure, all is not necessarily lost. Whereas some places recommend engine replacement (at a cost of \$10,000 or more), we can repair an engine that has suffered tensioner failure and subsequent valve damage on one bank for less than under half that price.
