Re: 2003 Ford Ranger, VIN 1FTZR15E63T [REDACTED]
TSB 04-17-9 * GRABBING CONDITION FROM REAR DRUM BRAKES
Published August 17, 2004 (Transmitted by Priority Mail.)

TSB 04-17-9	
TSB 04-17-9	• GRABBING CONDITION FROM REAR DRUM BRAKES
Effective Date: August 20, 2004

FORD: 2002-2005 Ranger

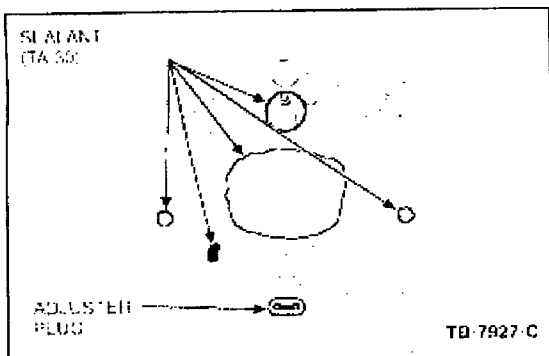
Figure 1 - Article 04-17-9

Some vehicles may exhibit a grabbing condition from the rear brakes during the first few brake applications. The condition only occurs after the vehicle has been parked for several hours.

1. Place vehicle on hoist and remove the rear wheels.
2. Remove the rear brake drums and replace the rear linings. Refer to Workshop Manual Section 206-02.
3. Inspect the rear brake assemblies for damaged, missing and/or improperly seated adjuster plug or parking brake cable.
4. Inspect and clean the lining contact area of the brake drum, machine if necessary.
5. Reinstall the rear brake drums and adjust the lining to drum clearance per Workshop Manual Section 206-02.
6. Thoroughly clean the backside of the rear drum brake backing plate to promote proper adhesion of sealant.
7. Apply sealant to the backside of the rear drum brake backing plate at the following interface areas (Figure 1):
 - Axle Flange
 - Wheel Cylinder
 - Parking Brake Cable
 - Hold Down Pins

NOTE: AVOID GETTING SEALANT ON THE BRAKE BLEED SCREW AND BRAKE TUBE NUT.
