U.S. Department  
of Transportation  
**National Highway  
Traffic Safety  
Administration**

**DOT Auto Safety Hotline**  
**Vehicle Owner's Questionnaire**  
**To Report Vehicle Safety Defects**  
**1-888-DASH-2-DOT**  
**(1-888-327-4236)**  
**INTERNET: www.nhtsa.dot.gov/hotline**

Vehicle Component Code  
192000 TIRES:SIDEWALL

Subject: 2004 Cedar Creek 5<sup>th</sup> Wheel Trailer

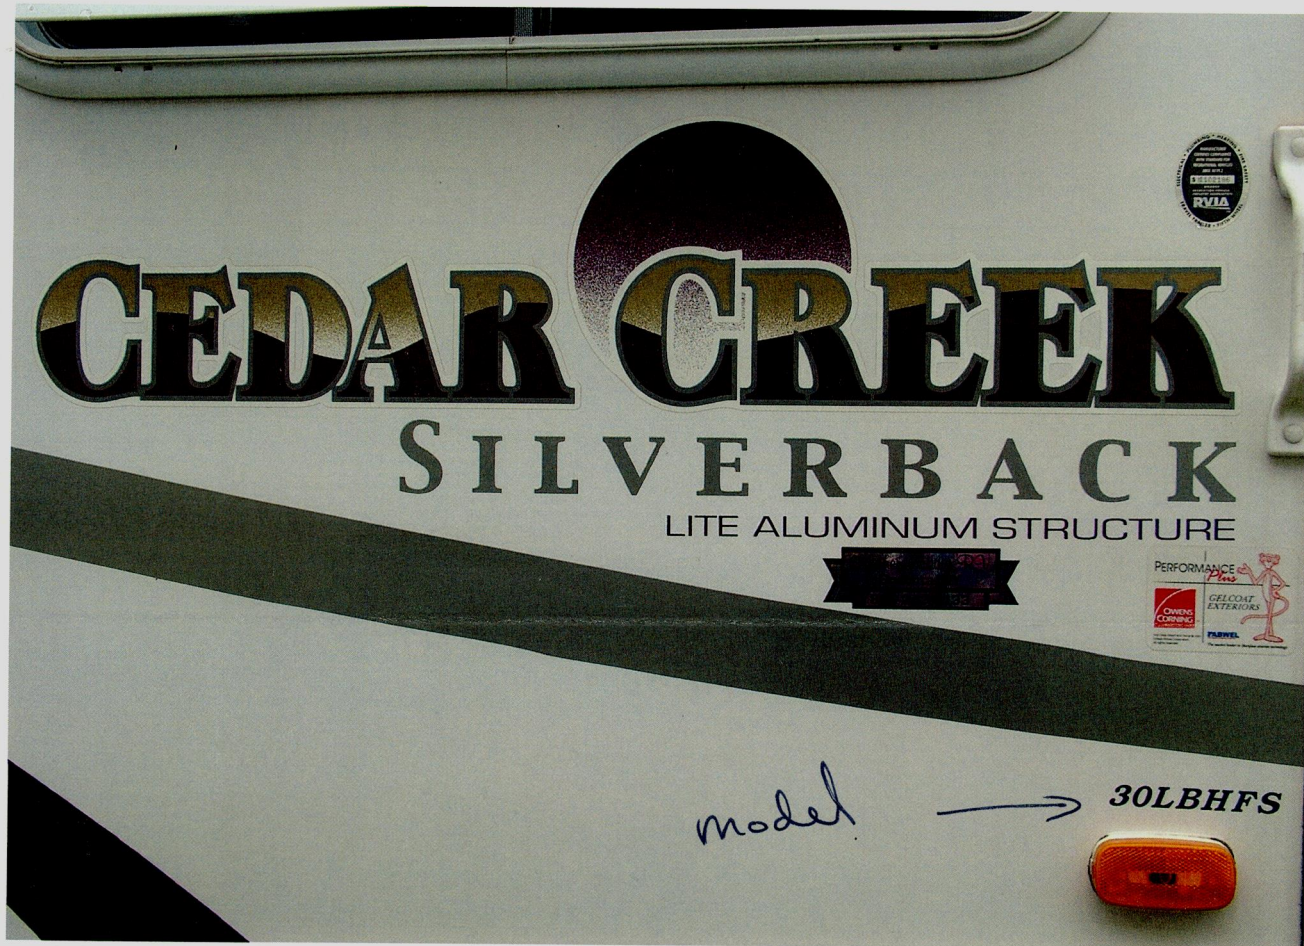
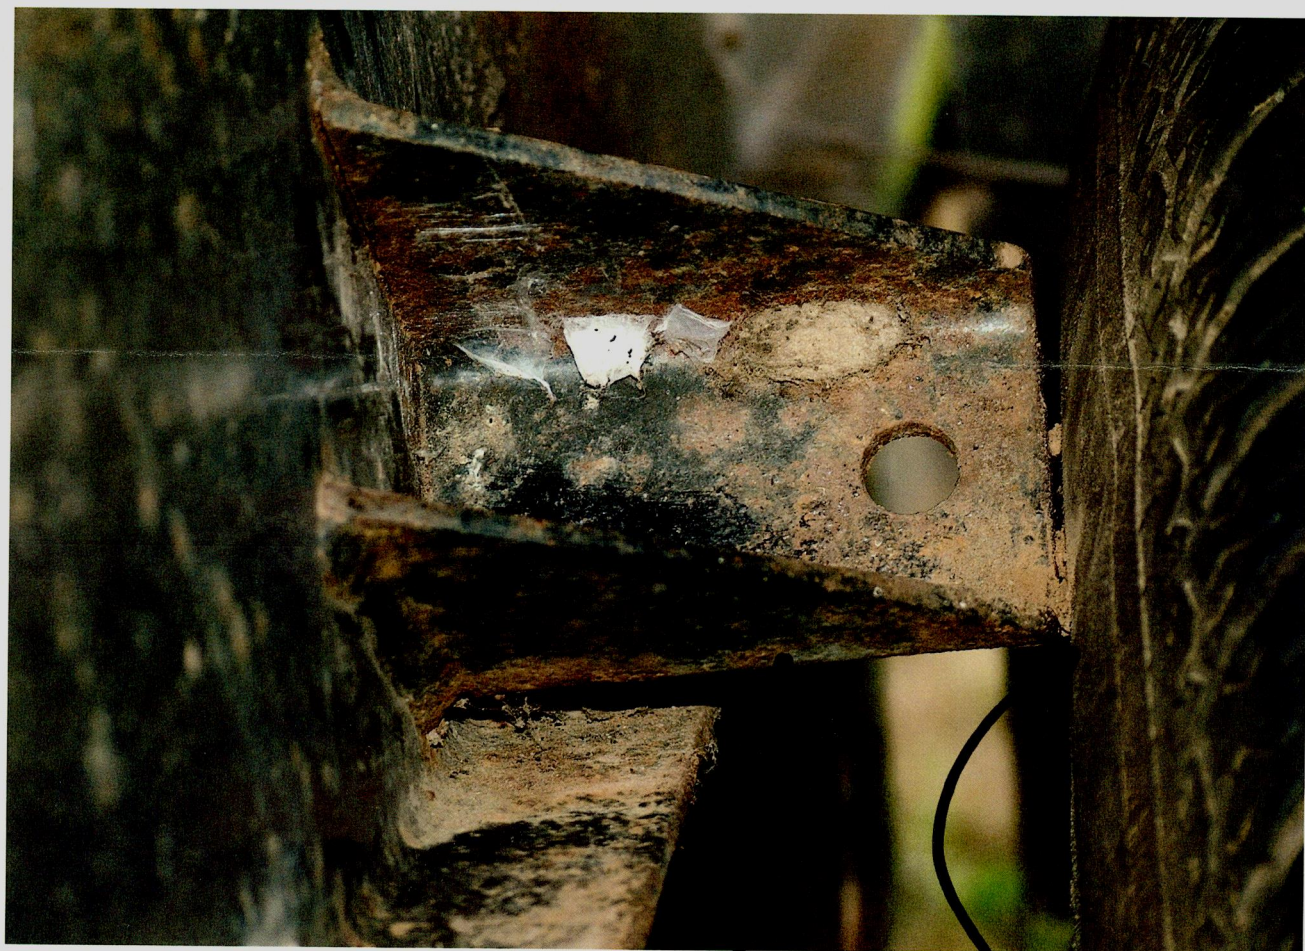
After we got it home we were underneath the unit, cleaning and painting the frame and noticed the inside of all 4 tires were worn down. Upon examination we realized there were 4 steel brackets protruding from the frame by each tire. The brackets had very little clearance to each tire, they varied a little bit bracket to bracket and we would estimate the clearance to be 1/32" to 3/8". It appears that when towed the brackets came in contact with the inside sidewall of the tire and abraded the sidewall away. This effect would be worsened as the trailer corners and sways.

Bracket

Time Side wall

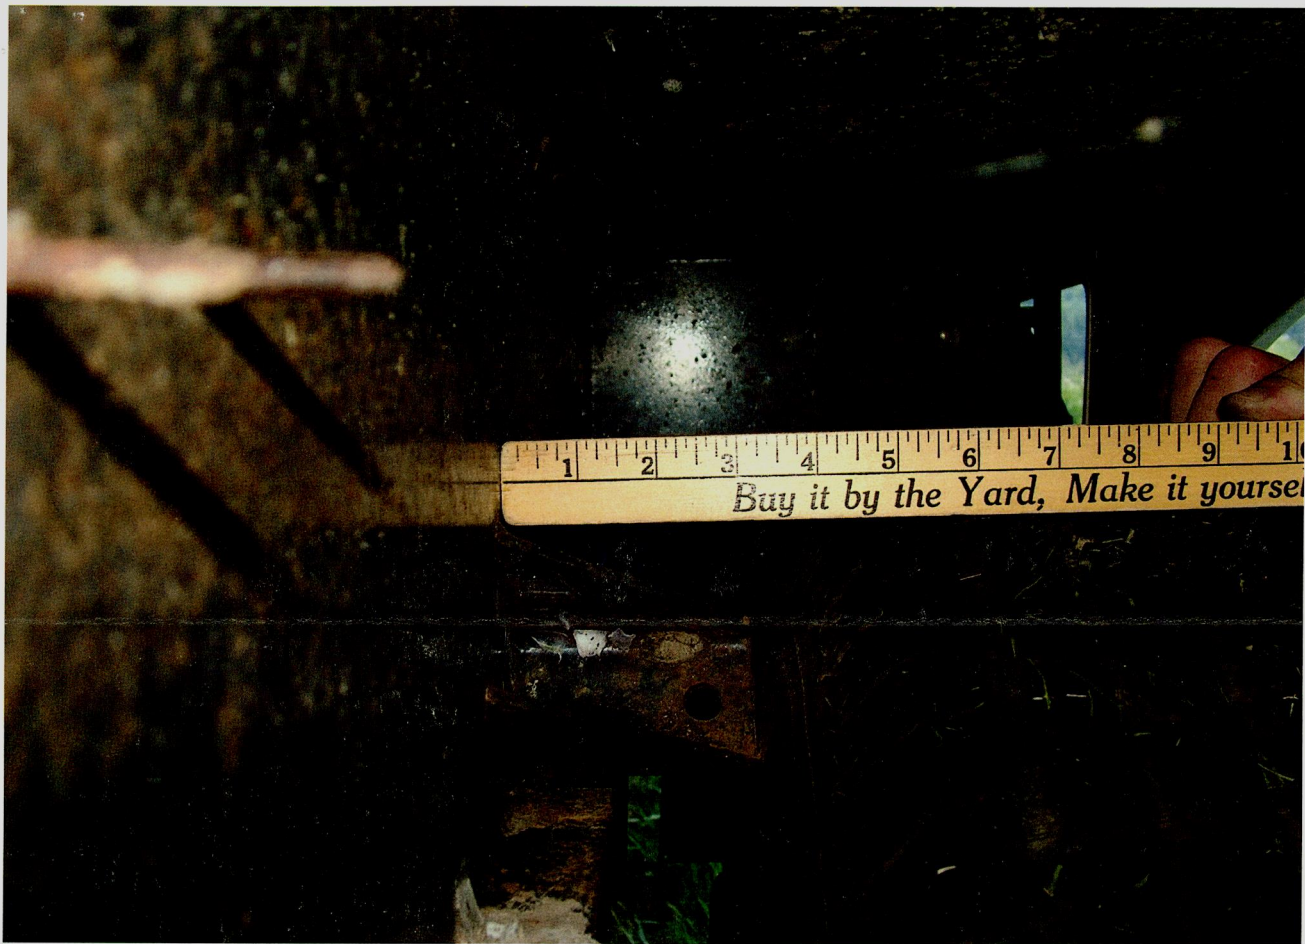
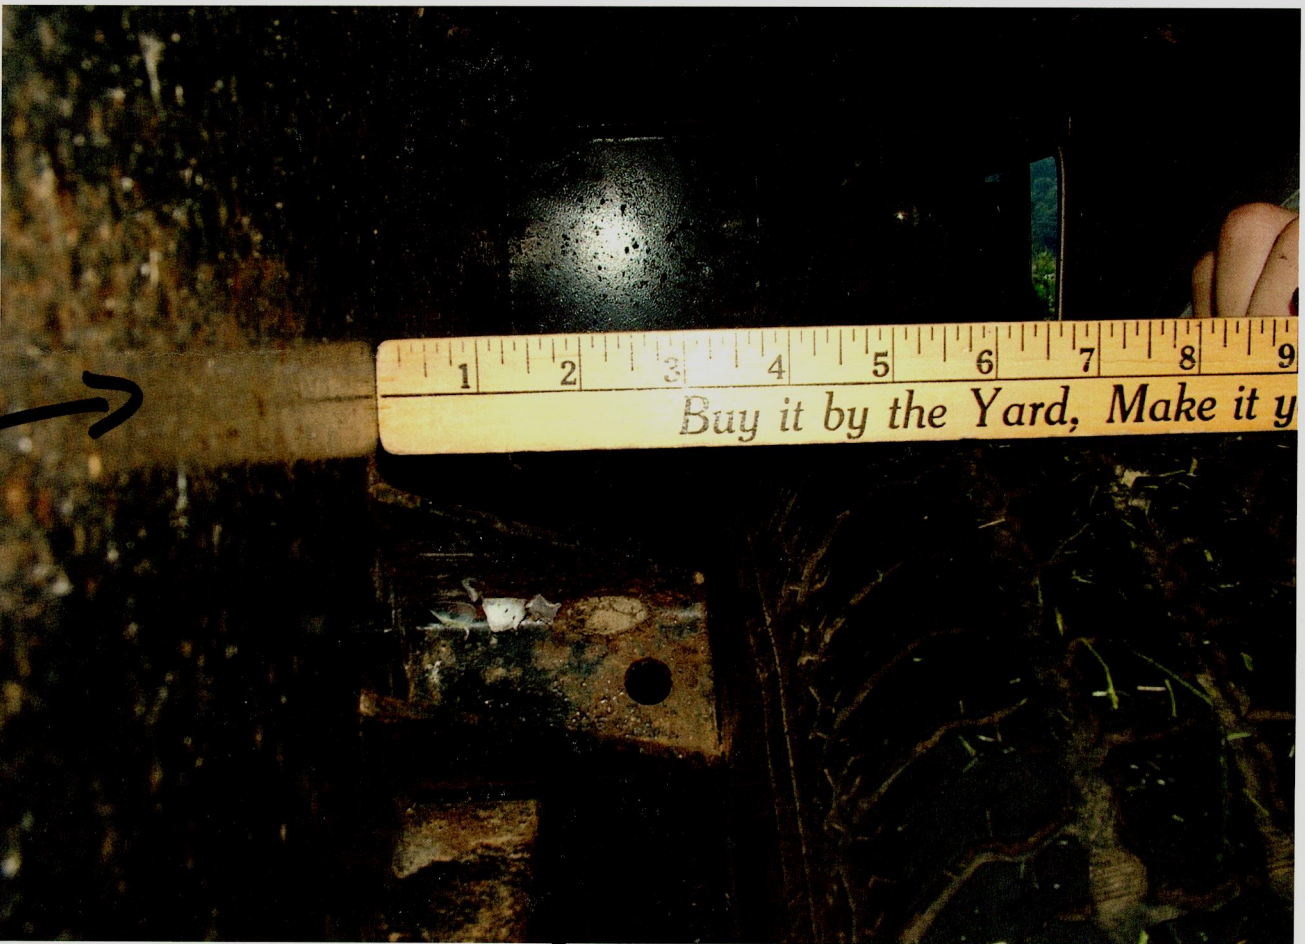
To us this was either a design defect or manufacturing defect; maybe brackets to handle the frame through manufacturing that were made too long or should have been removed. It appears to be an existing condition and was not something added or modified. Our concern is with this kind of defect that was not obvious unless you crawled under the unit and observed. In time, it would likely cause the tire to fail and potentially cause personal and/or property damage.

Frame

Bracket

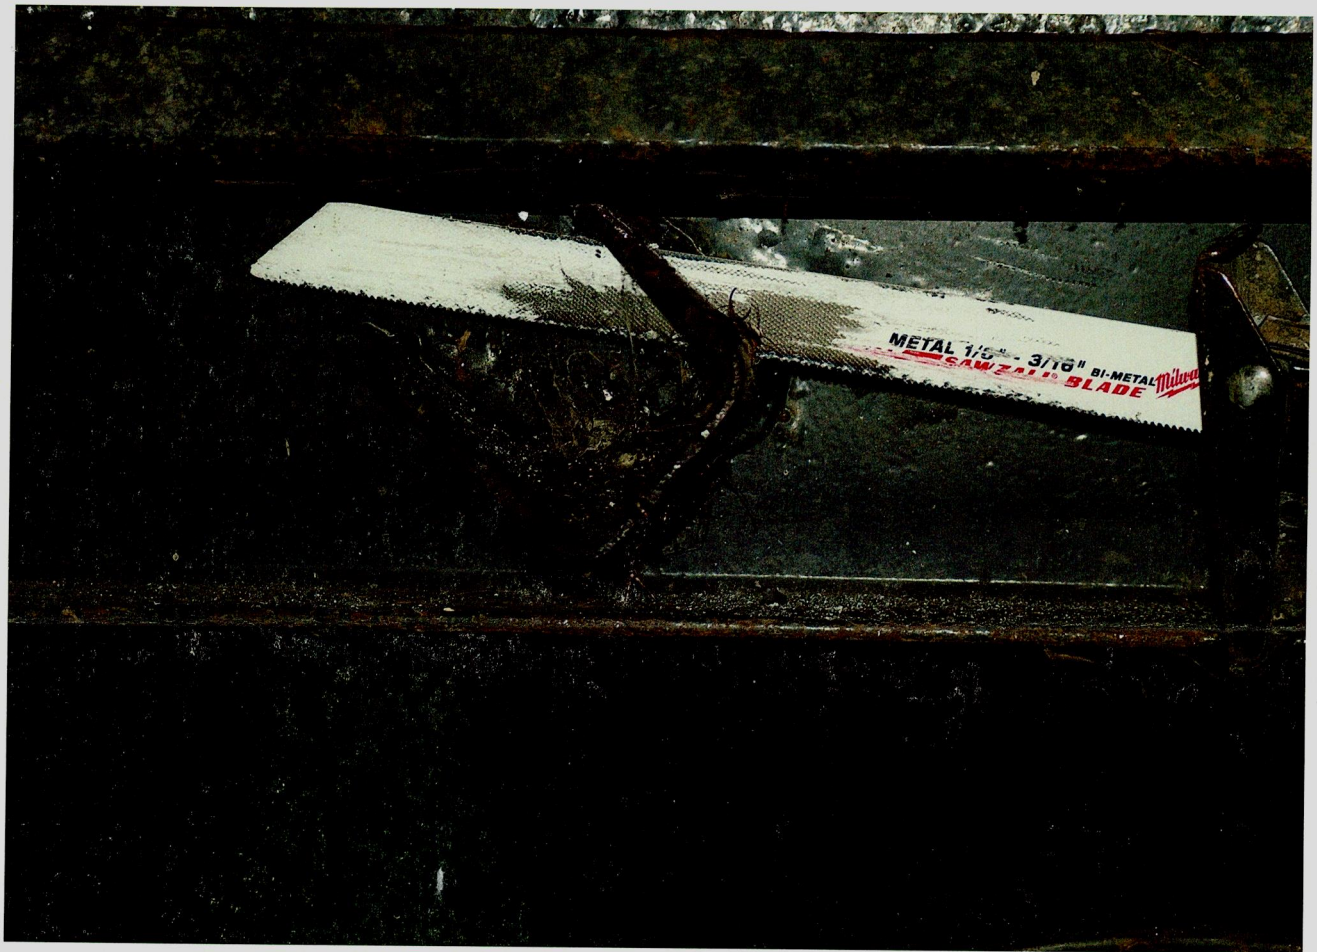
Removal  
of bracket

Since the time we filed our report, we removed the 4 brackets by removing the tires and cutting the brackets off the frame. We then took the trailer to a local garage for NYS inspection and in particular inspection of the wear on the tires. They felt that 2 of the tires needed to be replaced and the other 2 were worn but satisfactory. We had the 2 tires replaced, refer to attached bill.

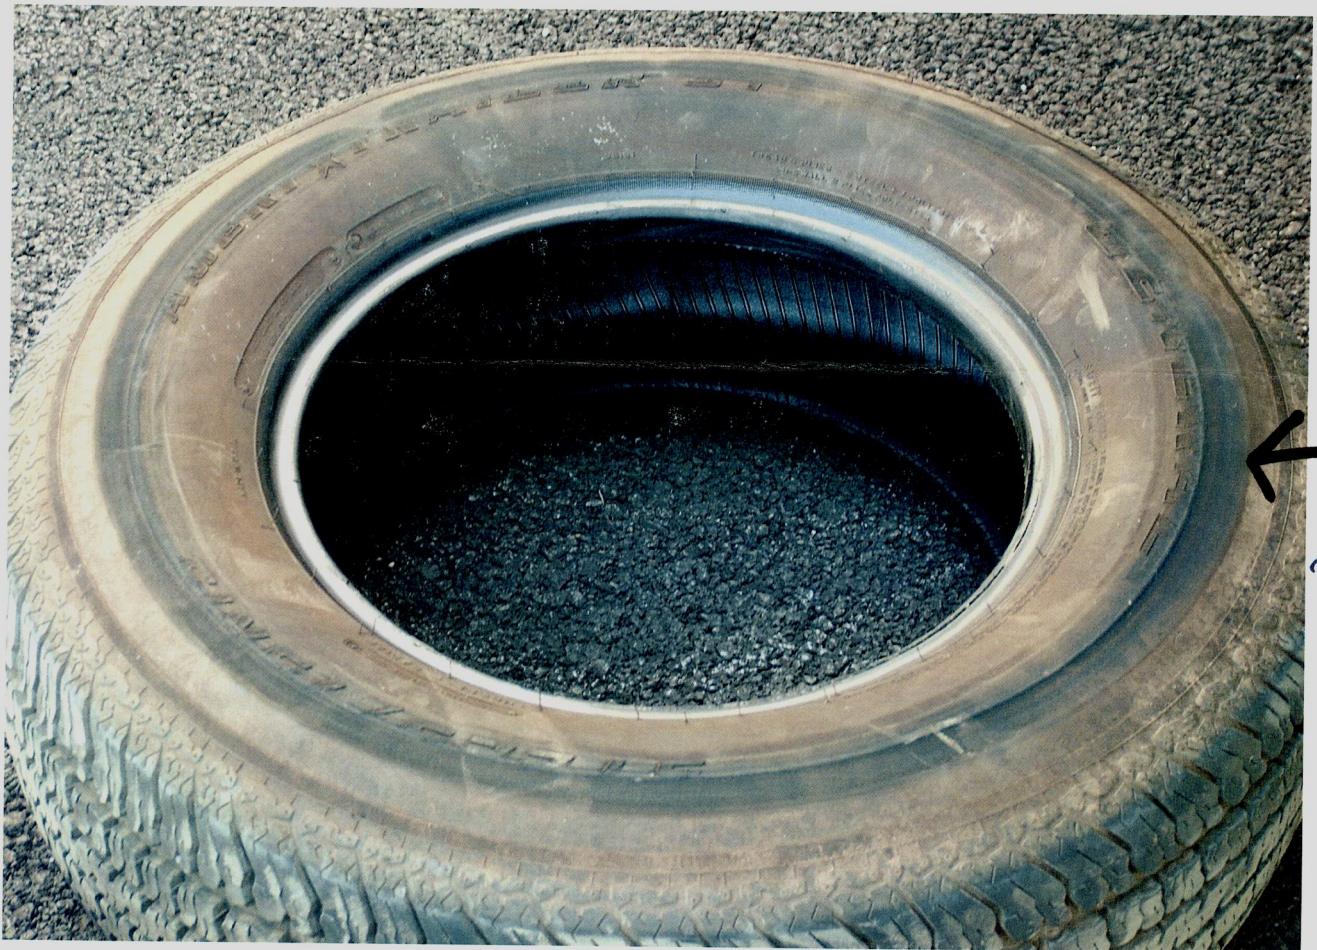
Area  
worn  
by  
Bracket

Replaced Tire

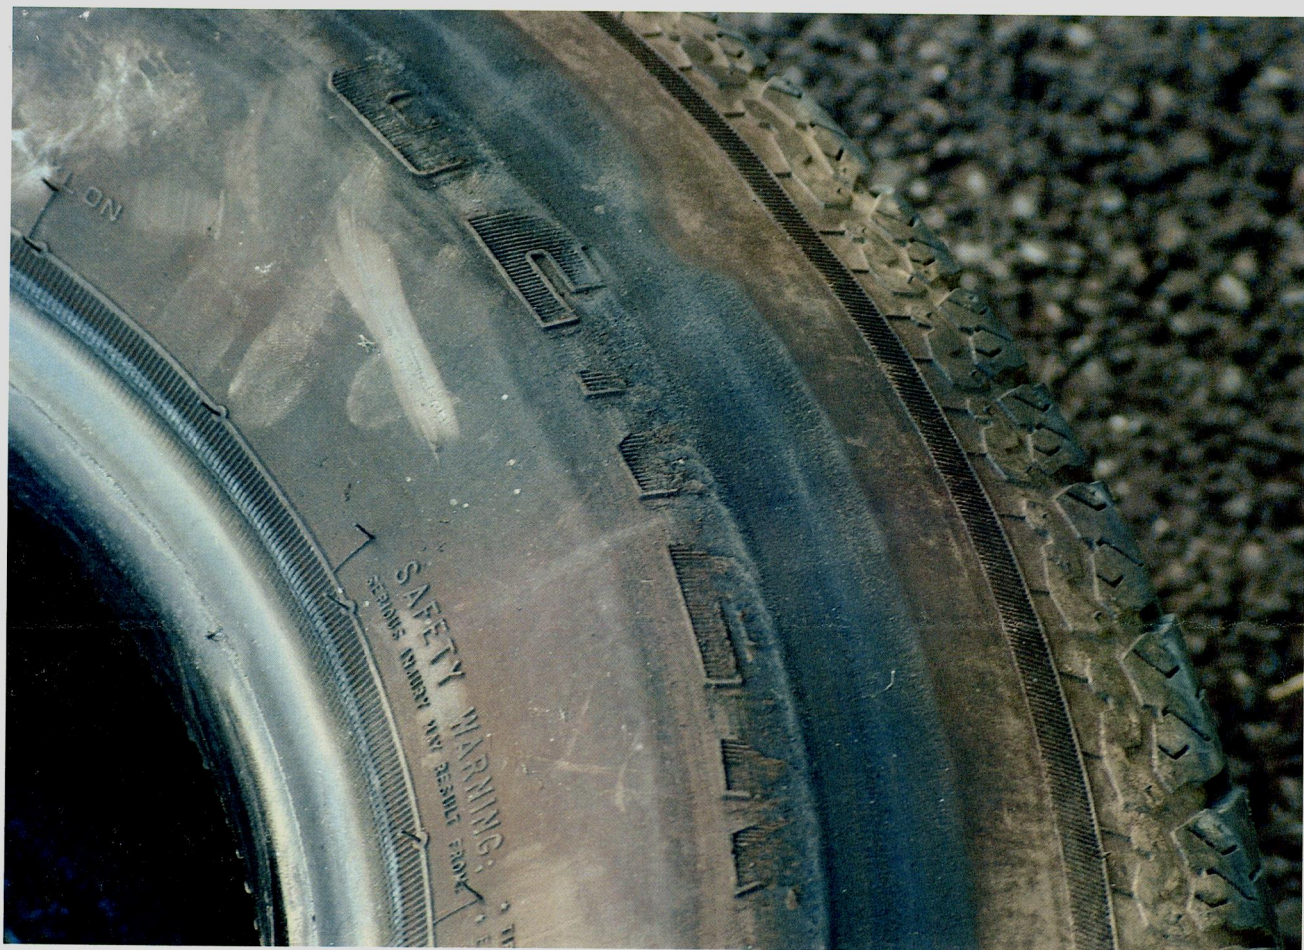
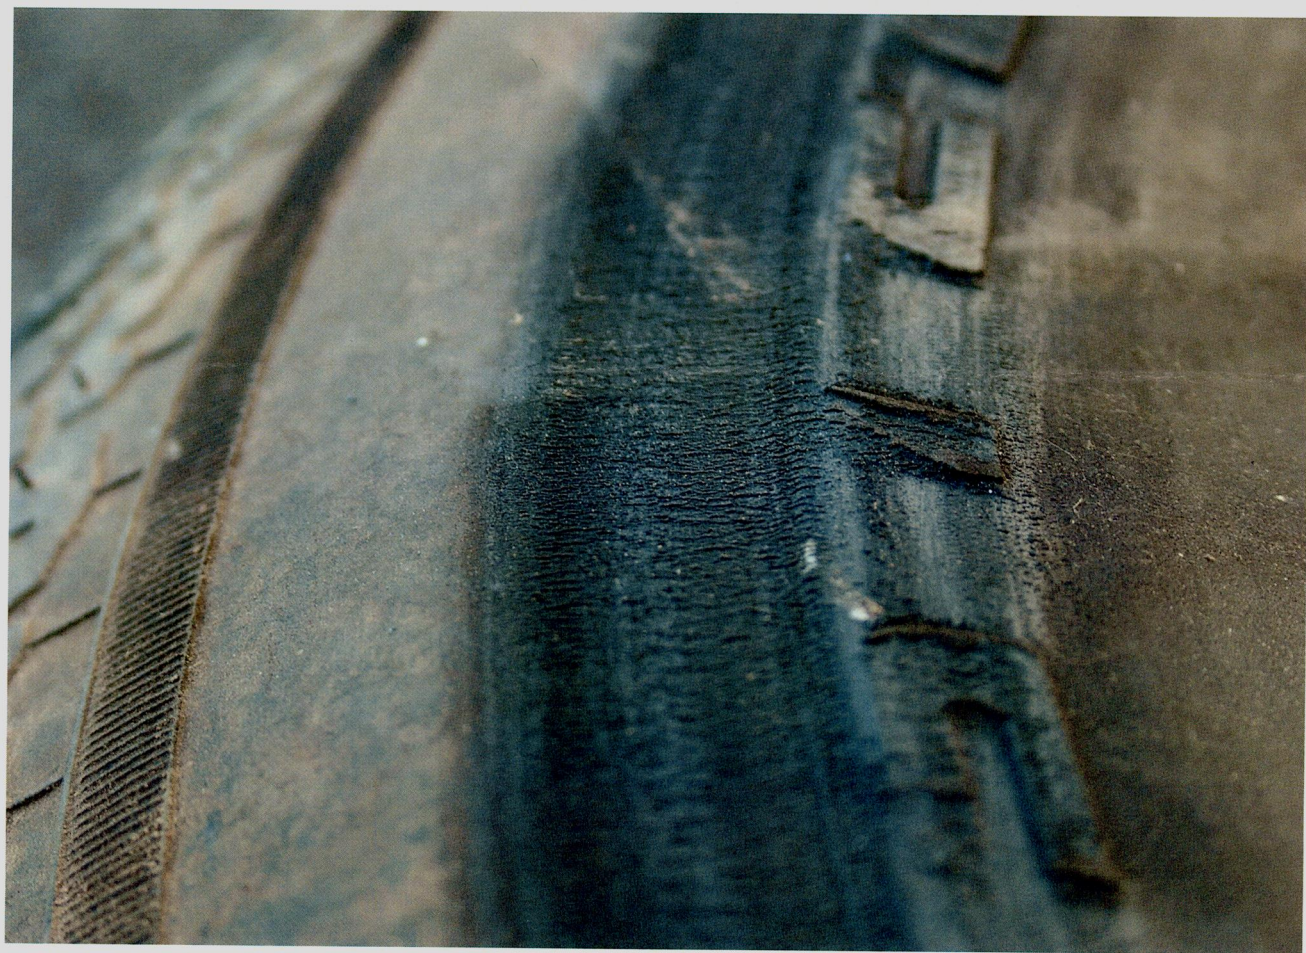
Tire wear
