DOT Auto Safety Hotline
Vehicle Owner's Questionnaire
To Report Vehicle Safety Defects
1-888-DASH-2-DOT
(1-888-327-4236)
INTERNET: www.nhtsa.dot.gov/hotline

17 digit Vehicle Identification Number 1GKEK13TX1R, Make GMC, Model YUKON, Model Year 2001, Date Purchased 20-APR-01, Dealer's Name WALLY MCCARTHY PONTIAC GMC, Engine: No: Cylinders 8, Fuel Type: Gas, Original Owner [X], Dealer's City ROSEVILLE, State MN, Zip Code, Transmission Type AUTOMATIC, Antilock Brakes [X], Cruise Control [X], Powertrain 4 WHEEL DRIVE, Vehicle Component Code 152000 SEAT BELTS:REAR, Multiple Failure: 1

Explanation of Complaint:

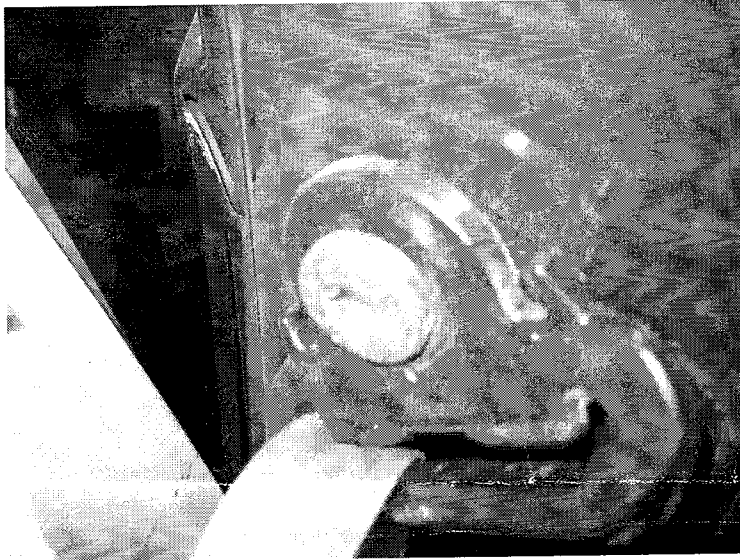
The rear driver side and passenger side seat belts bind up in the upper shoulder guide causing the seat belts to be jammed. When jammed the seat belts do not retract or extend to properly fit a passenger. To fix the jammed seatbelts the side trim panel must be removed to reach the shoulder guide and the belt needs to be freed by manually working the jammed belt back and forth, a difficult and time intensive feat. The jamming of the rear seat belts has occurred more than fifteen times since March of 2006.

Rear Seat Belt Shoulder Guide. Belt doubled over and will not extend or retract. Trim panel removed for access. Photo is of left rear passenger shoulder guide.

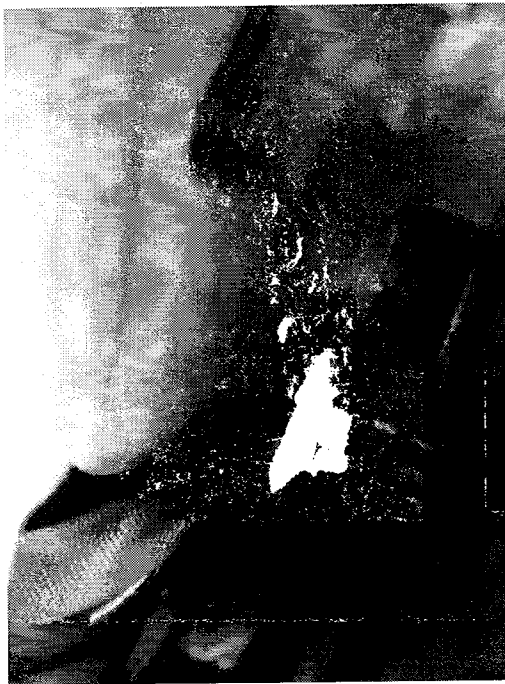
Belt folded over in guide.

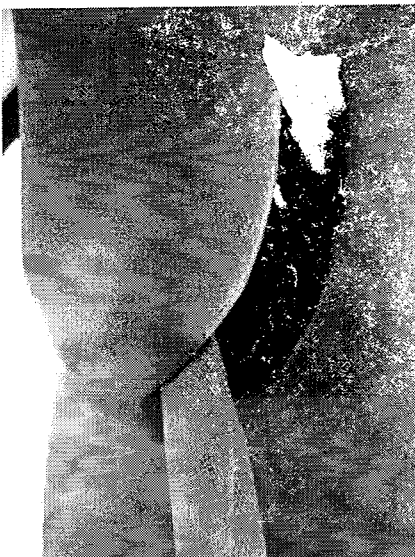
View with trim package attached.

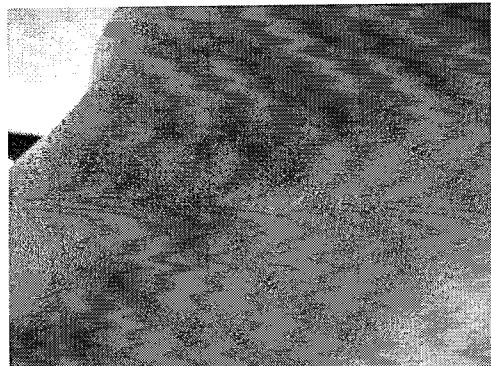
Plastic Stress Markings from continually removing panel to manually fix binding in upper shoulder guide.
