**DOT Auto Safety Hotline**  
**Vehicle Owner's Questionnaire**  
 To Report Vehicle Safety Defects  
 1-888-DASH-2-DOT  
 (1-888-327-4236)  
 INTERNET: www.nhtsa.dot.gov/hotline

Reference No.  
10199663

RE: Unsafe Vehicle Construction  
Beaver Motor home, Monaco Coach Corporation

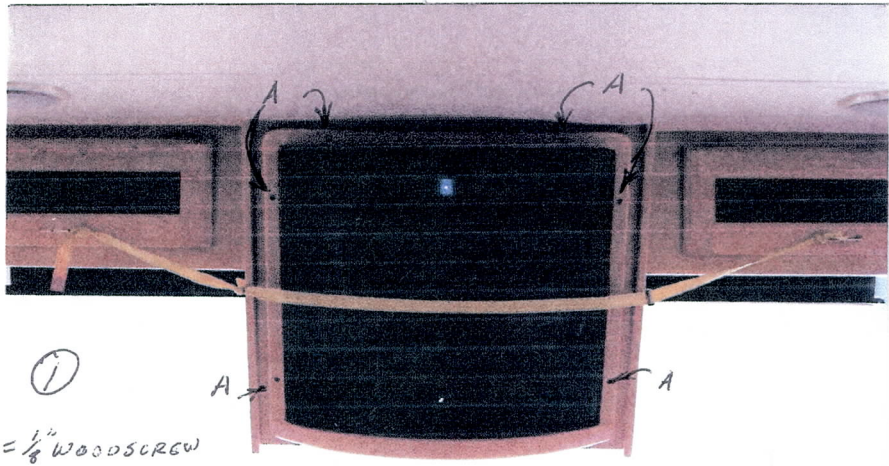
Photo 1: Shows the TV as it is suspended from the roof. Note the tie down strap used to get the coach home.

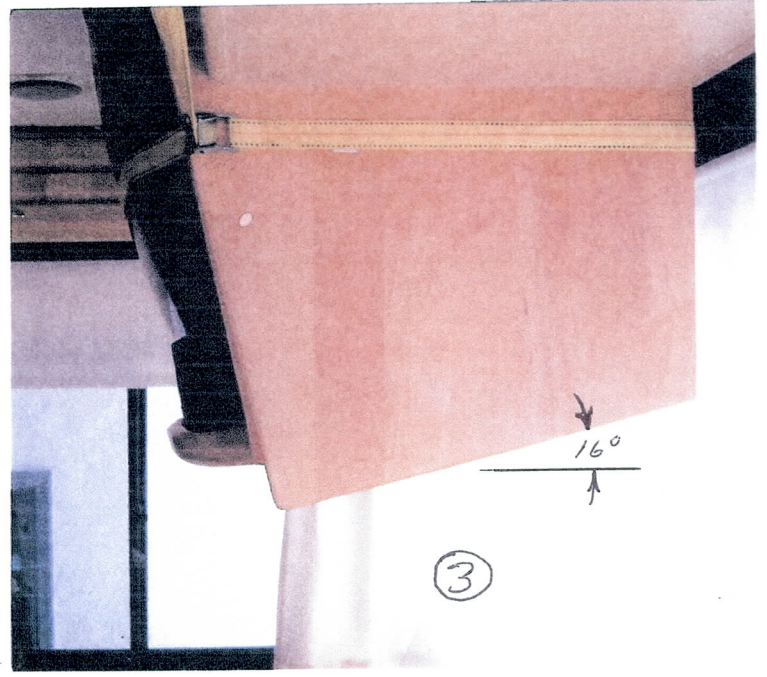
Photo 3: shows a side view of the cabinet. Note the base is sloping at 16°.

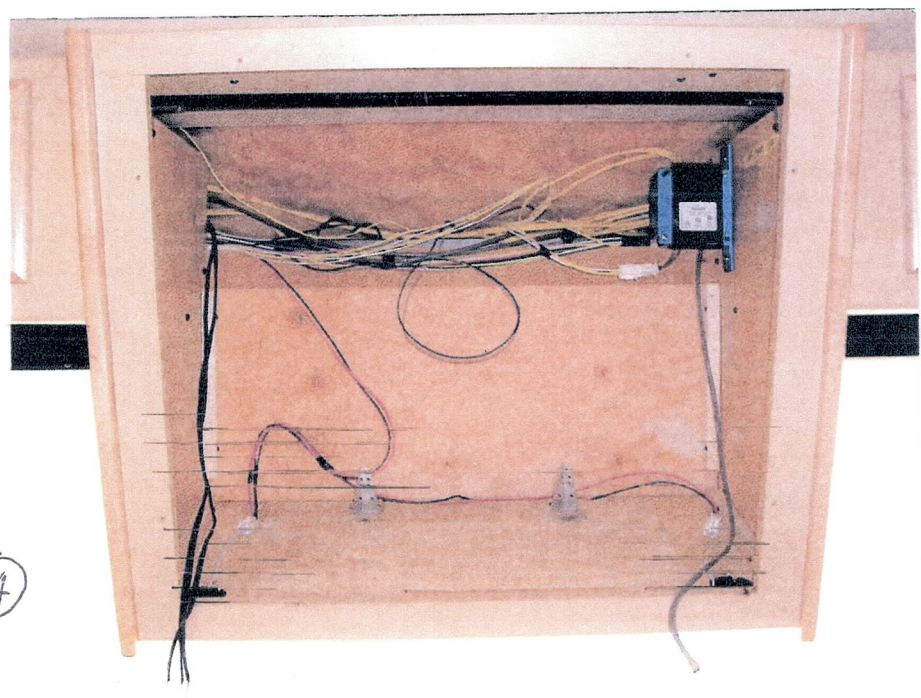
④

Photo 4: Shows the cabinet with the TV removed. Note there is a separate plywood sheet with 2 aluminum brackets in the bottom of the cabinet.

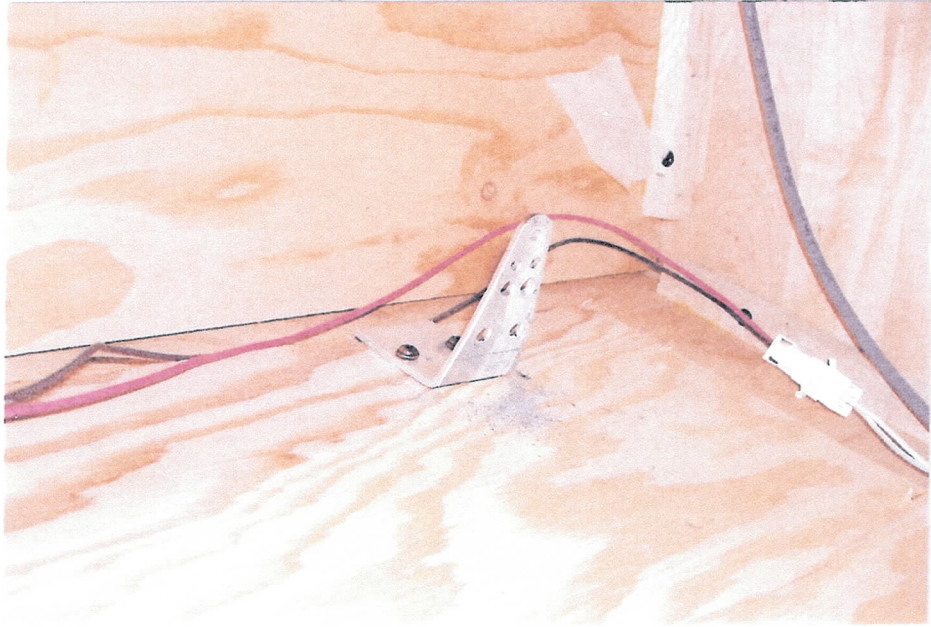
5

Photo 5: shows a closeup of the aluminum bracket. Note the black on the plywood in front of the bracket. It is powered plastic from the TV.

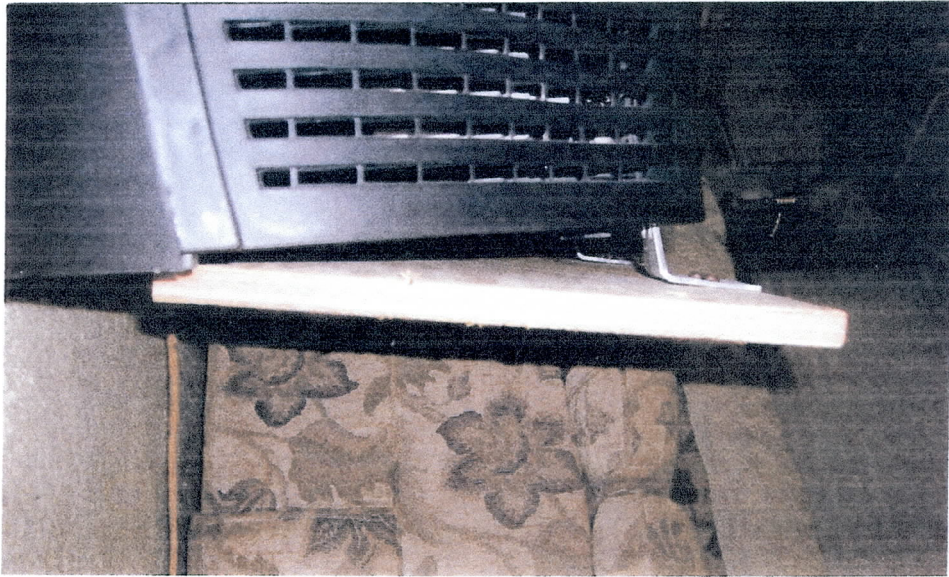
6

Photo 6: Shows the plywood sheet with the TV remounted to it.

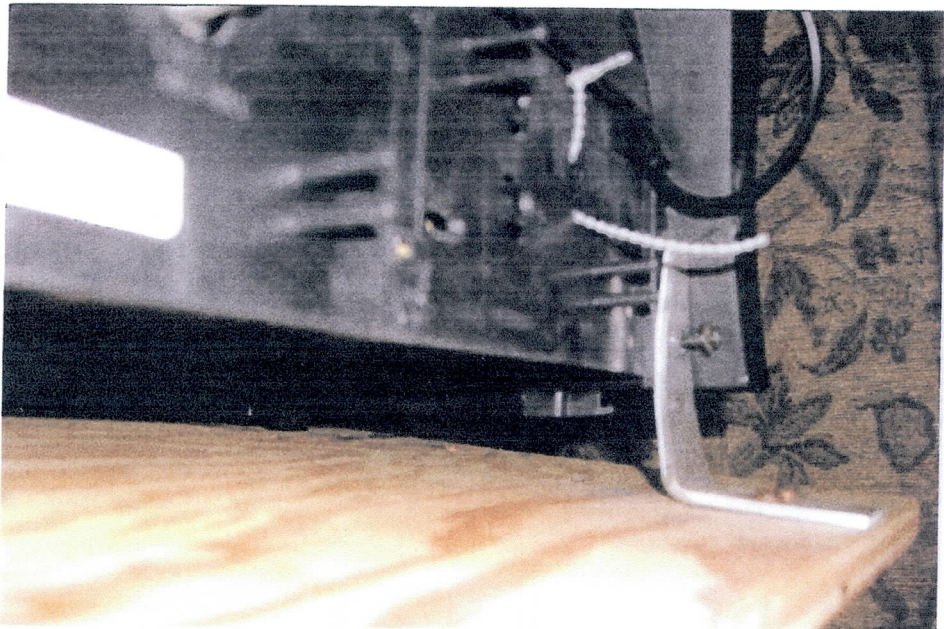
7

Photo 7: Shows a closeup of one of the two 1/8" sheet-metal screws attaching the TV to the mounting board. Note the 2 sheet metal screws are the only attachments between the TV and the mounting board. The TV just sits on the front of the board and is mounted at a 6° angle. Making the total slope of the bottom of the TV 22°.

Probable installation procedure: the TV was mounted to the plywood mounting board and held to it with two 1/8" sheet metal screws anchored in the plastic TV case, the board was set in the cabinet and the facia trim molding was attached to the cabinet with six 1/8" woodscrews countersunk into the facia. The TV was not attached to the facia, it just rested against it. The mounting board was then attached to the cabinet (from the bottom) with four 1/8" woodscrews (not countersunk). It appears that the cabinetry was assembled with power screw drivers with too much torque. There is evidence of over torqued screws in numerous locations in the coach.

Probable failure sequence: Highway vibration caused the TV to bounce. With only the two sheet metal screws, anchored in the plastic case for restraint it soon wore the plastic threads and the metal screws fell out. They were found in the front bottom of the cabinet. The rear of the TV is abraded giving evidence of the rear of the TV bouncing up and down about 2". Once the two metal screws had come loose the four woodscrews holding the mounting board to the cabinet were useless. The bouncing of the TV worked like a pry bar on the six woodscrews holding the facia. They then ripped the small amount wood they were embedded in loose. At emanate failure three of the six woodscrews had fallen to the floor ( both right side and lower left side). The top woodscrew on the right side had pulled out about 1" and had split the wood in the cabinet. The top woodscrew on the left side had pulled out of the cabinet frame and top left side woodscrew had pulled out about 3/4".
