CL-10201569

Re: General Motors Corporation
File No.: 07-13717

Re: GM Motor (Class Action Suit)

IM WRITING THIS LETTER CAUSE IM A VICTIM OF A SITUATION THAT GENERAL MOTORS IS VERY WELL AWARE OF UPPER INTAKE MANIFOLD/GASKETS AND COOLANT LEAKS DUE TO APPARENT POOR ENGINEERING. IN MY CASE THE WORST CASE SCENARIO HAPPENED COOLANT MIXED WITH ENGINE OILMAKING THE OIL INEFFECTIVE- AND DAMAGED THE ENGINE. AS PER GM 's INTERNAL SERVICE BULLETIN .I HAD TO REPLACE THE MANIFOLD IN MY 1998 PONTIAC BONNEVILLE SSE "TWICE". ON TOP OF THAT MULITPAL OTHER PROBLEMS ARE OCCURING TO AND ARE VERY FUSTRATING AND EXPENSIVE. TO MY UNDERSTANDING THIS IS NOT DOWN AS MAINTANCE.

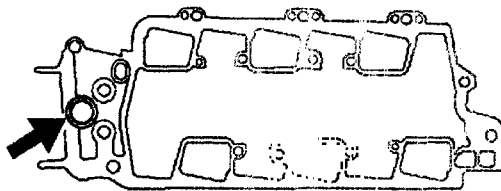
Some owners may comment on excessive engine coolant consumption, or an engine coolant leak near or under the throttle body area of the upper intake manifold.

Upper intake manifold composite material may degrade around the EGR stove pipe and could result in an internal or external coolant leak.

2. Refer to the arrow in the illustration of the upper intake manifold above. Inspect the inner diameter of the EGR passage for signs of material degradation. Degradation will appear as pitting of the composite material in the EGR port passage.
3. If degradation of upper intake manifold composite material is found, replace the lower and upper intake manifolds with the following numbers:
 - ^ Gasket Kit, Upper Intake Manifold - 89017554
 - ^ Manifold Kit, Upper Intake - 89017272
 - ^ Gasket, Lower Intake Manifold - 89017400
 - ^ Manifold, Lower Intake - 24508923

4. Follow the lower and upper intake manifold installation instructions found in the Engine Unit Repair Section of the appropriate Service Manual.
5. If degradation is not apparent, skip to Step 7.
- Verify the repair.
7. If no degradation is found, evaluate the vehicle for other causes of excessive coolant consumption as noted in the Engine Diagnosis Section of the appropriate Service Manual.

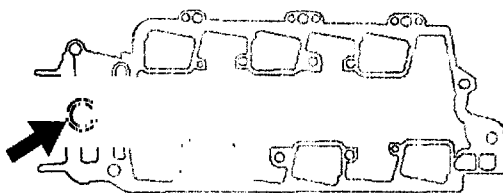
Some owners may comment on excessive engine coolant consumption, or an engine coolant leak near or under the throttle body area of the upper intake manifold.

Upper intake manifold composite material may degrade around the EGR stove pipe and could result in an internal or external coolant leak.

2. Refer to the arrow in the illustration of the upper intake manifold above. Inspect the inner diameter of the EGR passage for signs of material degradation. Degradation will appear as pitting of the composite material in the EGR port passage.

3. If degradation of upper intake manifold composite material is found, replace the lower and upper intake manifolds with the following numbers:

4. Follow the lower and upper intake manifold installation instructions found in the Engine Unit Repair Section of the appropriate Service Manual.
5. If degradation is not apparent, skip to Step 7.
6. Verify the repair.
7. If no degradation is found, evaluate the vehicle for other causes of excessive coolant consumption as noted in the Engine Diagnosis Section of the appropriate Service Manual.

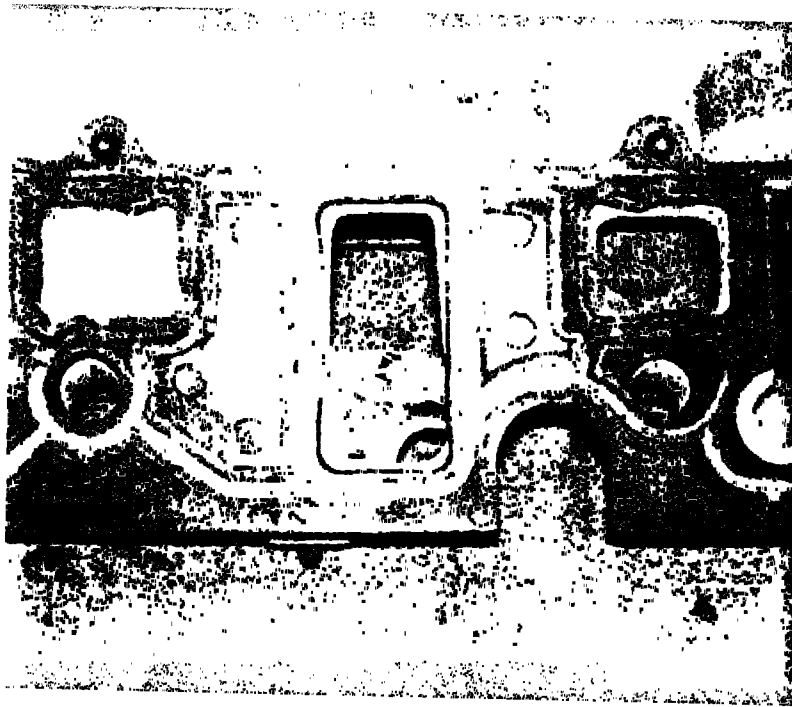
Lower Intake Manifold (LIM) gaskets

- The lower intake manifold gaskets in 3800 engines deteriorate over time creating internal coolant leaks that can cause the damage as a ruptured upper intake. While UIM failures are limited to the normally aspirated (non-supercharged) L-36 engines 95 – 05, the plastic-frame LIM gasket design was used in both supercharged and normally aspirated engines at least from the original equipment plastic frame gaskets carrying silicone rubber sealing beads break down and begin to leak as shown below.

Depending on where the break occurs, coolant may be sucked into the combustion chambers, leak into the crankcase, with bolts, or otherwise leak to the outside of the engine, sometimes pooling in depressions on the LIM casting. Sometimes the seal between an intake port and the crankcase causing poor idling and a vacuum in the crankcase that can damage the engine. Many believe that orange Dex-cool (organic acid) coolant, used by GM since 1996, reacts chemically with the plastic frame causing them to break down much more quickly than was observed when the older green (phosphated) coolants were used. Lower intake manifold gaskets are easily accessible when changing the upper intake manifold, it is strongly recommended that gaskets be replaced when the UIM is removed.
