Vehicle Owner's Questionnaire

CADILLAC

Tire Failure Type TREAD SEPARATION

## **Bridgestone Incident Report 841495 Supplement**

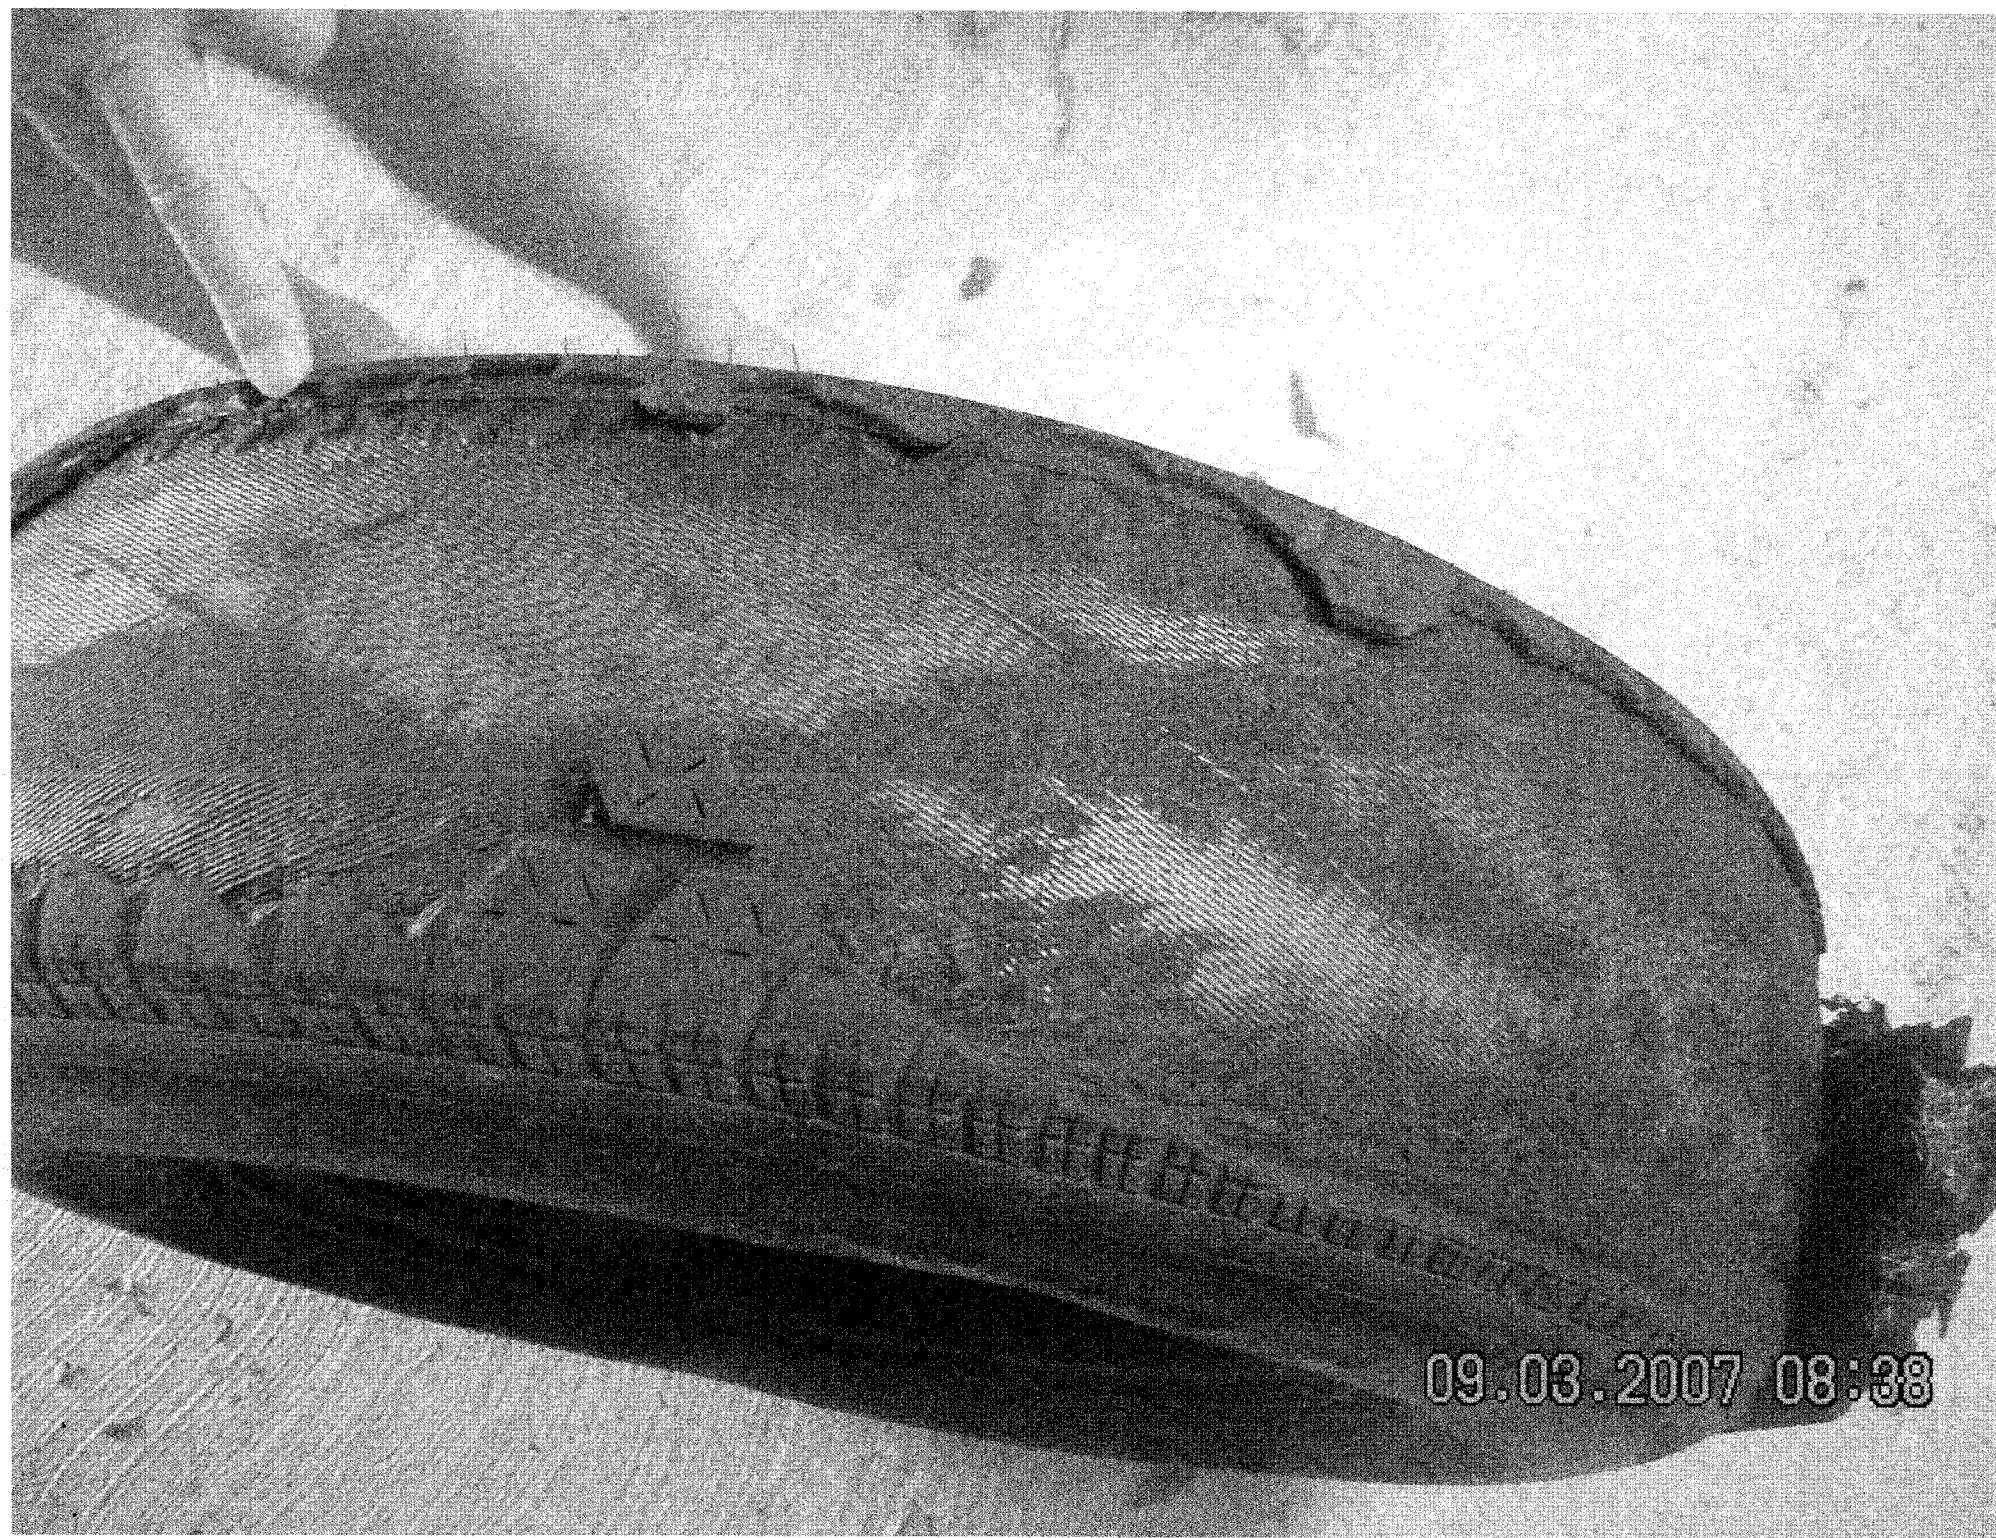
- 1. Right side of the vehicle bumper molding hit an unseen obstruction in the grass area (vehicle was stopped/parked half on the paved surface and half off the paved surface (grass) emergency lane because I had to change the wheel/tire on left side of vehicle and I wanted room to ensure I would not be hit by a distracted driver) and peeled the right front bumper trim off (pictures # 1 A,B,C enclosed) and creased the right rear trim molding (picture # 2 enclosed).**

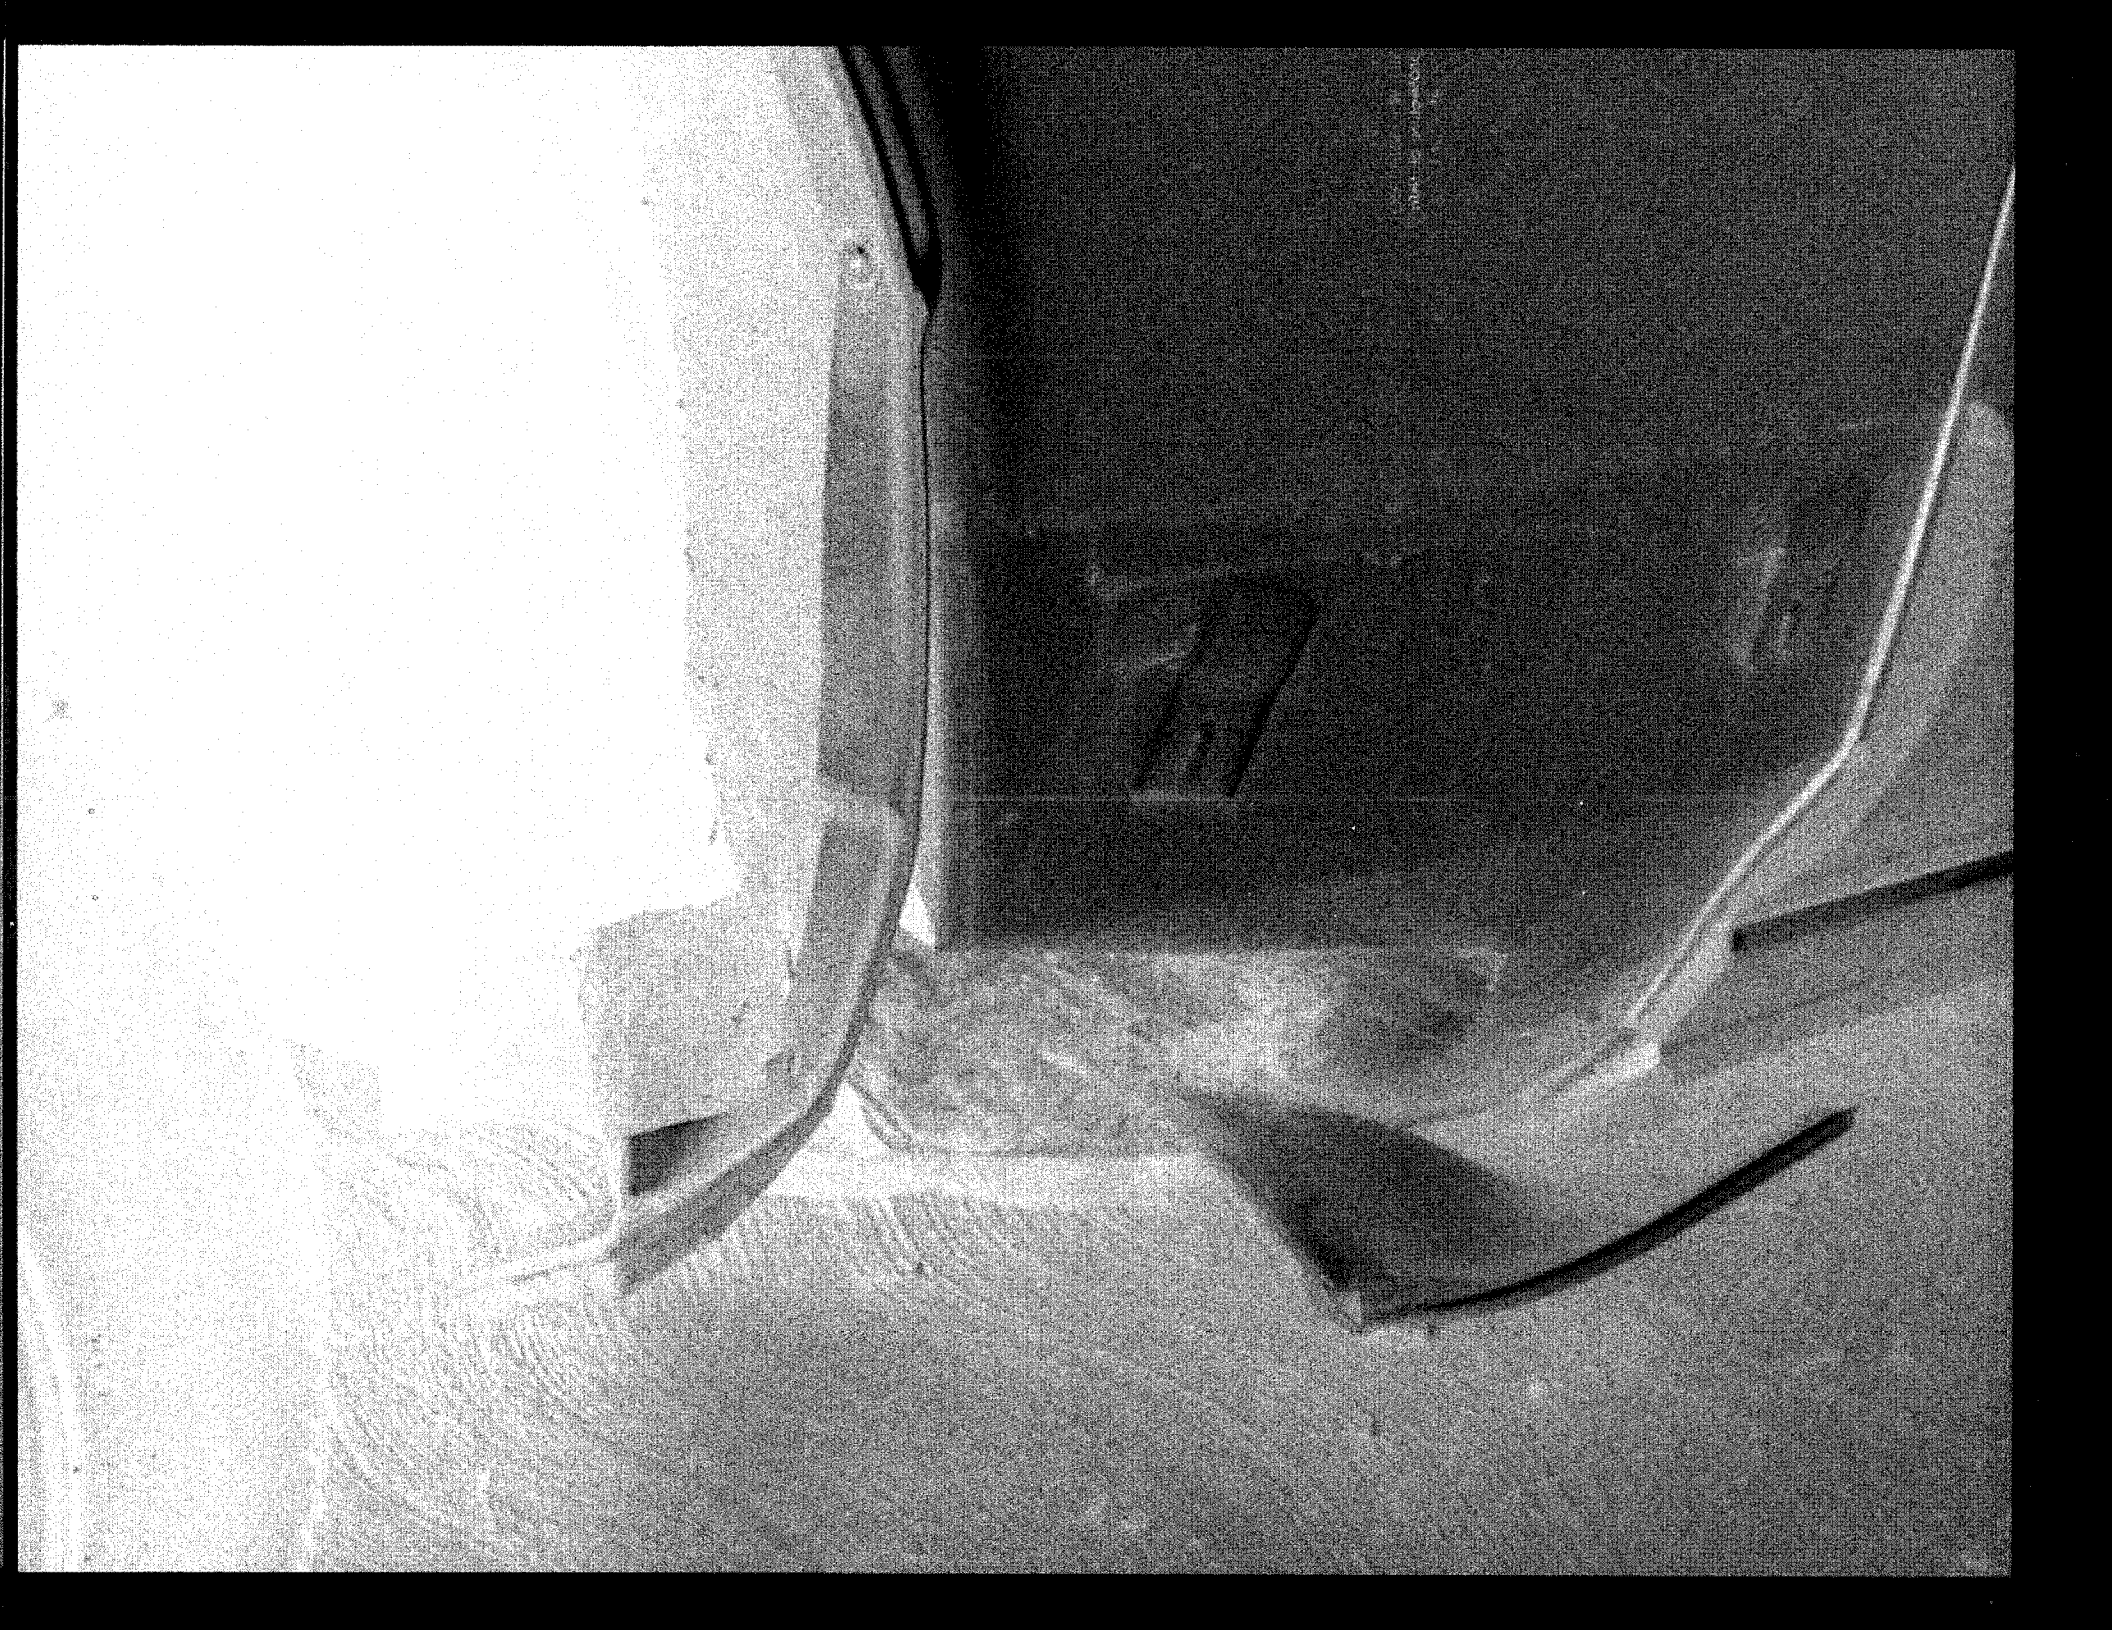
- 2. Separated/deflated tire (picture # 3) bent the left front fender, wheel well molding, bent/tore the rocker panel (pictures 4 A,B,C), chipped paint off driver door and trim panel (picture #5), peeled off left front fender trim piece (pictures (4 A,B,C) which hit left mirror on driver door loosening it, driver door small dent and tore vinyl /leather on left rear door window area (these two areas did not photograph well and were not enclosed). The two trim pieces were not retrieved as they were in south bound traveling lanes.**
