## DOT Auto Safety Hotline

**Vehicle Owner's Questionnaire**  
To Report Vehicle Safety Defects  
1-888-DASH-2-DOT  
(1-888-327-4236)  
INTERNET: [www.nhtsa.dot.gov/hotline](http://www.nhtsa.dot.gov/hotline)

Reference No.  
10202340

TL\*THE CONTACT OWNS A 1993 GMC SUBURBAN. THE CONTACT SMELLED FUMES AFTER FILLING UP THE GAS TANK. HE TOOK THE VEHICLE TO A MECHANIC AND WAS INFORMED THAT THE FUEL TANK WAS RUSTED. A NEW FUEL SYSTEM IS CURRENTLY BEING PLACED IN THE VEHICLE. THE CONTACT HAS PICTURES. (THE PURCHASE DATE WAS UNKNOWN.) THE CURRENT AND FAILURE MILEAGES WERE 148,000.  
(UPDATED ABOVE)

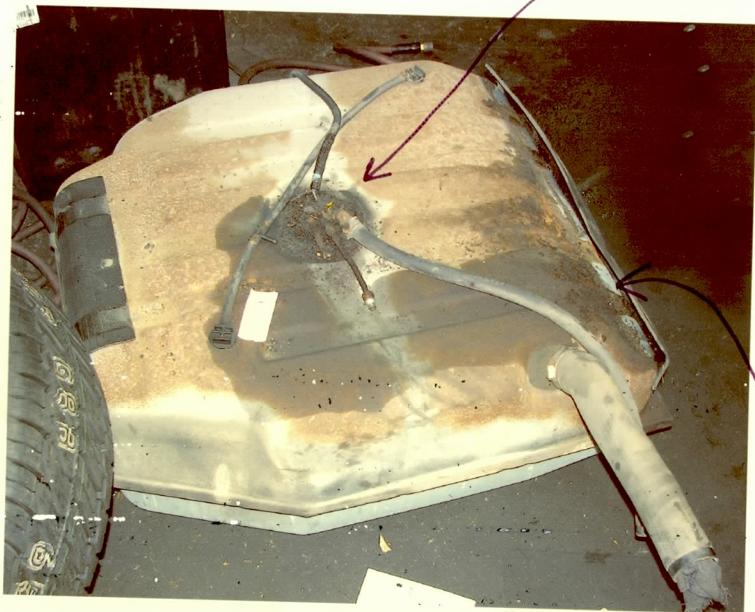
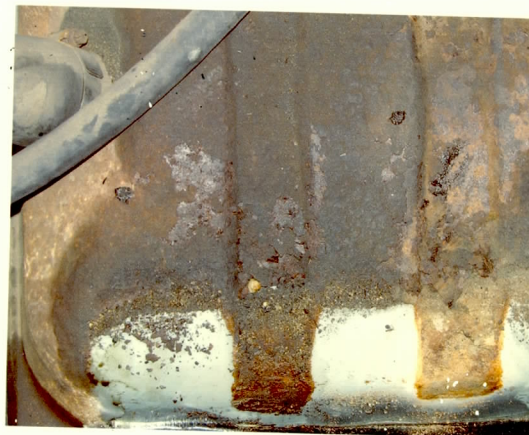
THE EXACT SOURCE OF THE FUEL LEAK WAS NOT DETERMINED, HOWEVER IT APPEARS THE LEAK WAS IN THE AREA WHERE THE FUEL LINES ENTER THE TANK. TWO PHOTOS ARE ENCLOSED. ONE PHOTO SHOWS THE ENTIRE TANK. THE OTHER PHOTO SHOWS THE LINES AND THE SEVERE RUST. NOTE THE FLAKES OF RUST AND HOW THE LINE SPLIT UPON GAS TANK REMOVAL

TANK

LEAK AREA

NOTE EXTENSIVE RUST  
DID NOT RUST THROUGH YET  
(TANK WAS REPLACED)

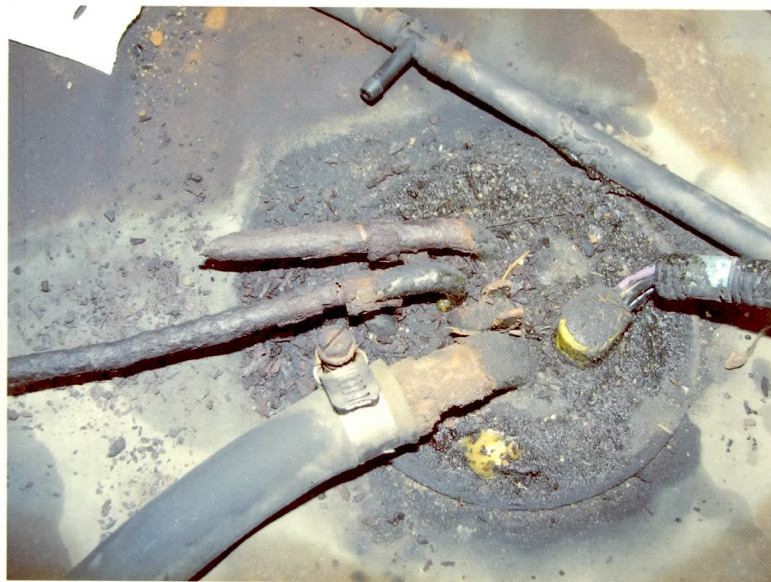
NOTE HOW FUEL LINES ENTERING TANK ARE SEVERELY RUSTED. FLAKES OF RUST ARE VISIBLE ON THE TANK.

(WE ARE FORTUNATE THE LINE DID NOT RUPTURE AND SPRAY FUEL UNDER THE VEHICLE.)

IT SEEMS THAT WATER COLLECTS ON TOP THE TANK HASTENING CORROSION...

DIGITAL PHOTOS ARE AVAILABLE IF DESIRED. ALSO THE LINES ALONG THE FRAME WERE RUSTED AND WILL REQUIRE REPLACEMENT. THANK
