DOT Auto Safety Hotline  
**Vehicle Owner's Questionnaire**  
To Report Vehicle Safety Defects  
1-888-DASH-2-DOT  
(1-888-327-4236)  
INTERNET: www.nhtsa.dot.gov/hotline

Reference No.  
10202950

**Fire Hazard**    GMAC Claim # [REDACTED]

Winnebago Journey D L, CA License # [REDACTED] Chassis VIN:  
#4UZAHAHAK22C [REDACTED] Model # 2002 WKP36GD, Serial # 10P86C [REDACTED] with  
under 50,000.00 miles, original owner.

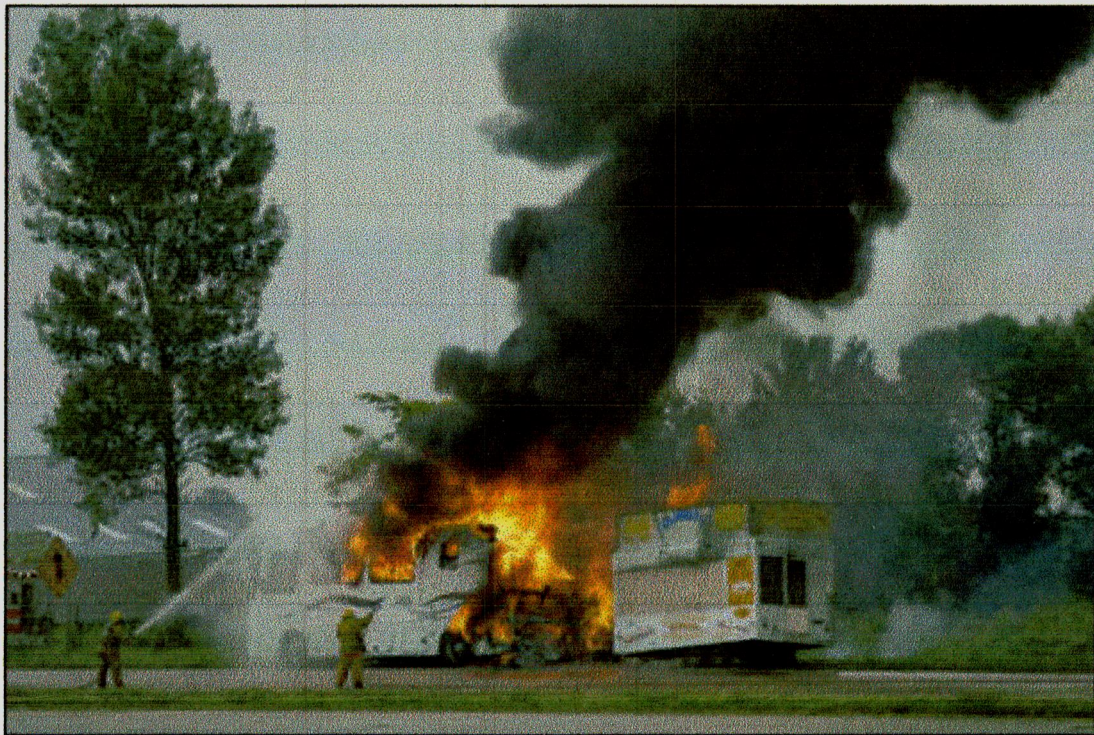
## In Winona County, a motor home is no more

The family, using their RV to pull a fair concession stand, left the Steele County Fair in Owatonna and were enroute to a county fair in Illinois, when a fire started in the engine compartment of their 36-foot motor home, said Lewiston Fire Chief [REDACTED]. Flames shot through the rear bedroom area and then engulfed the vehicle, which was destroyed.
