DOT Auto Safety Hotline
Vehicle Owner's Questionnaire
To Report Vehicle Safety Defects
1-888-DASH-2-DOT
(1-888-327-4236)
INTERNET:www.nhtsa.dot.gov/hotline

Ocean County Sherriff's Dept. Office of the Fire Marshal
P.O. Box 2191, Toms River, NJ 08754-2191
Phone: 732-341-3451/1-800-331-8152 Fax: 732-341-3154
Fire Investigation Report (Privileged and Confidential)

HARD FACTS™

In accordance with your request, this organization conducted a forensic automotive engineering examination that focused upon the recovered remains of the [REDACTED] vehicle on May 18, 2007. The subject vehicle was examined at Insurance Auto Auctions in Morganville, New Jersey where it was staged under stock number 3105780.

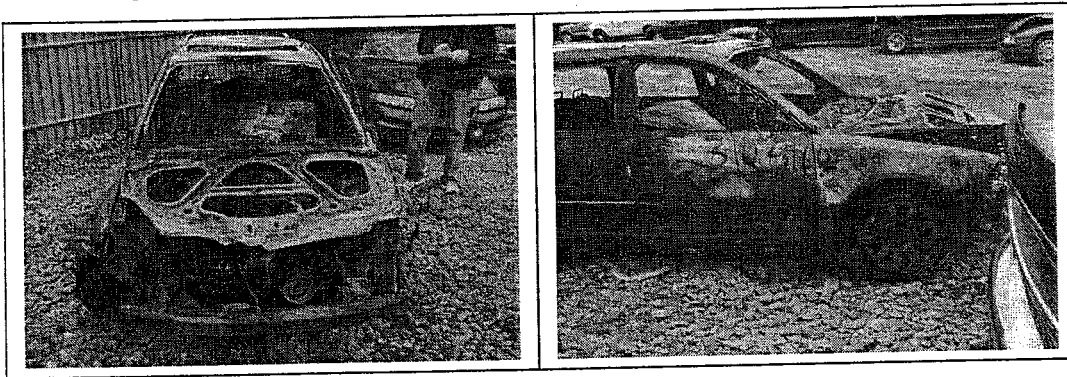
There was no evidence of historic unrepaired impact damage on the exterior sheet metal body components. The exterior exhibits signs of fire related damage with emphasis to the front.

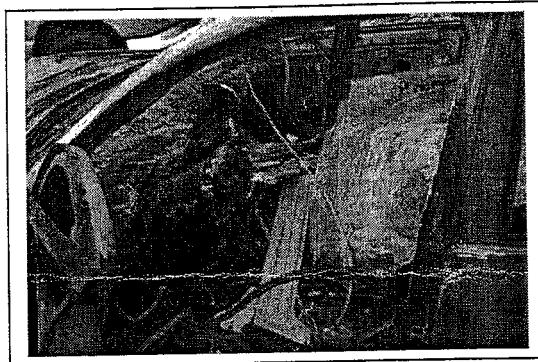
The interior physical evidence confirms the fire initiated within the power plant compartment

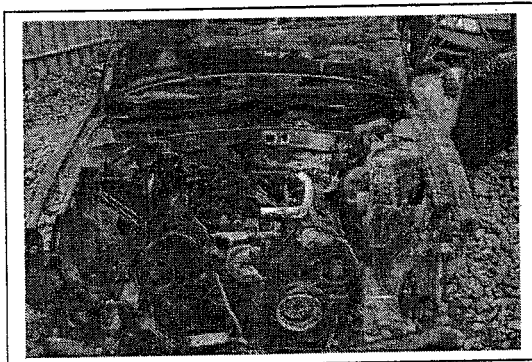
Examination of the power plant compartment revealed evidence of severe fire damage.

All components and assemblies are either partially or fully consumed by fire damage.

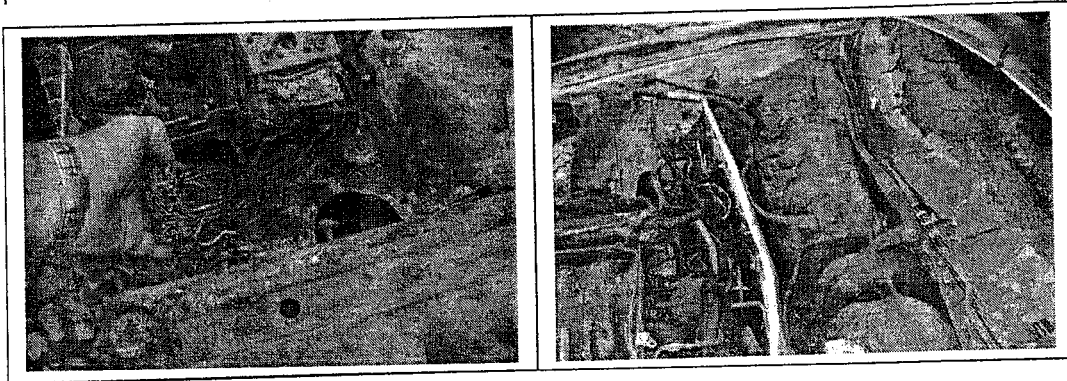
The locus point of the vehicular fire is within the power plant compartment, more specifically in the left side area near the fender. The fire, itself, originated due to an electrical short in the ground of an electrical harness in the area. In addition, there is evidence of a high voltage electrical short circuit to the terminal lead of the vehicle's battery to the ECM. The wire shorted out against the vehicle's steel

cowl with temperatures high enough to weld the 12 gauge wire against the body panel.

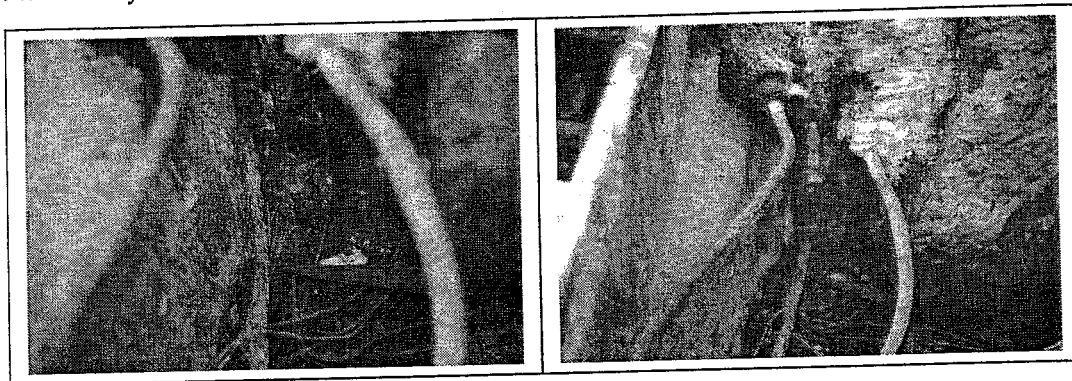
Review of the vehicle's service history profile disclosed damage in the same area, as the locus point, on February 19, 2006 that was subsequently repaired by Auto Body Craftsman of Island Heights, New Jersey.
