CL-10210570-2355

November 20, 2007

Department of Transport  
National Highway Traffic Safety Administration  
Office of Defect Investigation  
1200 New Jersey Ave. S.E.  
West Building  
Washington, DC 20590

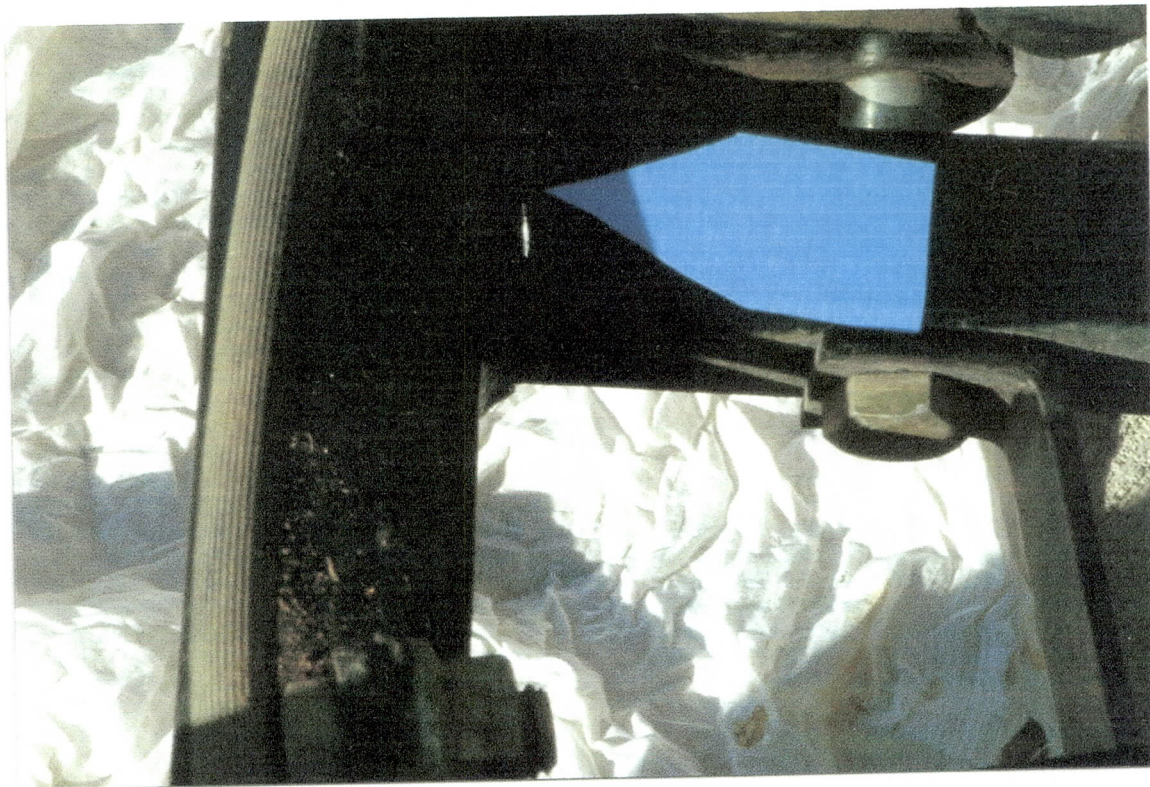
Pictures #3 and #4, and #5 and #6, respectively show close ups of the right and left sides of the breaks in the frame.
