Vehicle Owner's Questionnaire

17 digit Vehicle Identification Number Located at bottom of windshield on driver's side: SMTC00L57 [REDACTED]
 Make: TRIUMPH Model: ROCKET III Model Year: 2005
 Date Purchased: 31-JUL-04 Dealer's Name and Telephone Number: _____ Engine: No: Cylinders: _____ Fuel Type: Gas
 Original Owner: Dealer's City: _____ State: _____ Zip Code: _____
 Transmission Type: MANUAL Antilock Brakes Cruise Control
 Powertrain: FRONT WHEEL DRIVE REAR WHEEL DRIVE
 Vehicle Component Code: 060000 ENGINE AND ENGINE COOLING
 Multiple Failure: 1

Rocket III - Transmission Damper & Drive Shaft

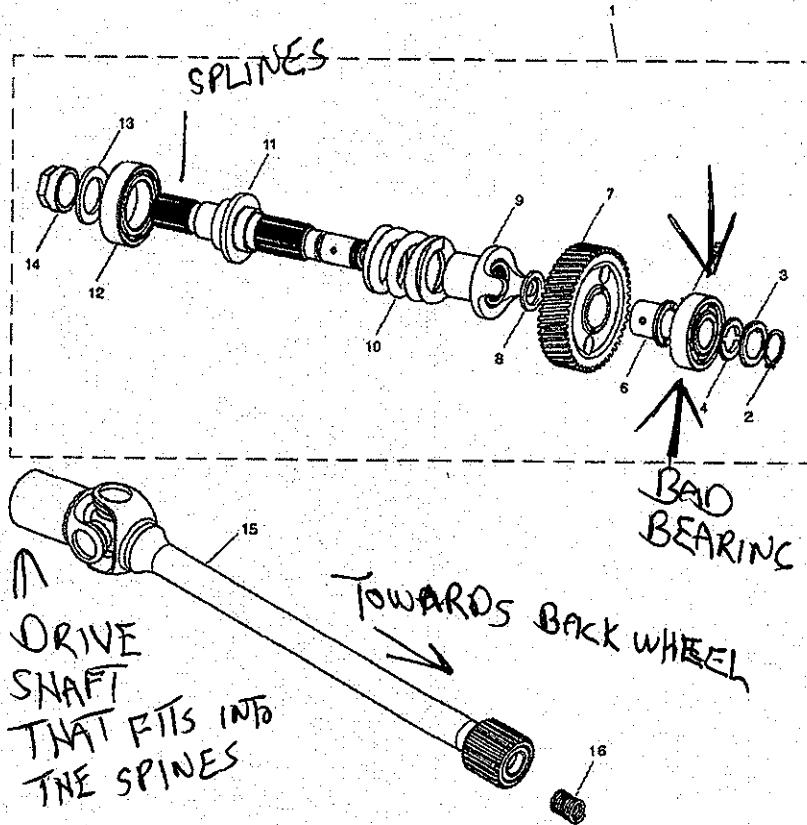
Transmission Damper & Drive Shaft

Within this package you will see pictures of the remains of the ball bearing that disintegrated. The bearing was part of the transmission Damper and is shown by a schematic. Also on the web there was a poll taken and that info is in this packet.

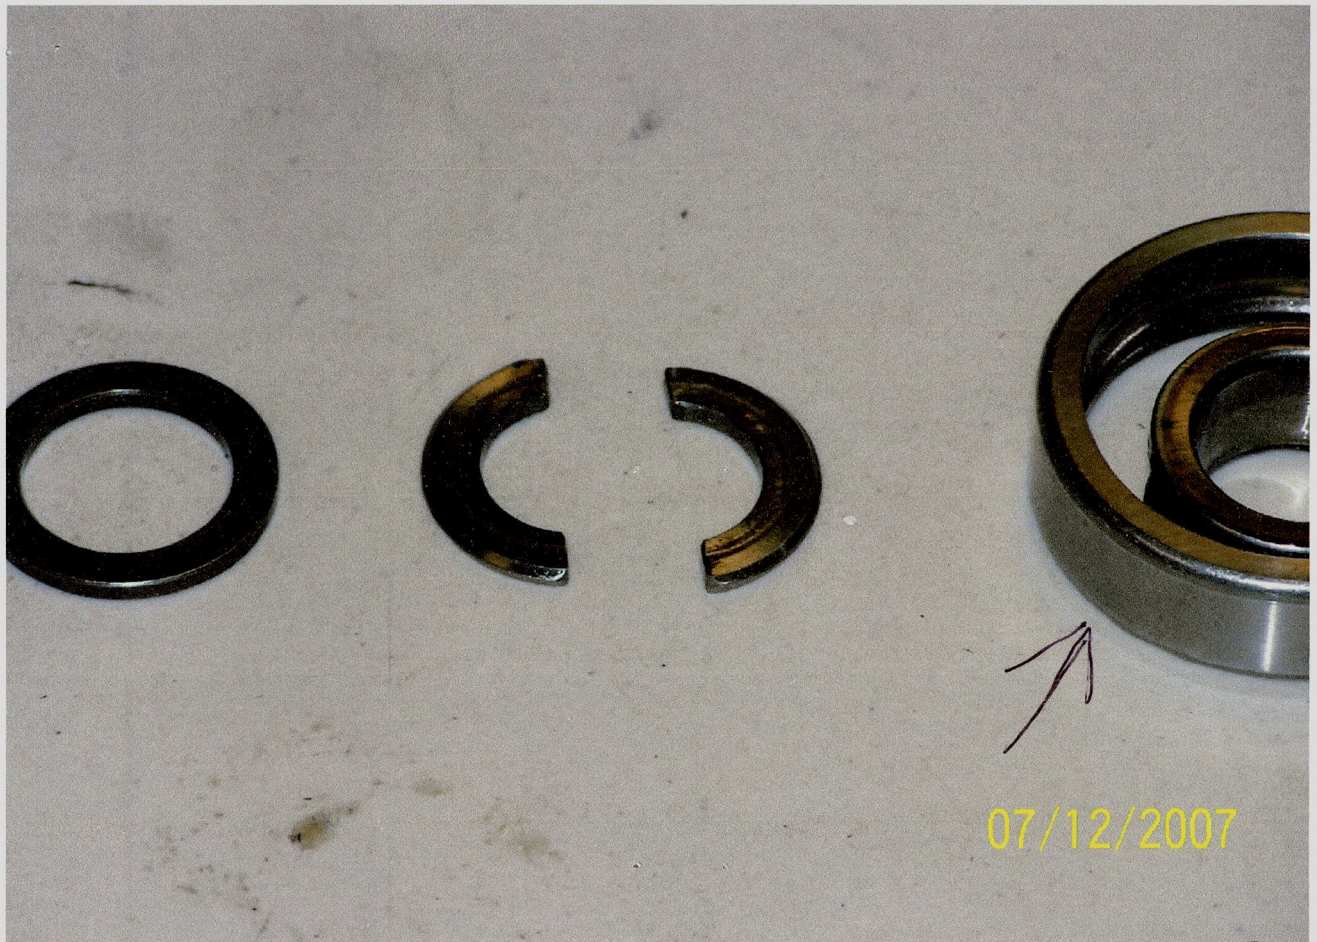
THIS IS WHAT
WAS STILL ATTACHED
TO SHAFT

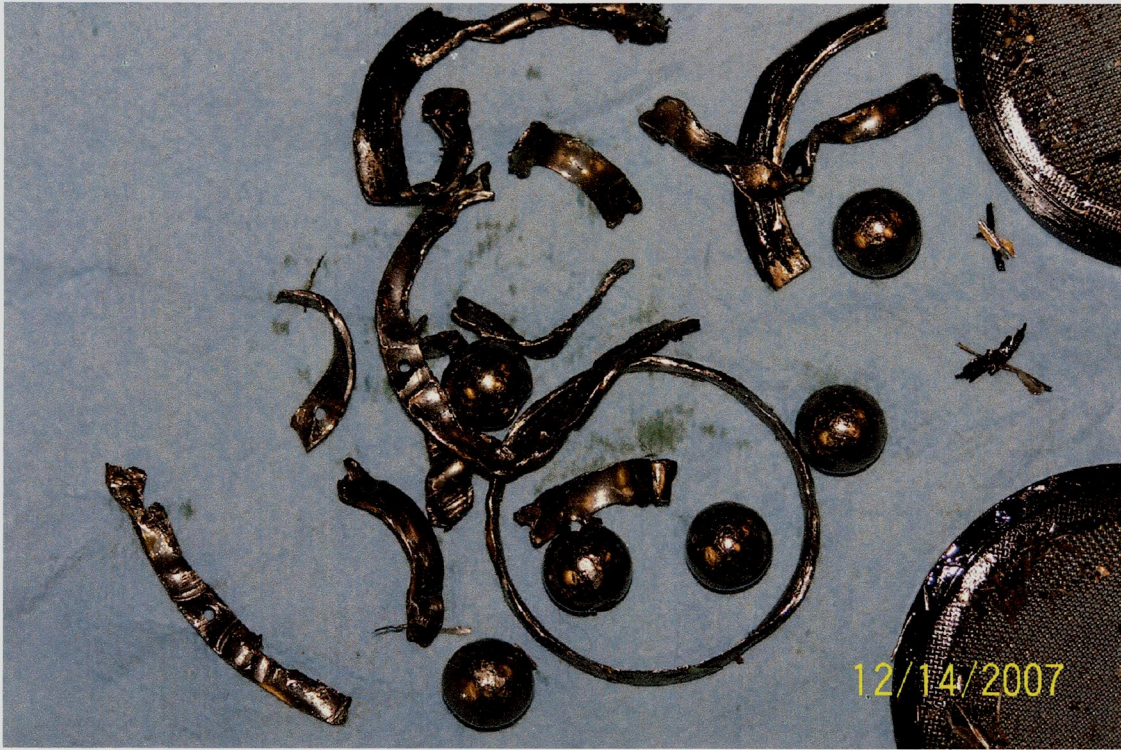
← THE PARTS OF THE 1 BEARING FOUND AT THE ENGINE FILTER THIS WAS ALSO RESTRICTING OIL FLOW TO ENGINE.

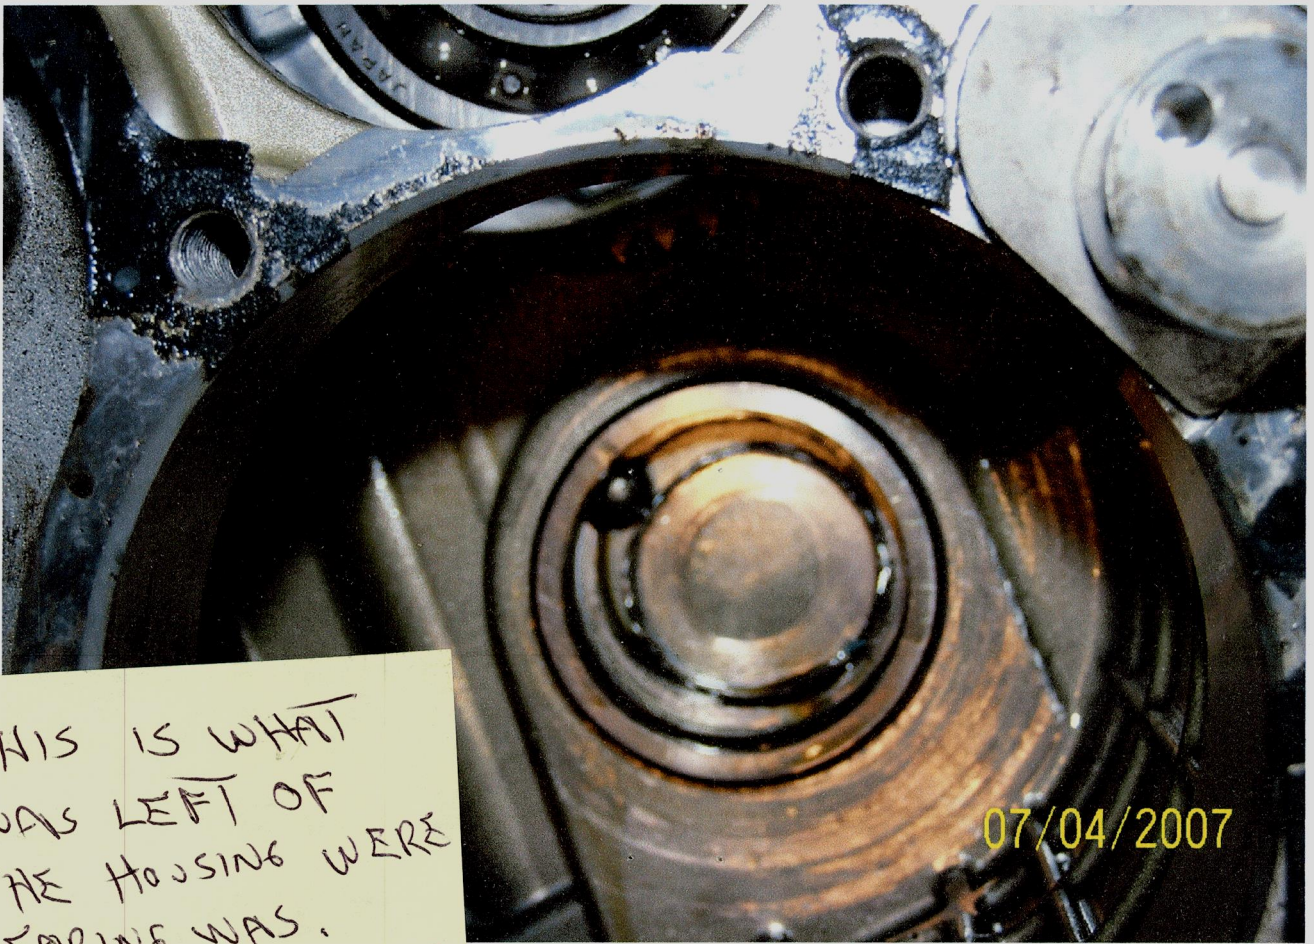
THIS IS WHAT
 WAS LEFT OF
 THE HOUSING WHERE
 BEARING WAS.
 CIRCLED IS ONE BALL
 LEFT IN BEARING
 ARROW POINTS TO OIL GALLERY
 THAT LUBES THE BEARING
 REF 1021 8676
