DOT Auto Safety Hotline
Vehicle Owner's Questionnaire
To Report Vehicle Safety Defects
1-888-DASH-2-DOT
(1-888-327-4236)
INTERNET:www.nhtsa.dot.gov/hotline

Incident Date(s), Failure Mileage, Failure Speed, Bendix ESD-225 Air Disc Brakes 976087B 22K3 NFD14

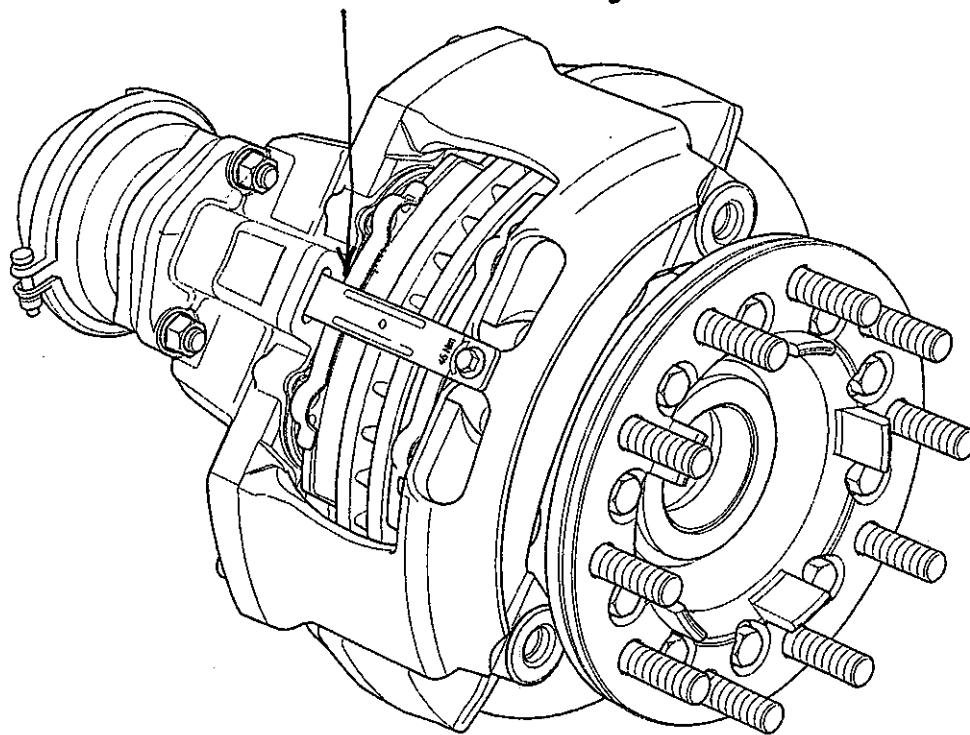
water entering in this AREA.

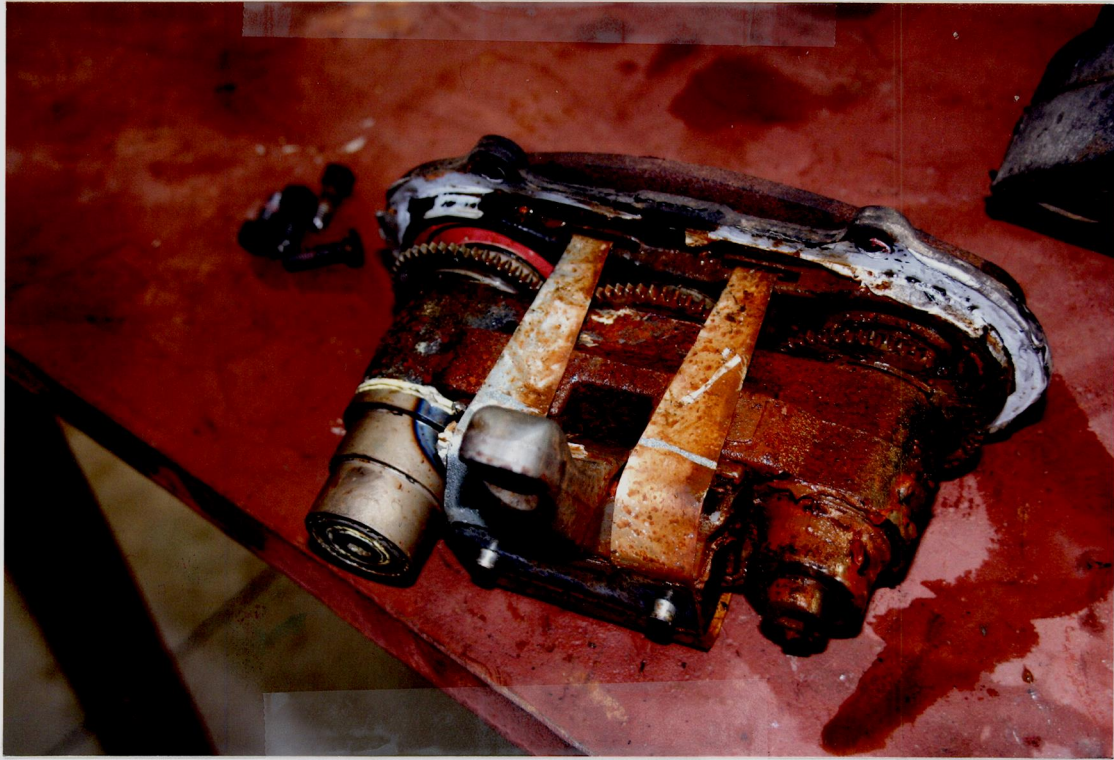
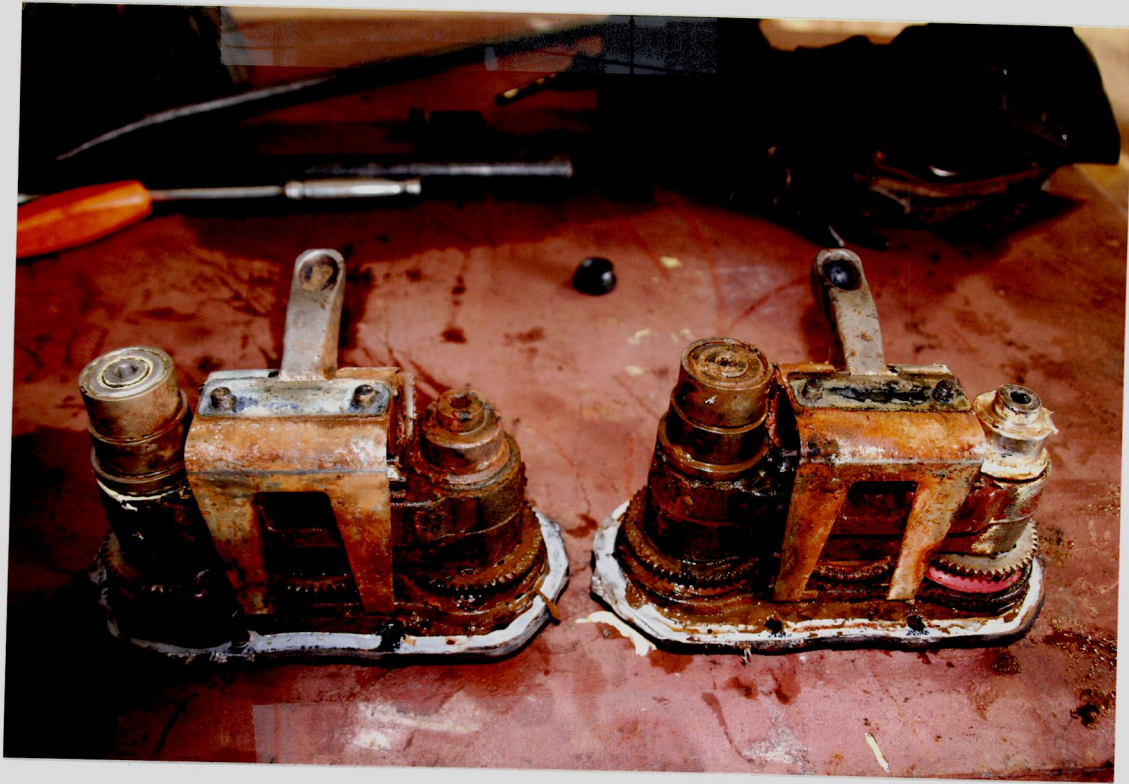
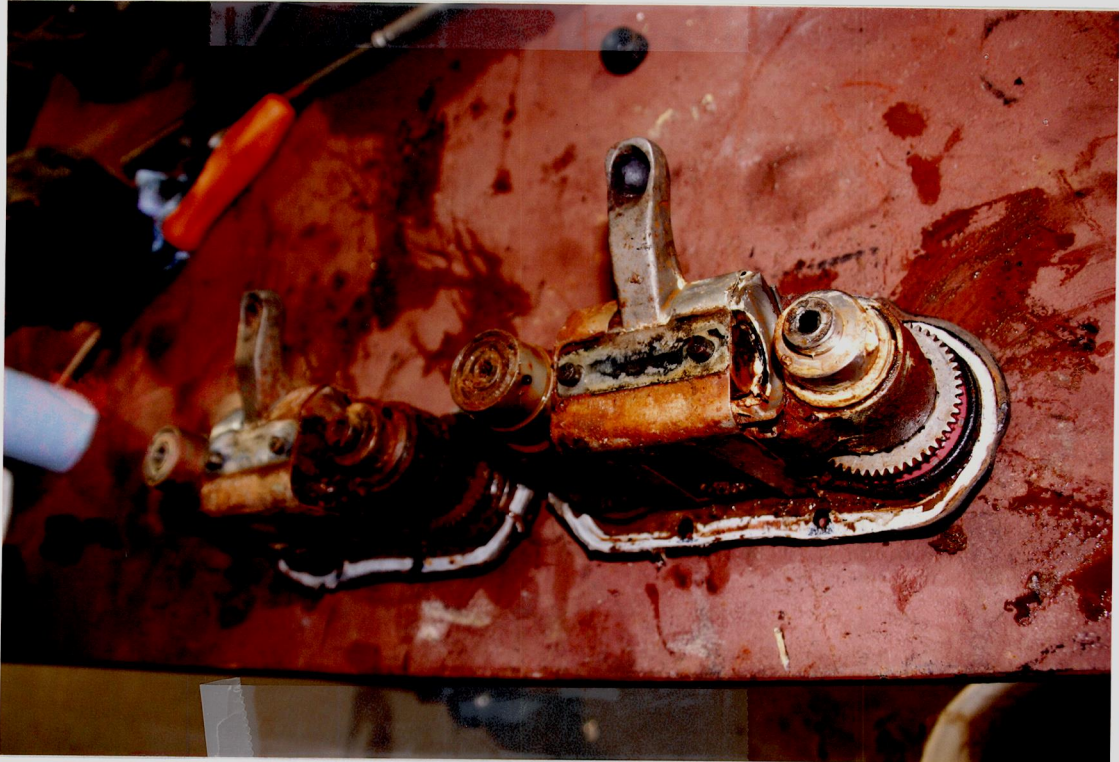
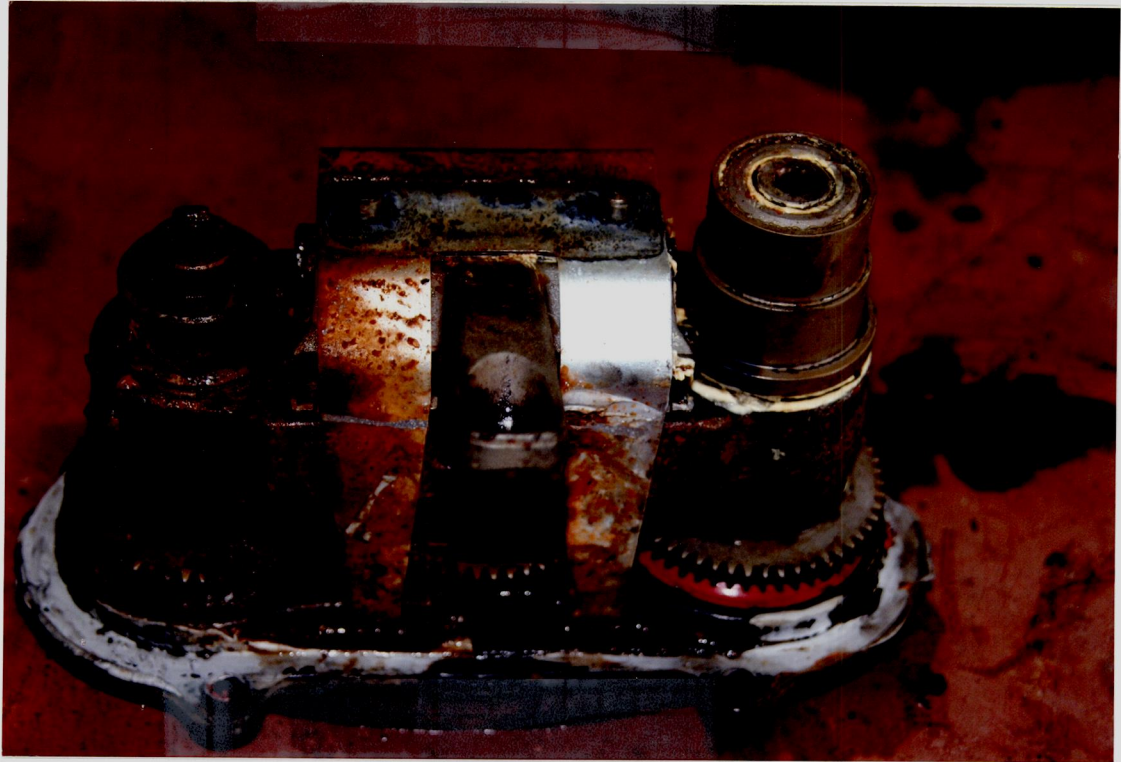
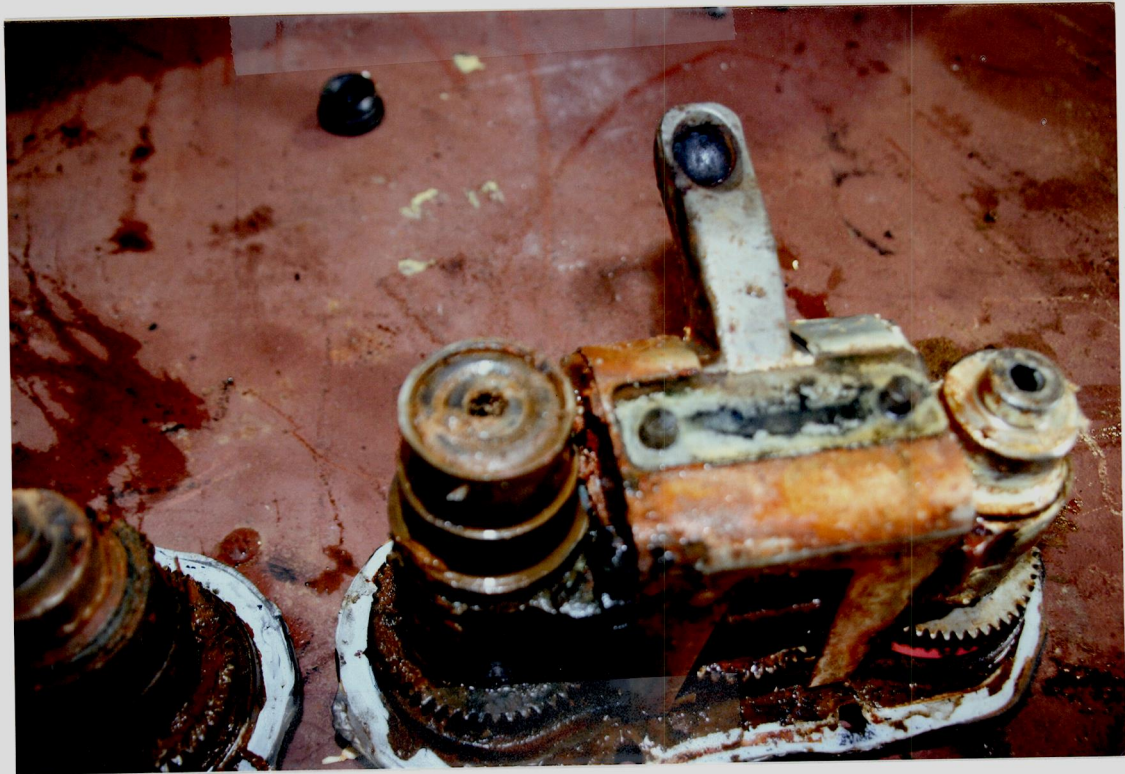
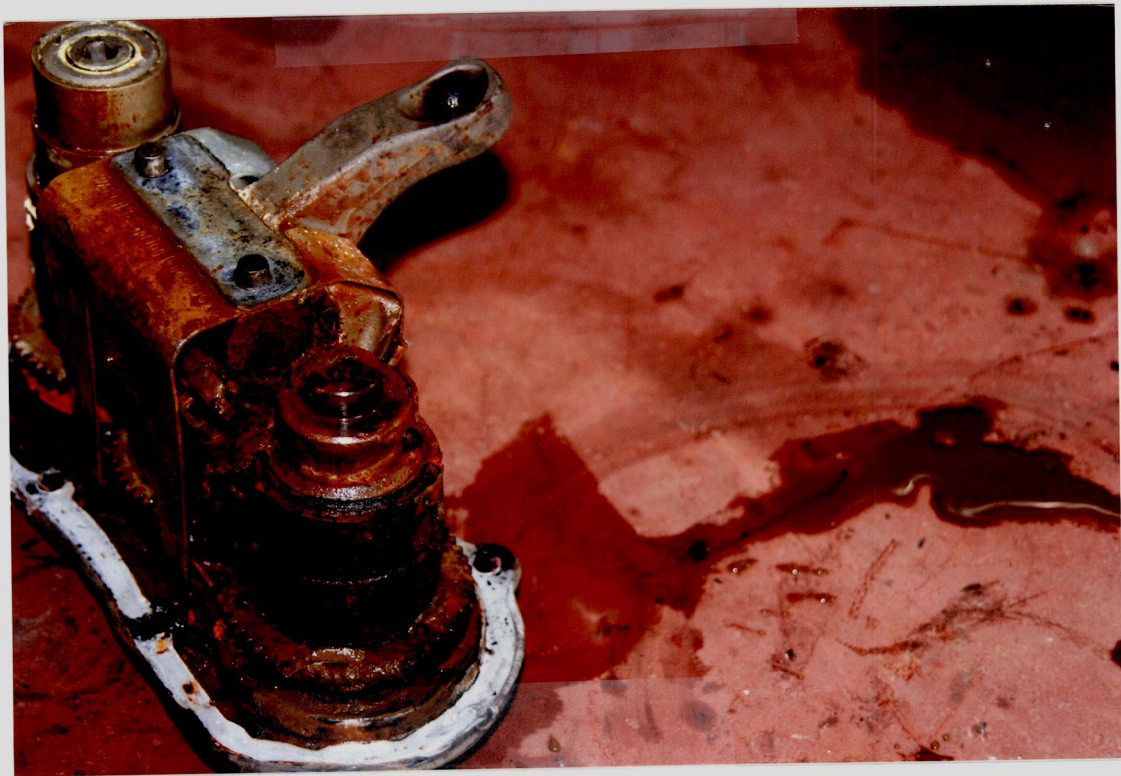
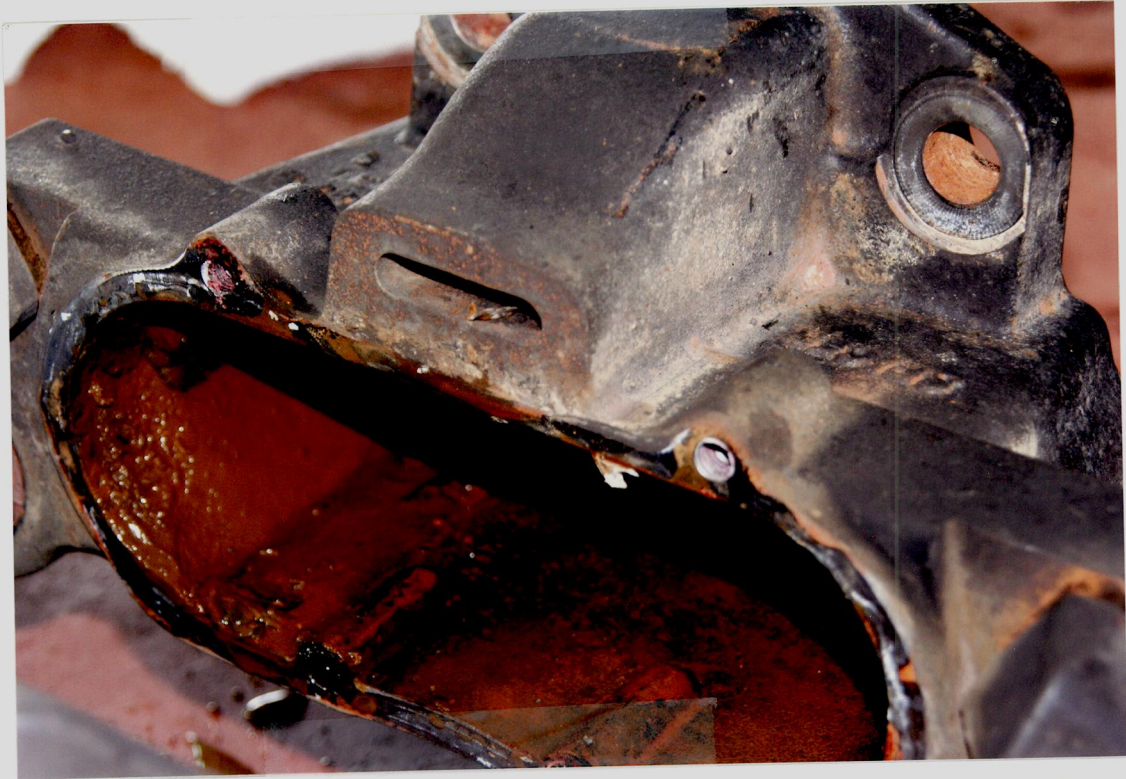
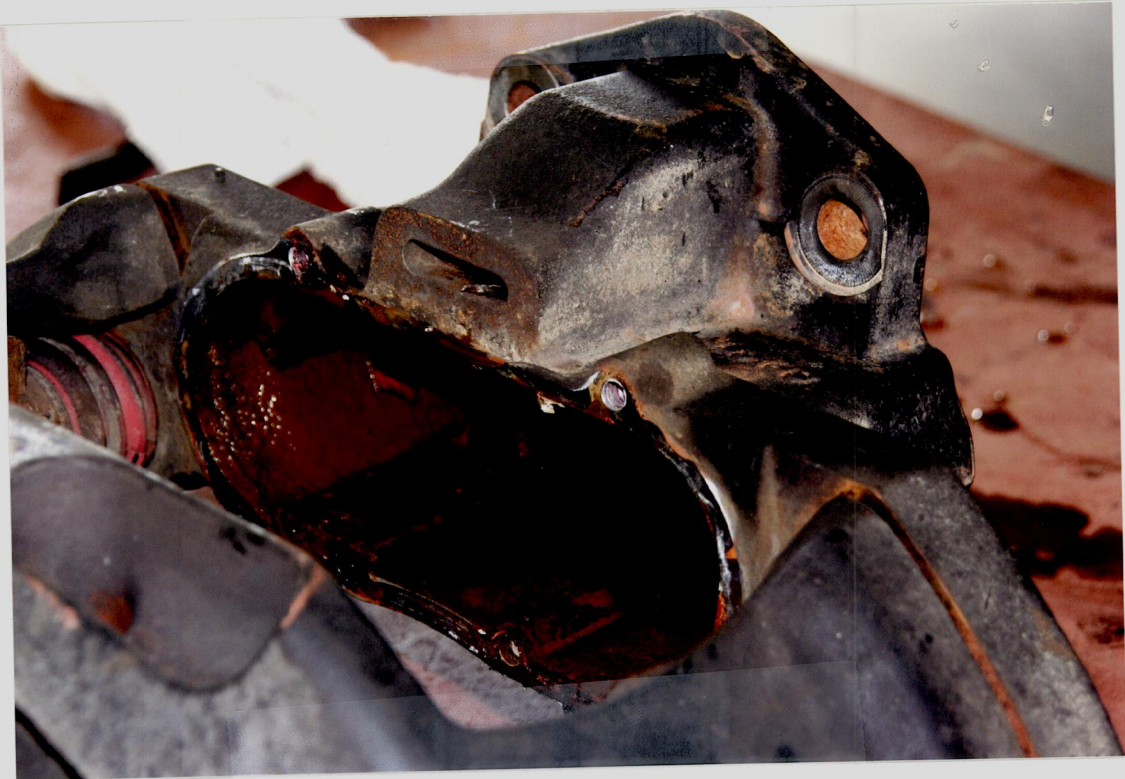
On our yearly maintenance of the front axle, I had my mechanic also inspect the front disc brakes to see if we had any damage due to the overheat condition. When we pulled the air chamber off the caliber assembly, we found the actuator chambers completely full of water. On further breakdown of the caliber assemblies, we found the water to be road water and the migration route was through the silicone sealant used to seal this assembly in place of a gasket. The overheat conditions were caused from ice in this assembly. After enough heat was generated to melt the ice, the brake would fully release, but as you can see from the enclosed pictures there is severe corrosion setting in these mechanisms.
