**DOT Auto Safety Hotline**  
**Vehicle Owner's Questionnaire**  
To Report Vehicle Safety Defects  
1-888-DASH-2-DOT 2008 AUG 4  
(1-888-327-4236)  
INTERNET: www.nhtsa.dot.gov/hotline

Reference No.  
10232521

Make  
MINI

COOPER SPORT

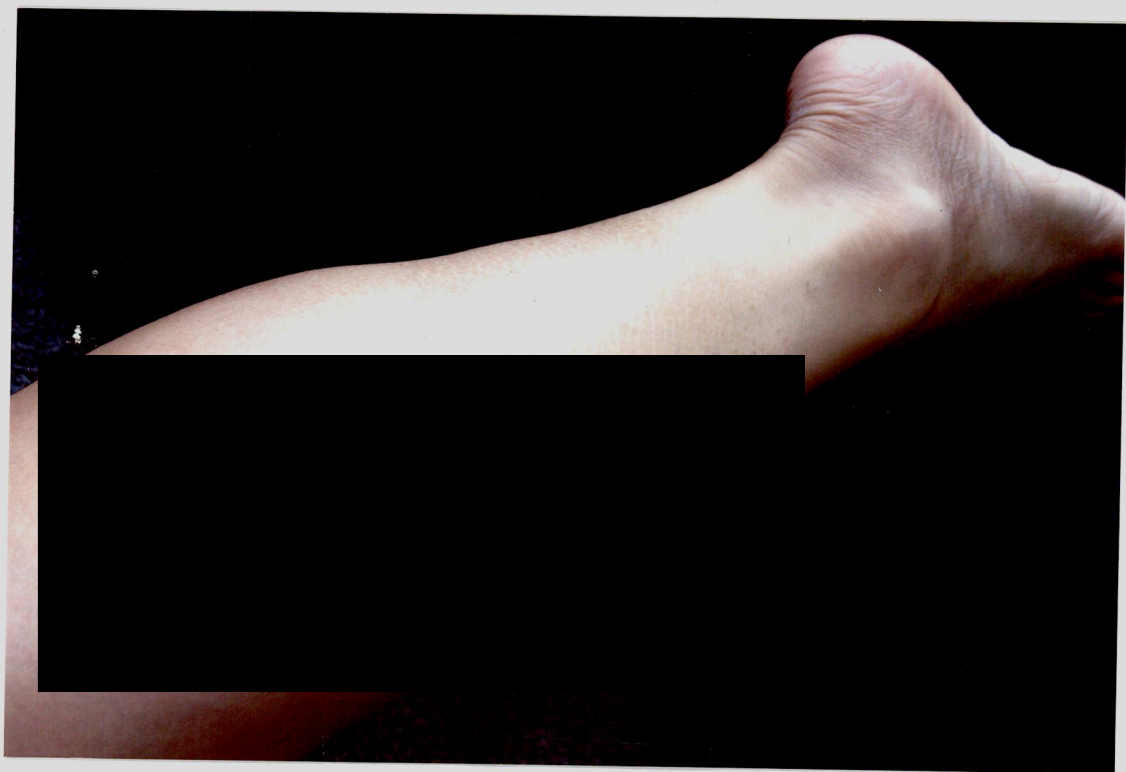
Current status: Dealer offered to inspect my car to check if exhaust pipe falls within design specifications. I believe the pipe likely meets the design as specified by the manufacturer, but that the design itself is flawed. Unlike most cars, the exhaust pipe is located in the middle rear of the vehicle (rather than off to the side), and more importantly, it slightly protrudes out past the edge of the rear bumper. This particular design/location makes someone accessing the trunk much more susceptible to accidentally touching the edge of the exhaust pipe and burning their leg.

Note that in conversations with the dealer, they acknowledged that several others have reported this problem as well and that they are aware of the issue. They, however, do not believe that it is a design flaw or a safety issue, and have no intentions of fixing it. I believe this issue could easily be fixed without significantly altering performance/design/aesthetics, by simply making the exhaust pipes shorter such that they are slightly recessed underneath the bumper. Included are several photos documenting the severity of the burn that I received.
