**DOT Auto Safety Hotline**  
**Vehicle Owner's Questionnaire**  
**To Report Vehicle Safety Defects**  
1-888-DASH-2-DOT  
(1-888-327-4236)  
INTERNET: www.nhtsa.dot.gov/hotline

17 digit Vehicle Identification Number Located at bottom of windshield on driver's side: 1YVFP80C13 [REDACTED]  
Make MAZDA Model MAZDA6 Model Year 2003  
Date Purchased 6/28/03 Dealer's Name and Telephone Number PARK MAZDA 3306457275  
Original Owner  Dealer's City AKRON OH State OH Zip Code 44319 Engine: No: Cylinders 4 Fuel Type: GAS  
Transmission Type AUTO  Antilock Brakes  Cruise Control Powertrain Vehicle Component Code 160000 STRUCTURE Multiple Failure:

Incident Date(s) 01-JUN-2008 Failure Mileage 80000 Failure Speed Right Rear Fender Fell Apart From Rusted out holes.

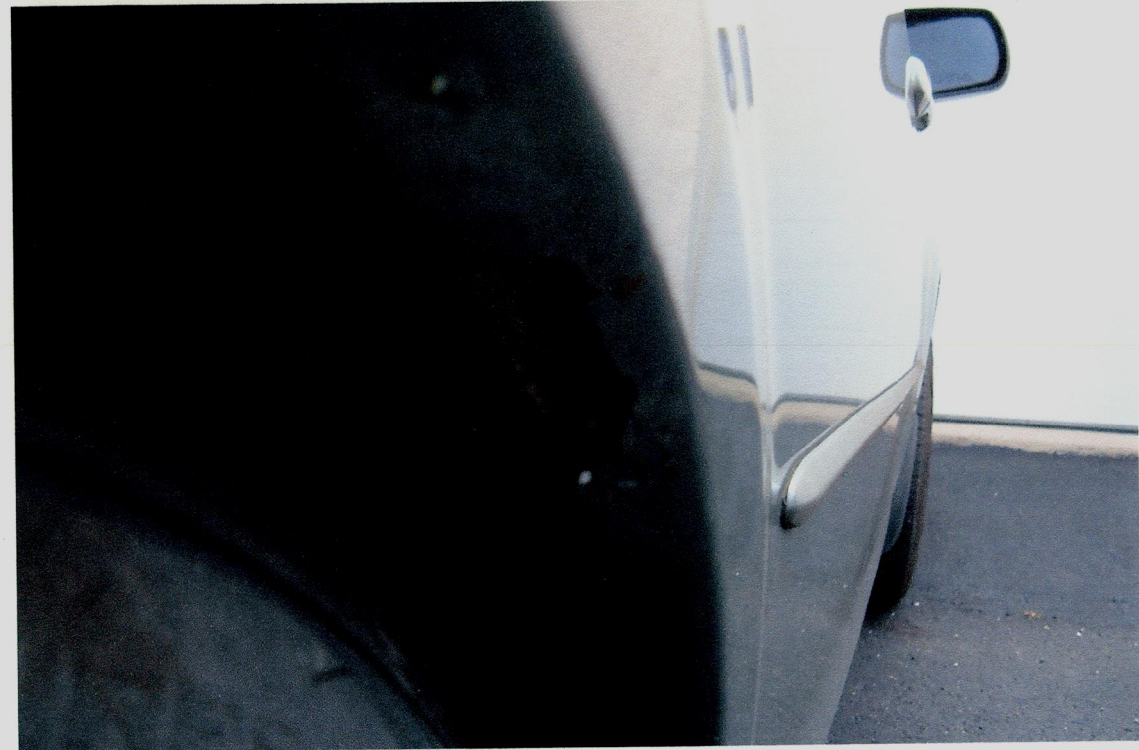
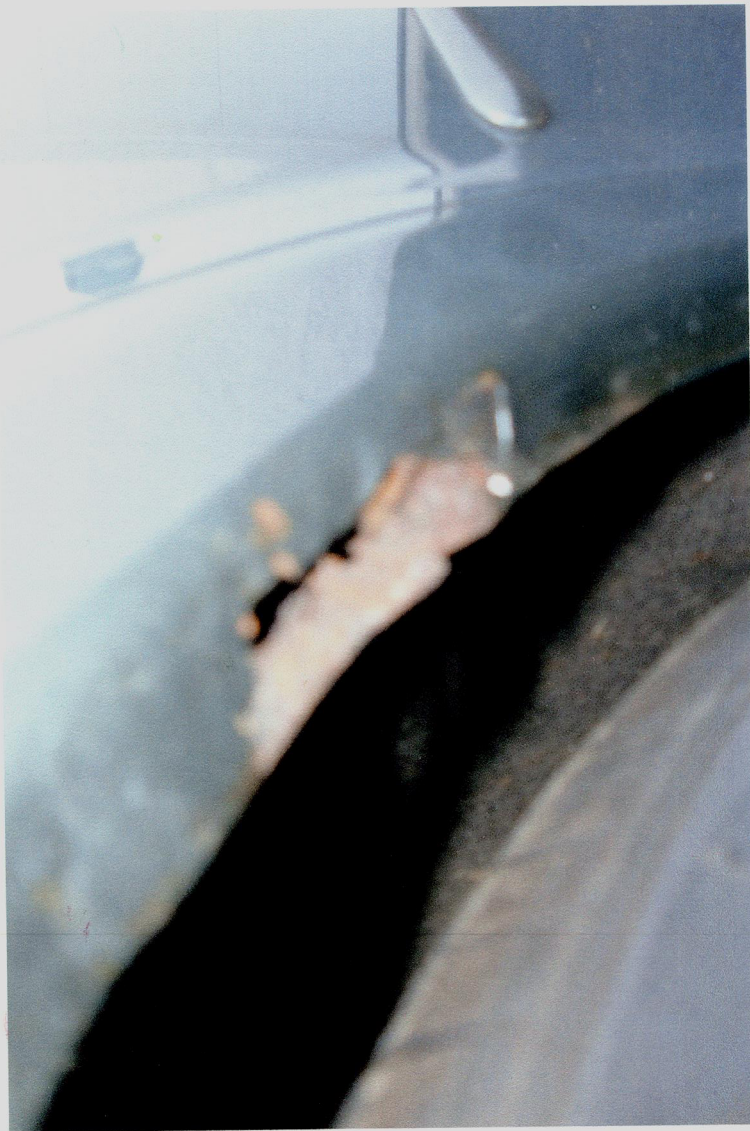
Missing Pieces Right Wheel  
Well 2003 [REDACTED]

Body Repair Shop  
pulled on  
this area.  
RESULTS!

Missing Pieces From Right Wheel  
Well 2003 [REDACTED]

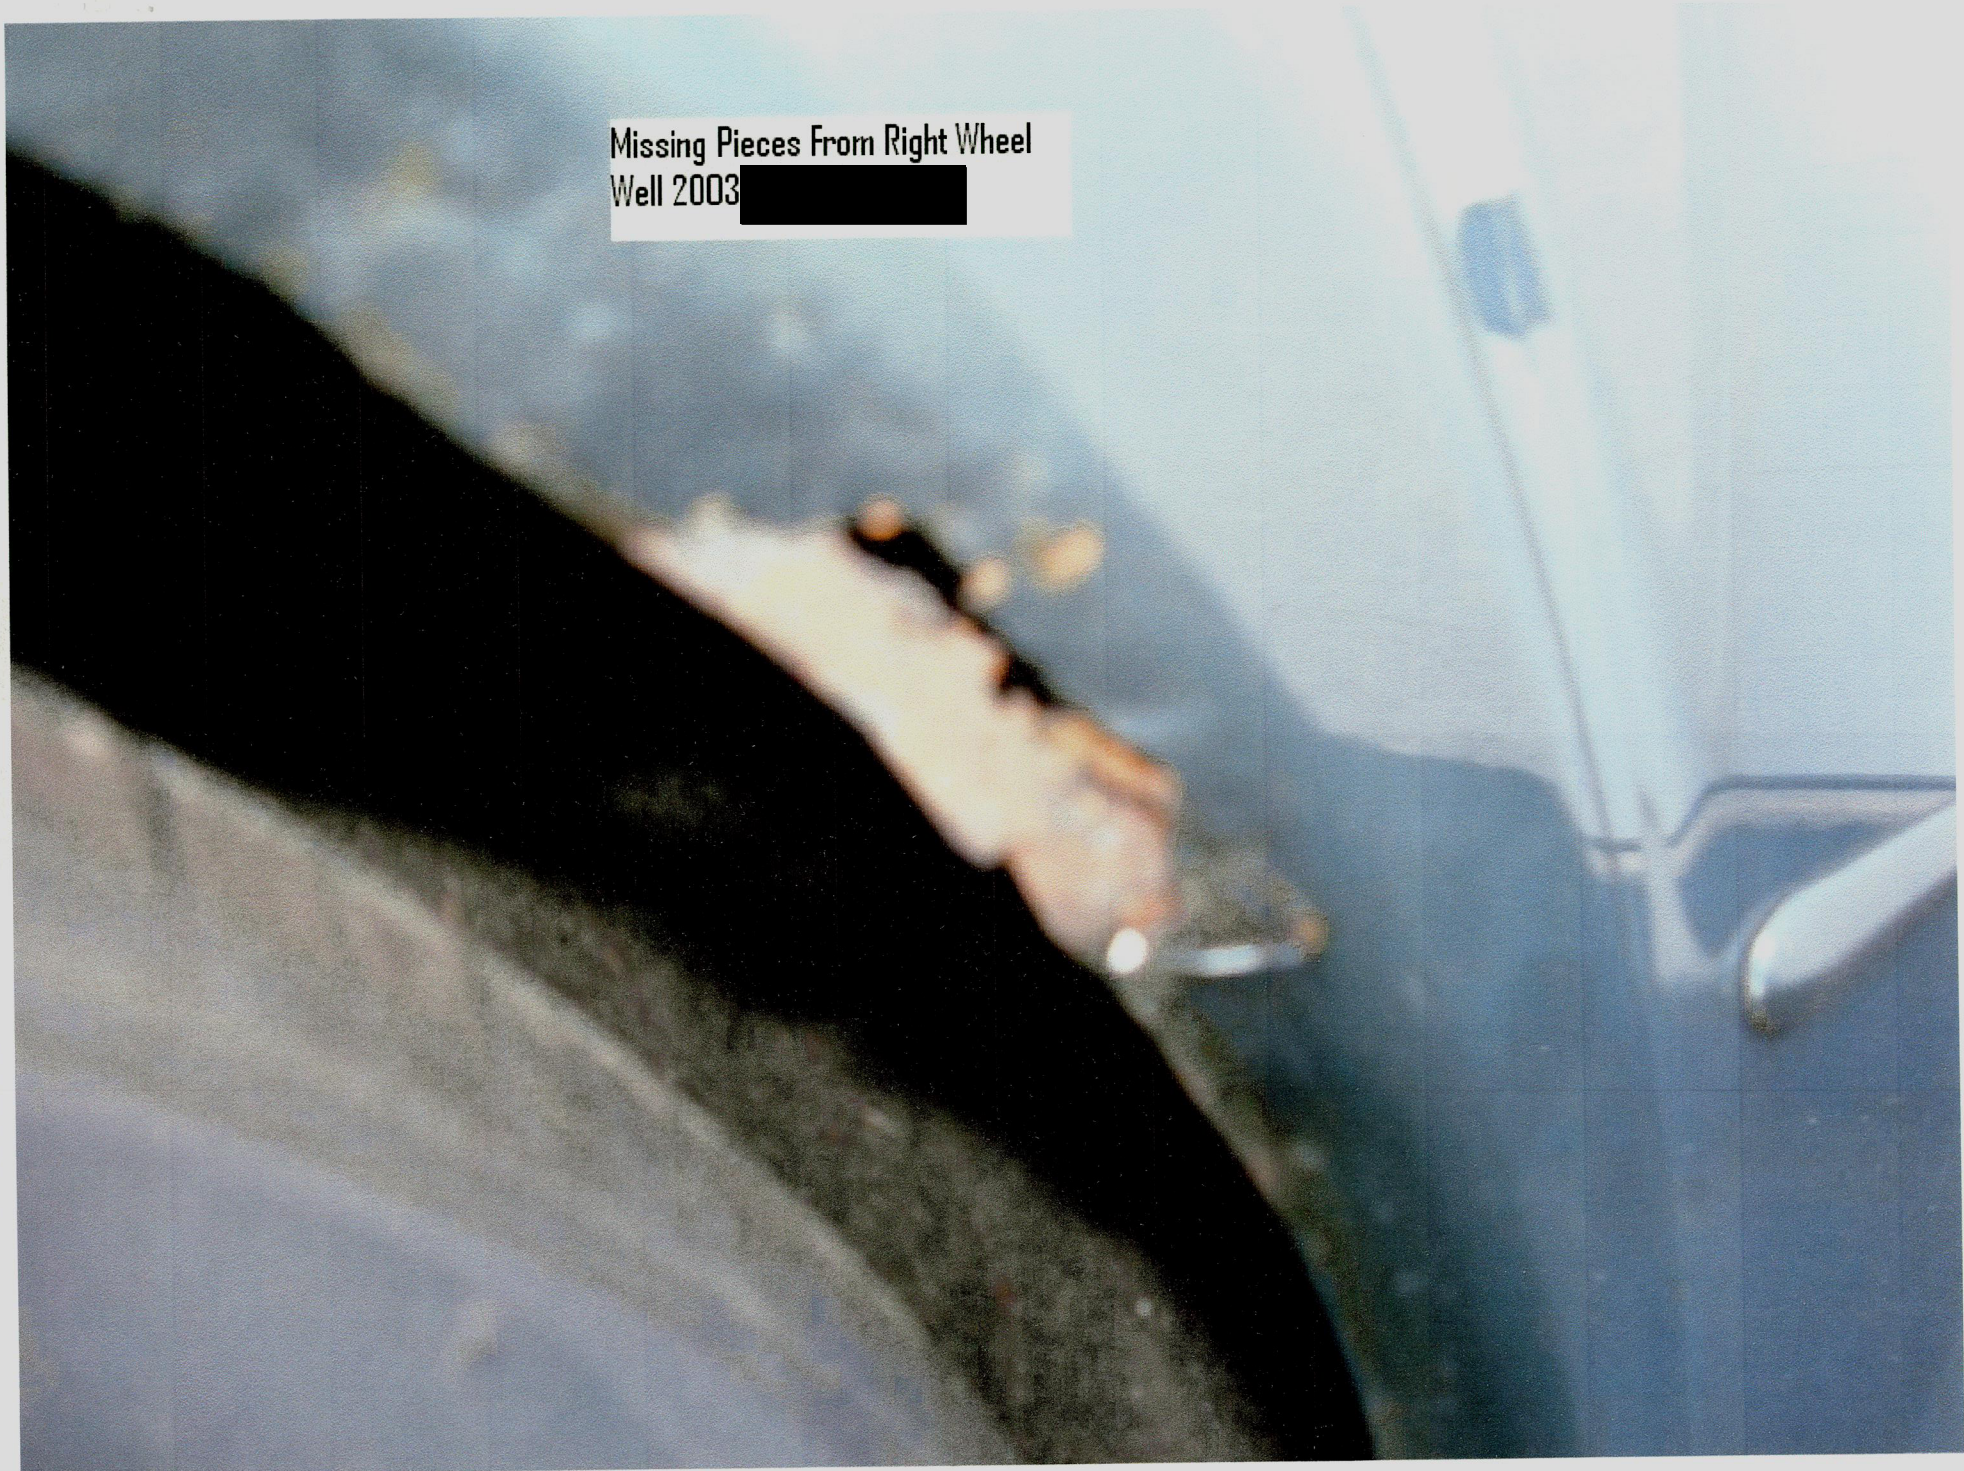
Broken Pieces From Wheel  
Well [REDACTED]

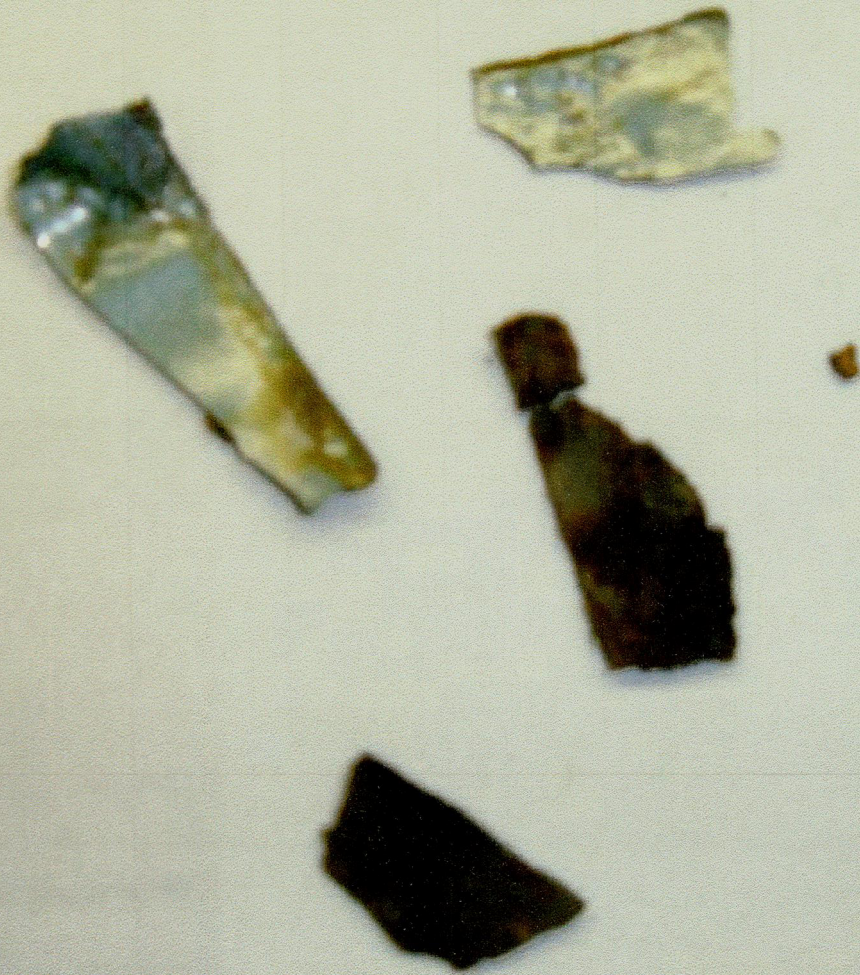
2003 Mazda [REDACTED]  
Right Side Wheel Well

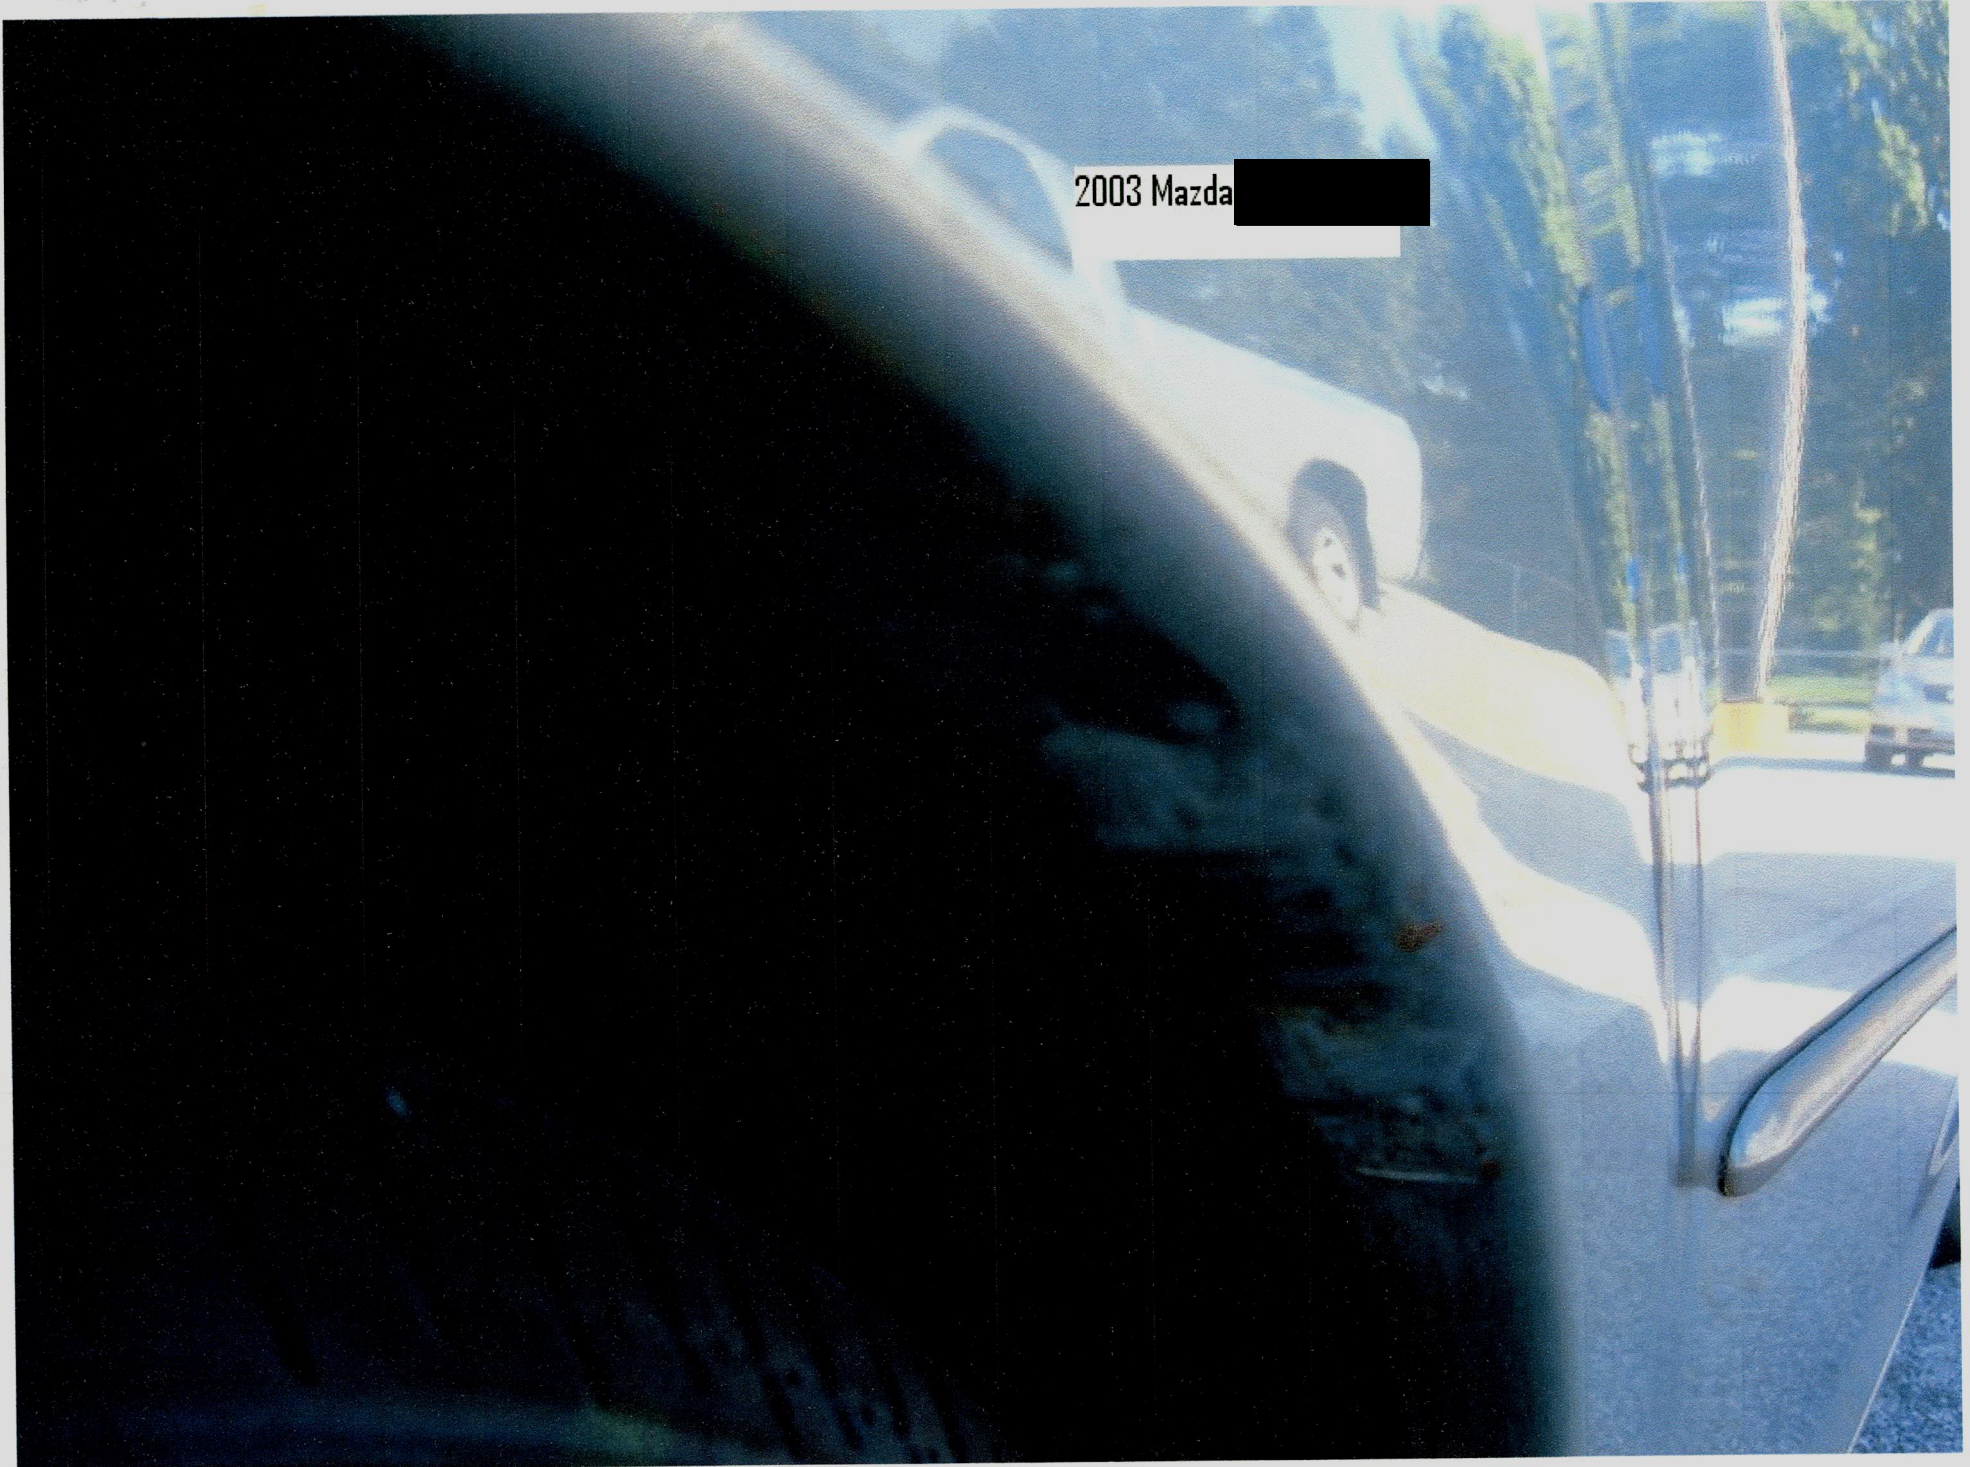
Silver Mazda - Parked @ Bridgestone Golf  
Tournament 8/2/08 Akron Ohio -Silver Left Wheel  
Well Unable to read Vin #

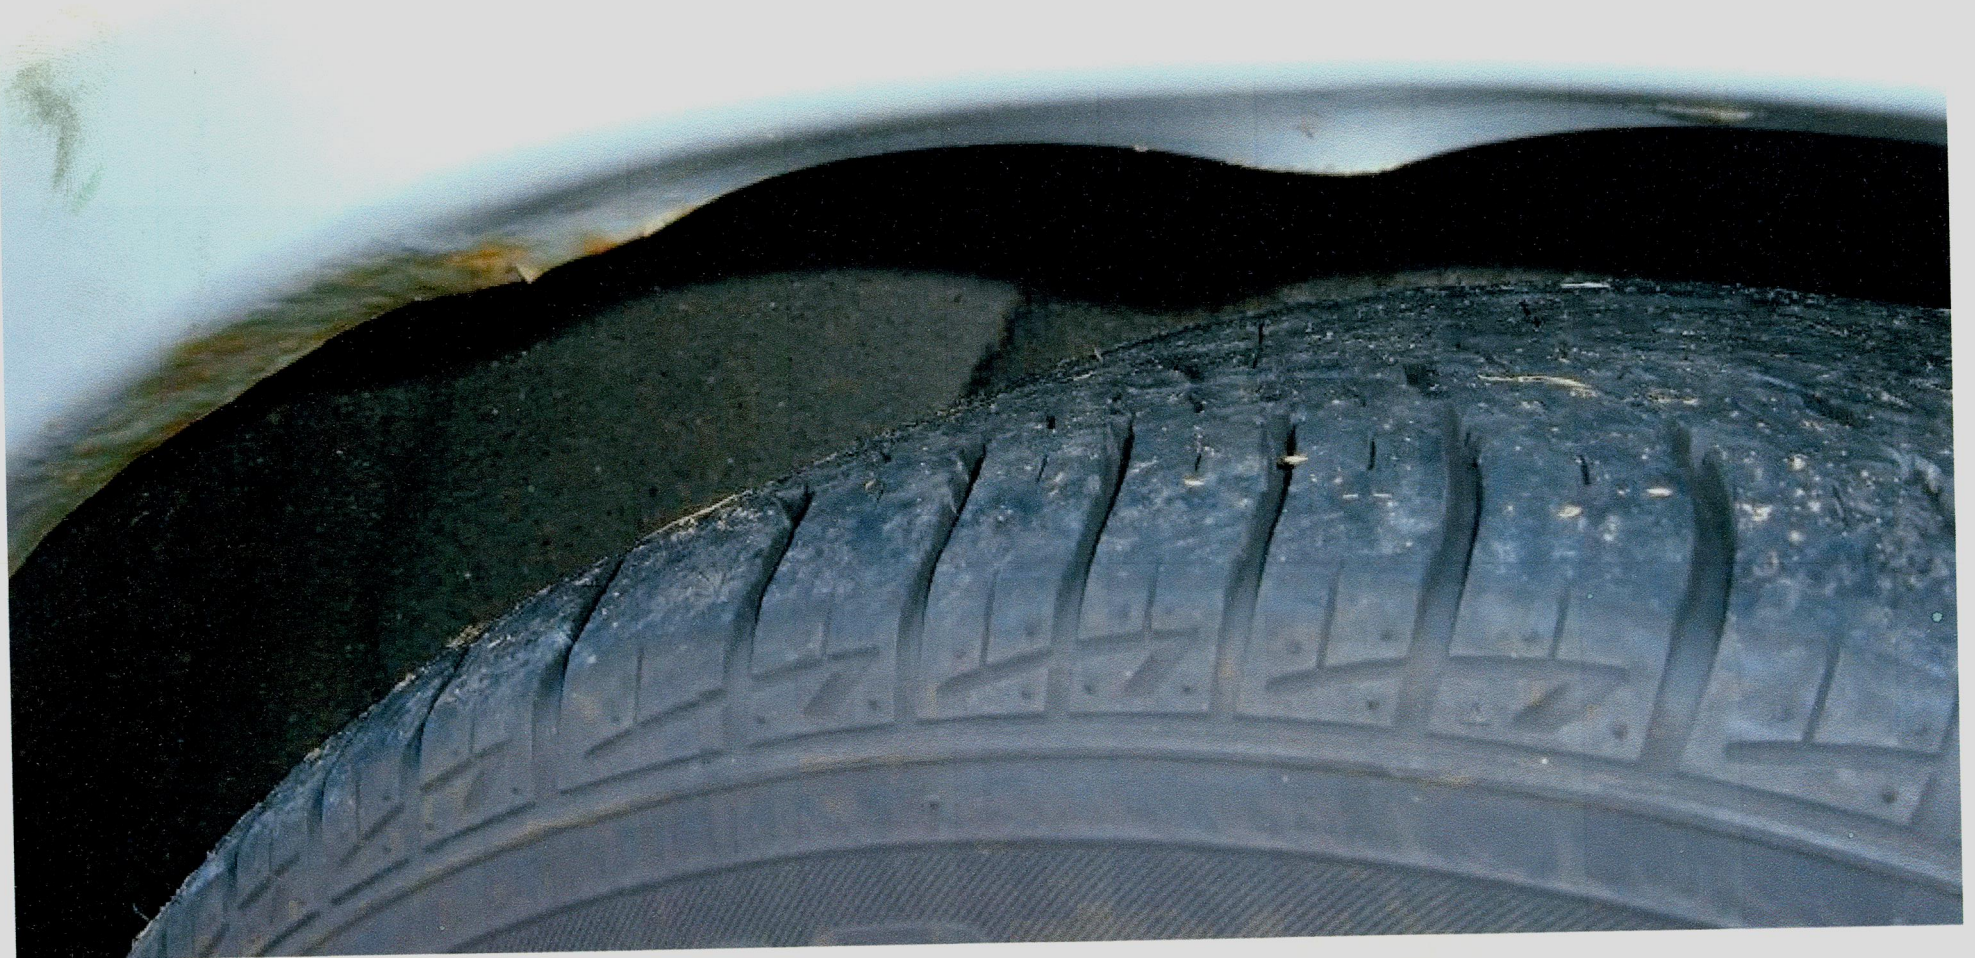
2003 Silver Vin 1YVFP80D53 [REDACTED]  
North Canton Ohio Huffsteller Auto  
Sales

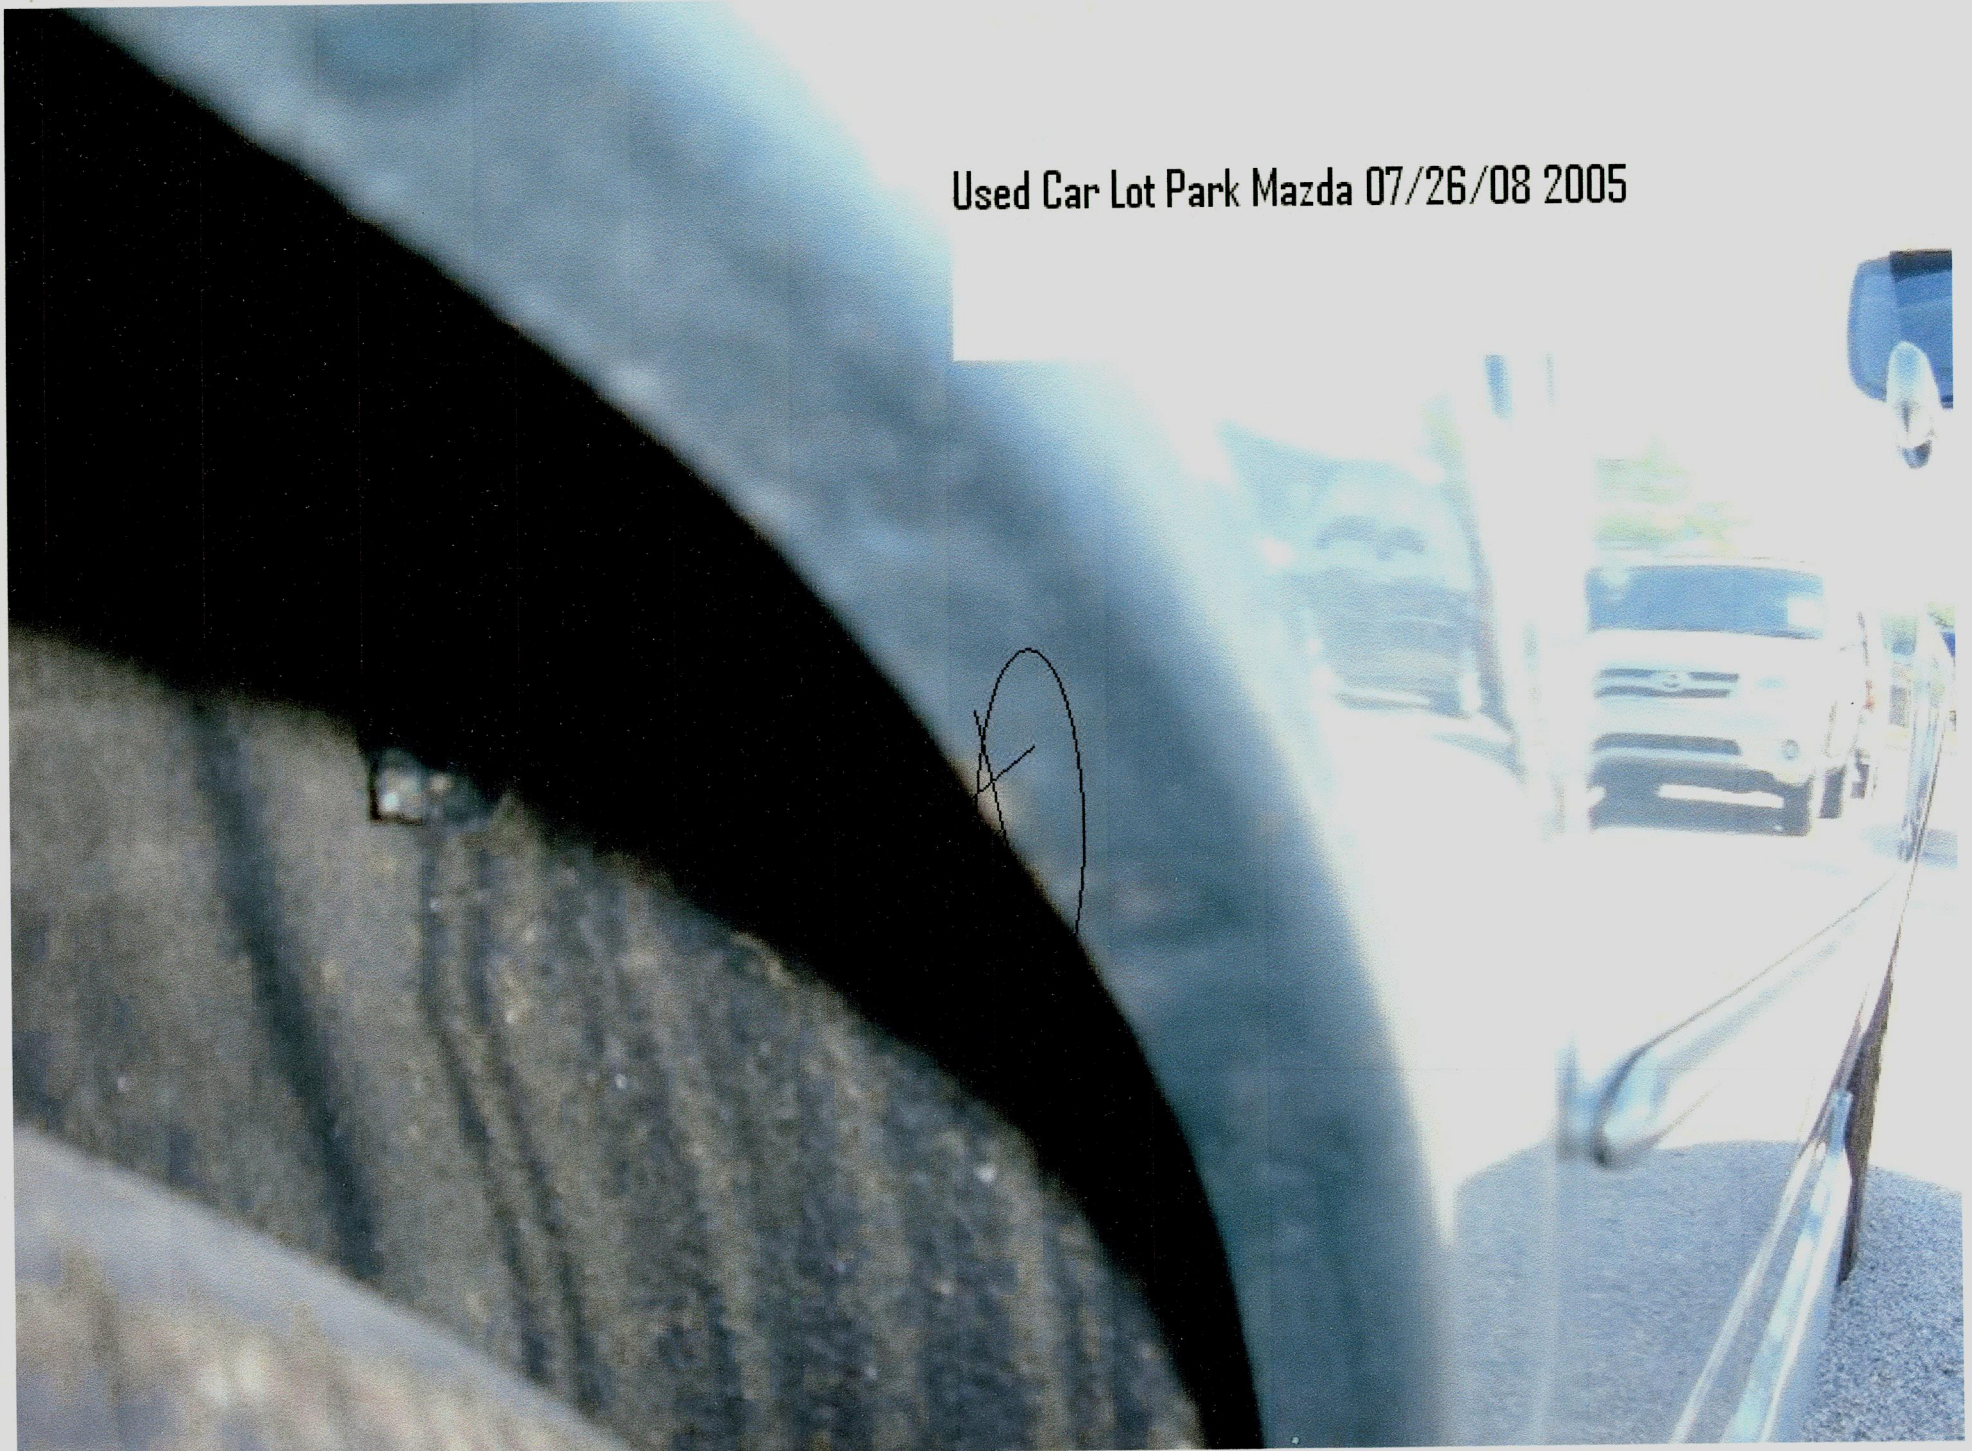
Byers Mazda Dublin Ohio 07/29/08

How IT STARTED.

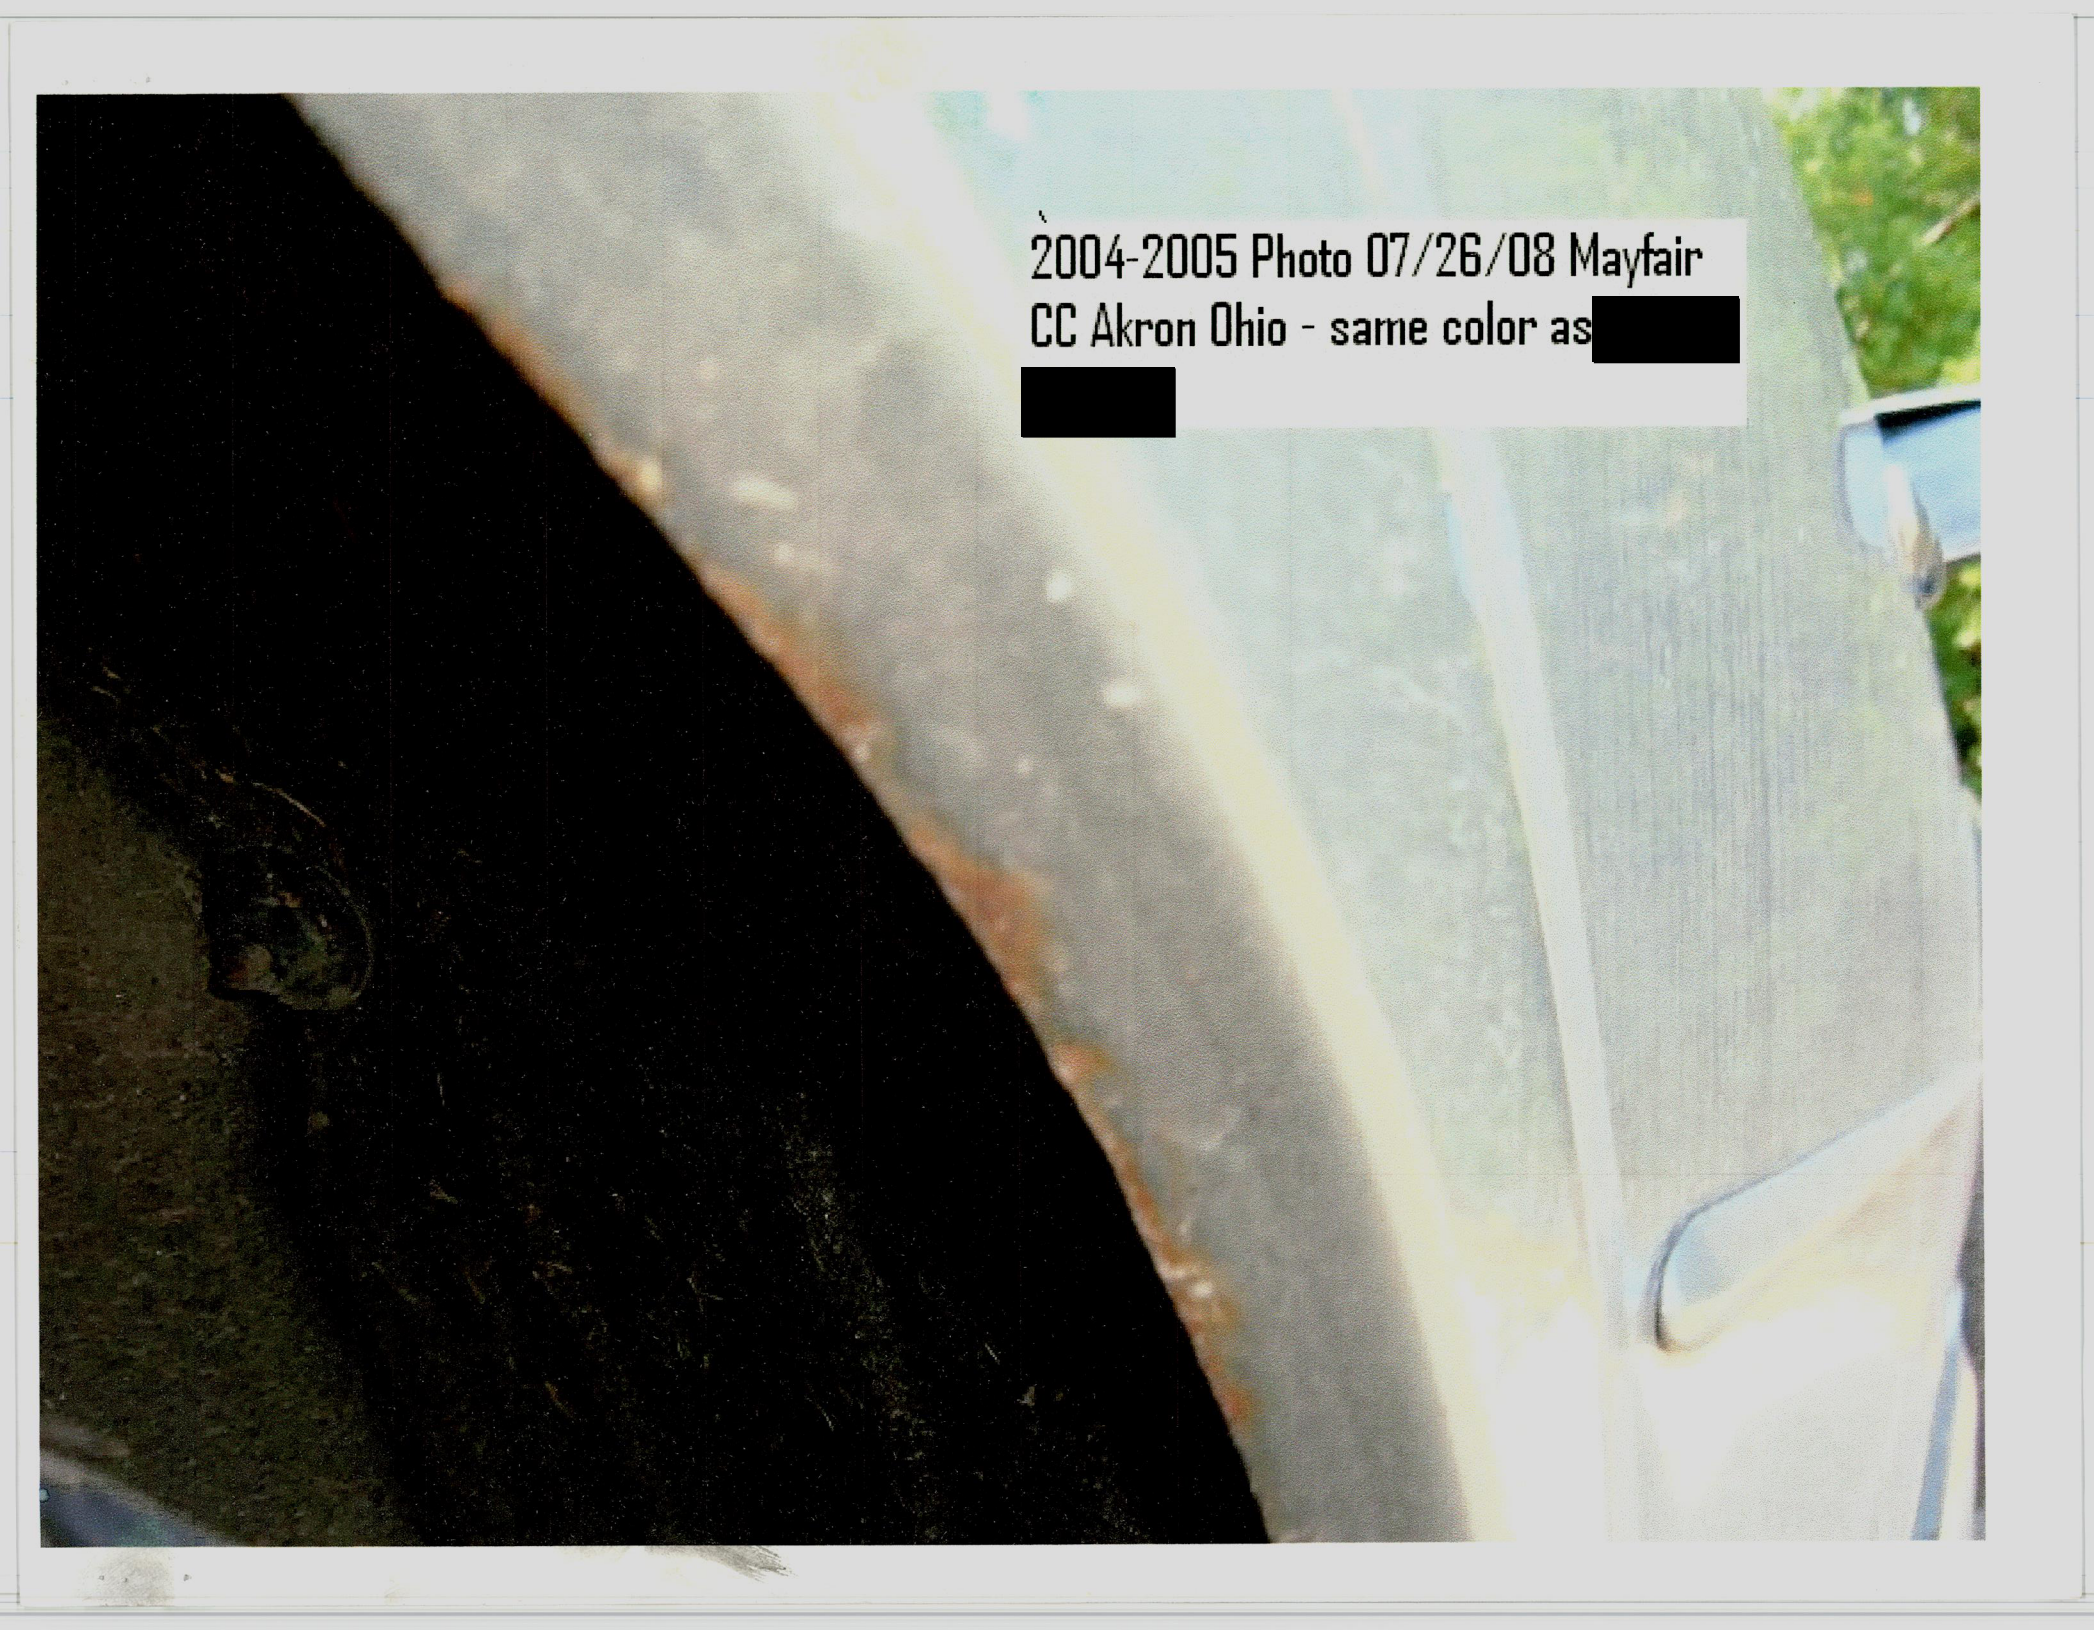
2004-2005 Photo 07/26/08 Mayfair  
CC Akron Ohio - same color as [REDACTED]  
[REDACTED]
