US Dept. of Transportation  
National Hwy. Traffic Safety Administration  
Office of Defects Investigation  
1200 New Jersey Ave. SE West Bldg.  
Washington D.C. 20590  
1-888-327-4236

This letter and supporting documentation is to call your attention to a safety related defect in a motorhome fuel tank that leaks diesel fuel and may cause catastrophic fire, personal injury or death.

Model year: 2000  
Model: U320  
Serial Number: withheld at this time  
Build Number: withheld at this time

**Basic Defect Description:**

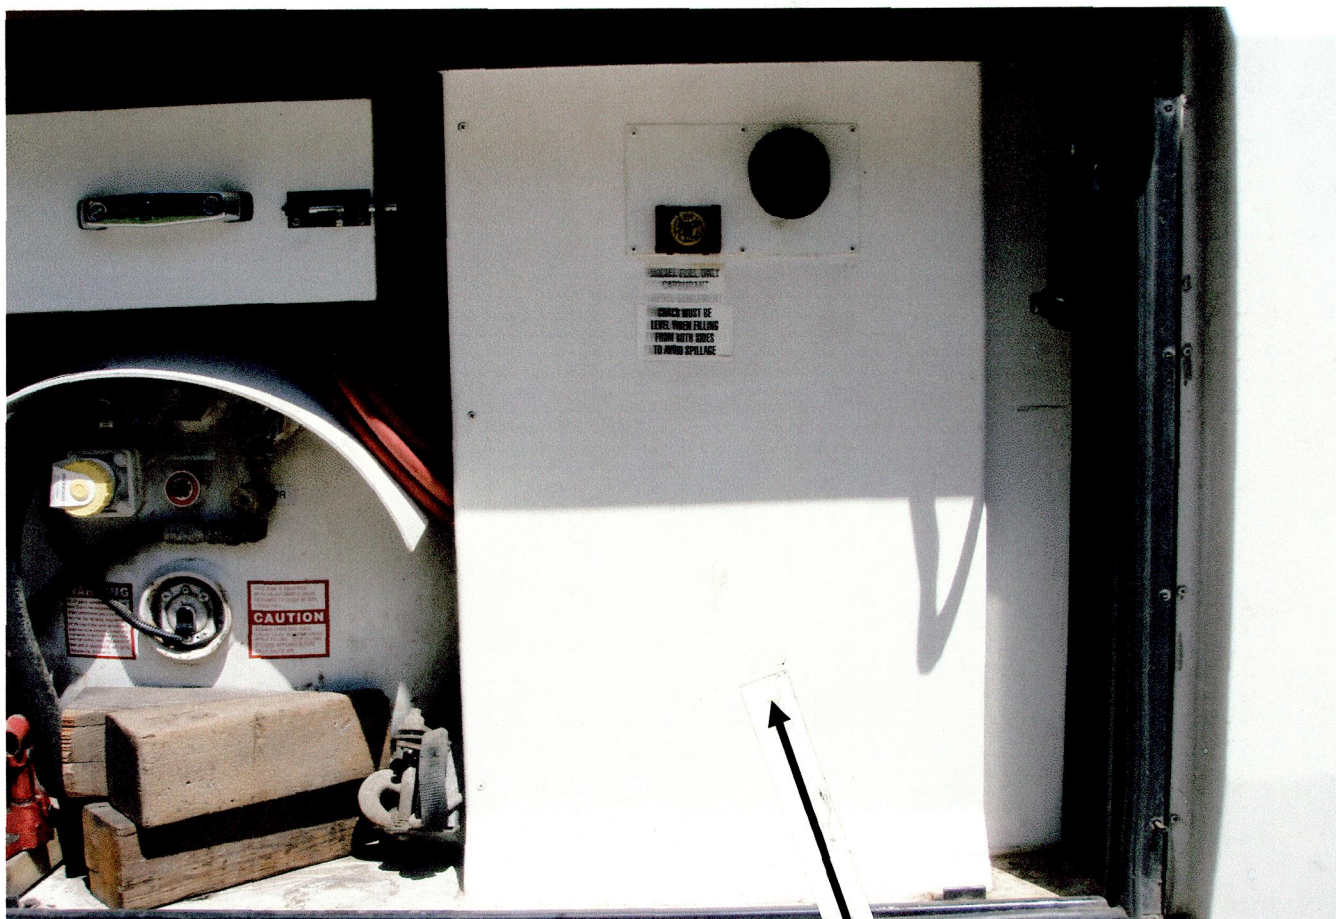
Fuel tank in question is located in a baggage compartment just below the main floor of the motorhome. The tank rests on top of the sub-floor. Sub-floor is located approx. one foot above ground level and the bottom of said sub-floor is exposed to the exterior. There are multiple baggage compartments in these motorhomes and the fuel tank rests typically in the most forward compartment (against the forward bulkhead). The fuel tank is further identified as being below and slightly rearward of the driver and passenger seats in the living compartment. See Picture #1.

Fuel tank is accessible for fueling from both the left side and right side of the motorhome. On this motorhome it is the right side in question. This baggage compartment is known as Passenger Forward Compartment, also known as Passenger 1 Compartment (Compartment Right-1 if counting from front to back). Located in this Compartment is the Diesel Fuel Tank. See Picture #1.

**PICTURE 1**  
FOREWORD PASSENGER SIDE BAGGAGE COMPARTMENT  
W/ FIBERGLASS COVERING OVER ALUMINUM FUEL TANK

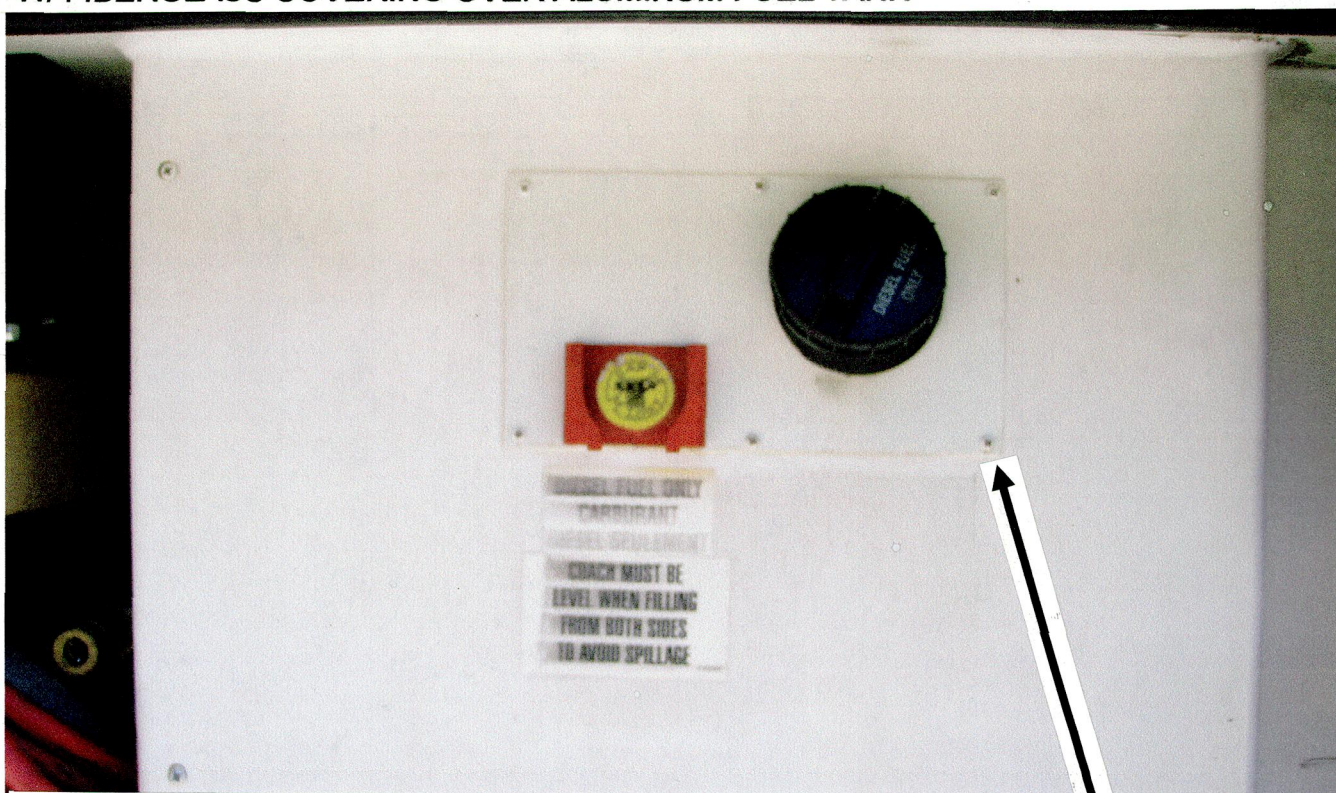
This Diesel Fuel Tank is covered with a "decorative fiberglass tank cover" as shown in Picture #1. (Prior to model year 1999 the decorative tank cover was not used.) There is a smaller fiberglass cover approx. 4.5" x 8" attached to the decorative tank cover. This smaller cover allows access to the fuel level sender unit (fuel gauge system). This smaller cover is secured with six small steel sheet metal screws. See Picture #2.

**PICTURE 2**  
FIBERGLASS COVERED ALUMINUM FUEL TANK. CLOSE-UP VIEW  
OF 4.5" X 8" SECONDARY FIBERGLASS COVER SURROUNDING FUEL  
FILLER NECK. NOTE: 6 SCREWS SECURING SECONDARY COVER.

The ideal repair would involve draining and cleaning the fuel tank and welding over the holes in the affected area. The six screws securing the 4.5" x 8" fiberglass cover probably cannot be shortened sufficiently (and still secure the cover properly) to prevent contact with the aluminum fuel tank. Therefore, some other securing method must be found.

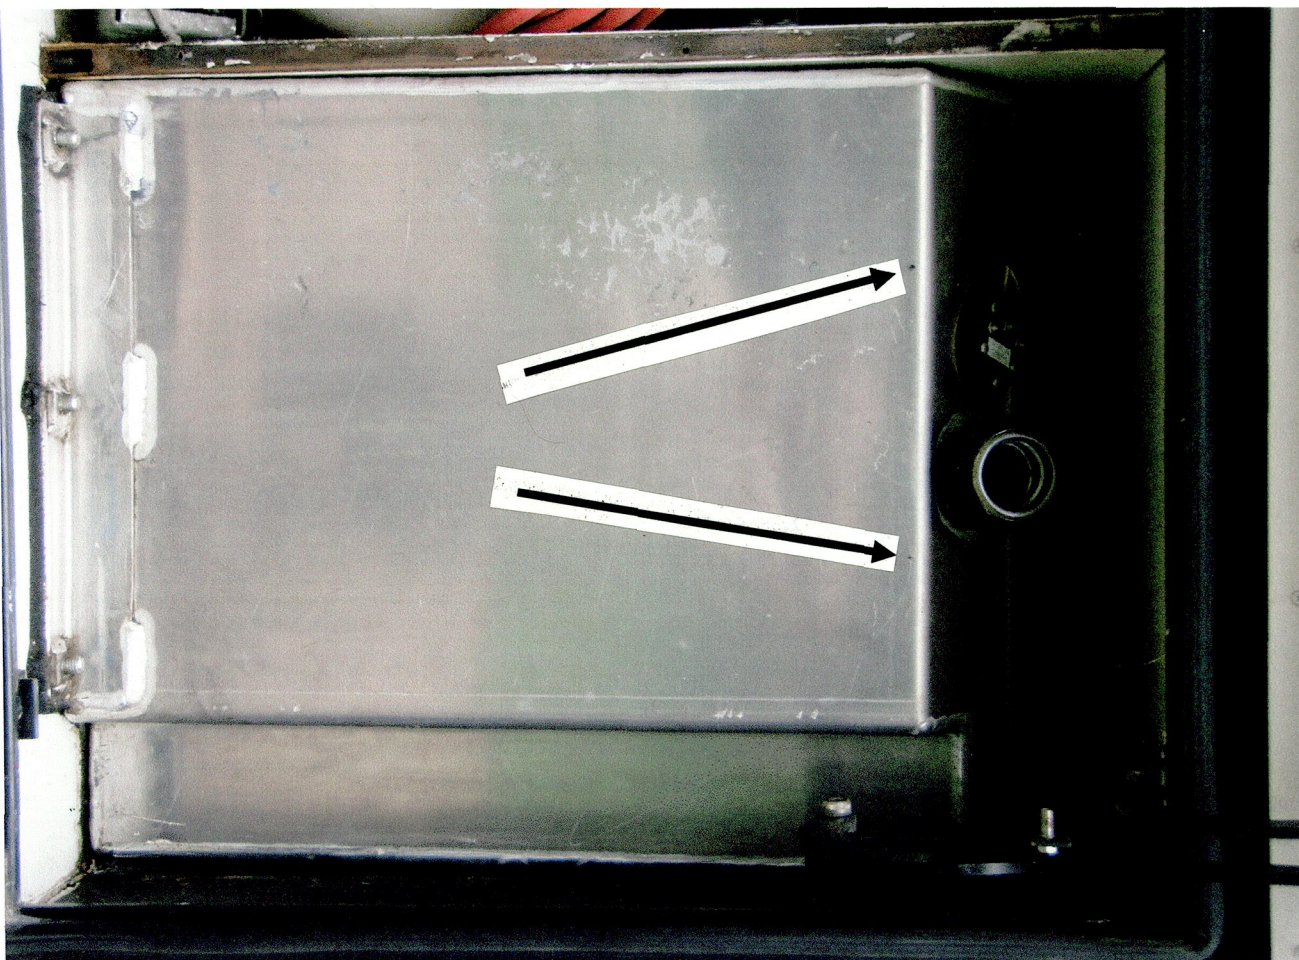
The company is apparently aware of the tips of these sheet metal screws rubbing against the aluminum fuel tank, because some of the screws have been cut or ground shorter than the others. It appears that normal road vibration is causing the screws to wear against the aluminum. With that in mind, time to failure is a function of miles driven.

Picture #3 shows the aluminum fuel tank with the decorative fiberglass tank cover removed. The arrows further show the location of two holes near the top of the tank.

**PICTURE 3**  
ALUMINUM FUEL TANK W/ FIBERGLASS COVERING REMOVED  
NOTE: TWO HOLES IN ALUMINUM TANK

On my motorhome, I used 2-part epoxy to fill in the holes. This is probably not a long-term fix. The sheet metal screws were ground down so no portion of the screw protrudes through and up against the aluminum tank wall.

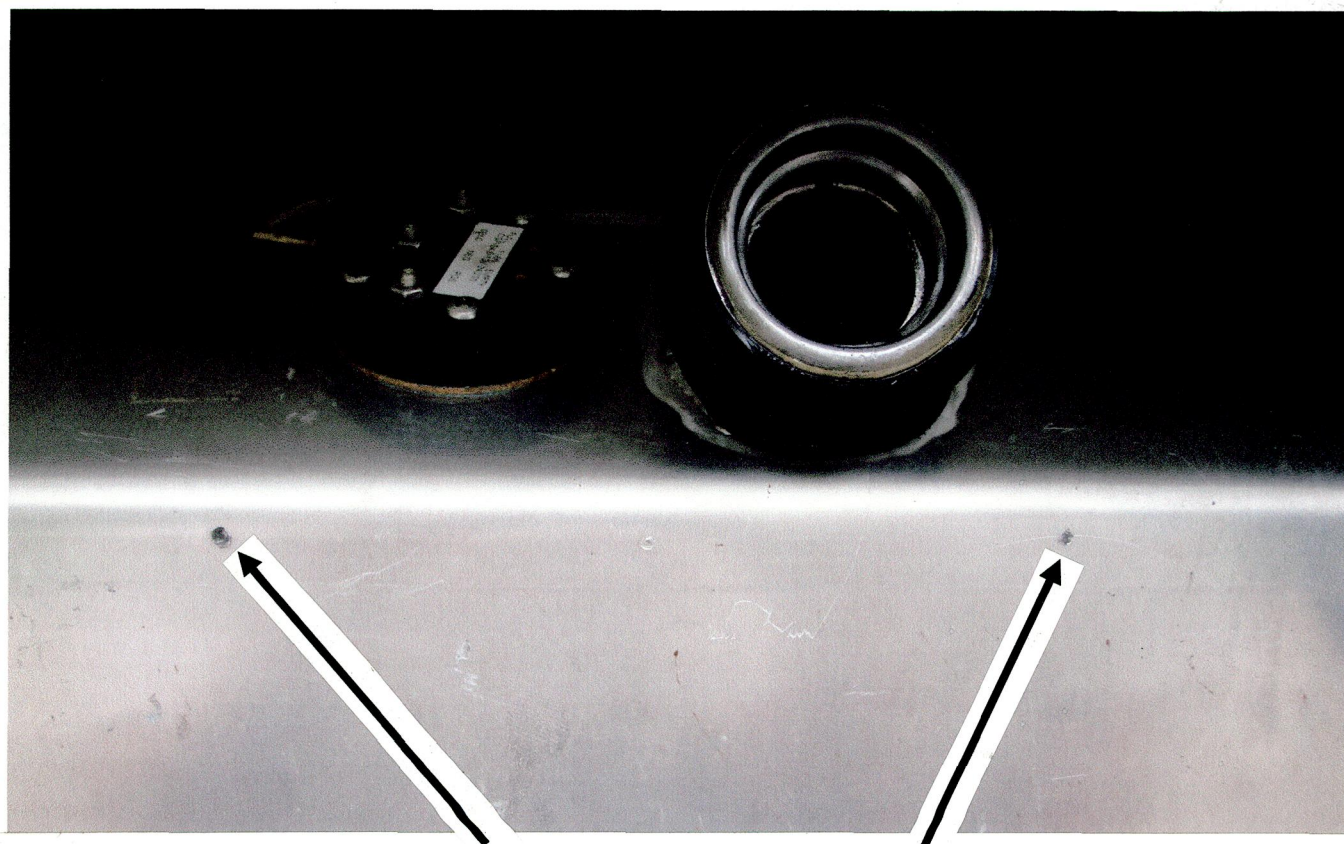
Picture #4 shows a close-up of Picture #3 above. The arrows further show the location of two holes near the top of the tank.

**PICTURE 4**  
ALUMINUM FUEL TANK CLOSE-UP OF FILLER NECK AREA  
AGAIN, NOTE: TWO HOLES, ONE RIGHT SIDE OF FILLER  
NECK AND ONE LEFT SIDE OF FILLER NECK

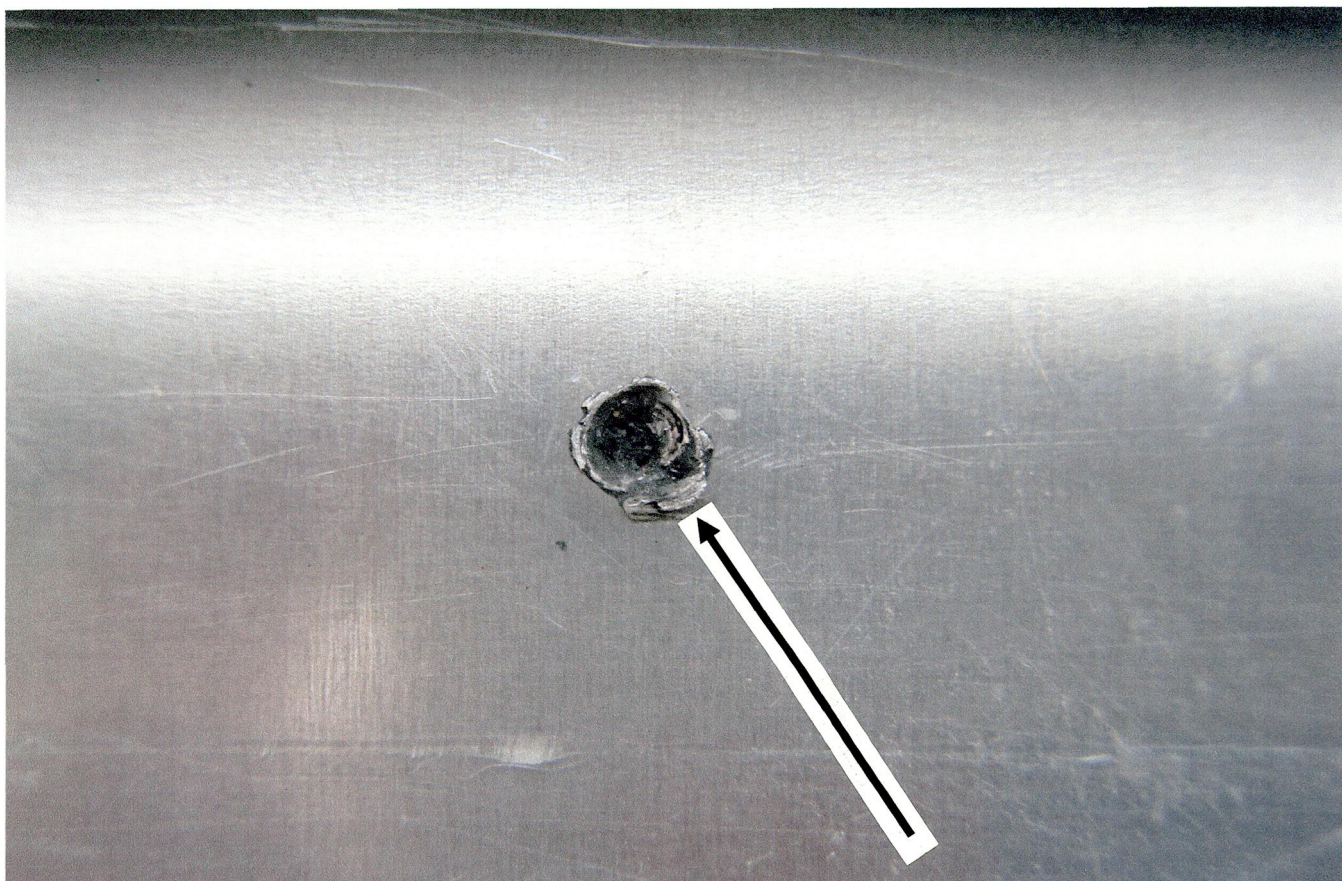
Picture #5 shows a close-up of the hole located to the left side of the filler neck. This hole penetrated the tank and allowed fuel to escape into the lower sub-floor.

**PICTURE 5**  
CLOSE-UP OF HOLE IN ALUMINUM TANK, LEFT SIDE OF FILLER NECK

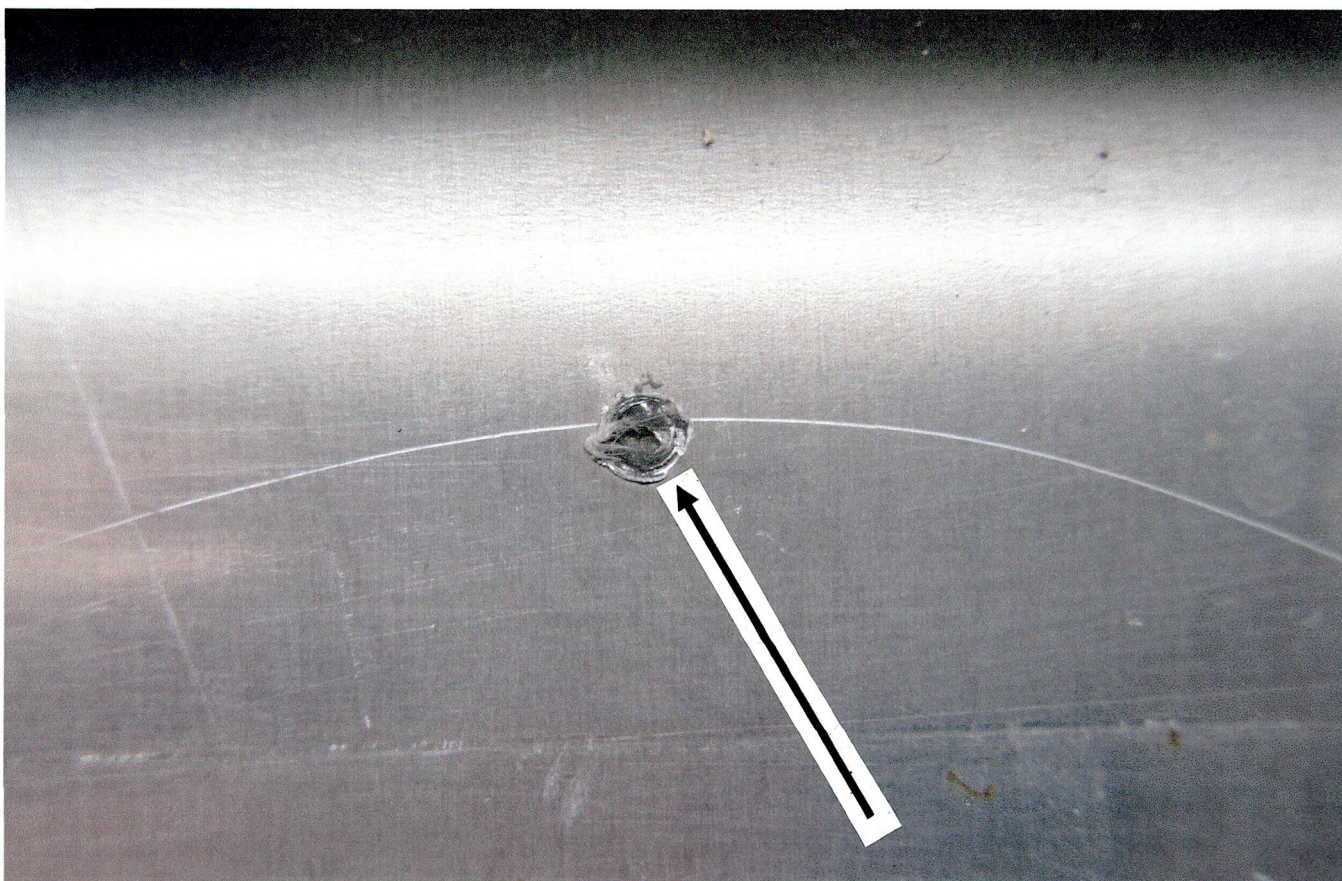
Picture #6 shows a close-up of the hole located to the right side of the filler neck. This hole did not penetrate the tank, but is estimated to have a depth of approx. 75% of the tank wall thickness.

**PICTURE 6**  
CLOSE-UP OF HOLE IN ALUMINUM TANK, RIGHT SIDE OF FILLER NECK
